# **Preliminary reconnaissance report on the Provincial Highway 86 Bridge No.24**

**Bridge Division, NCREE**

**Feb. 15. 2016**

# **Provincial Highway 86, Bridge No.24**

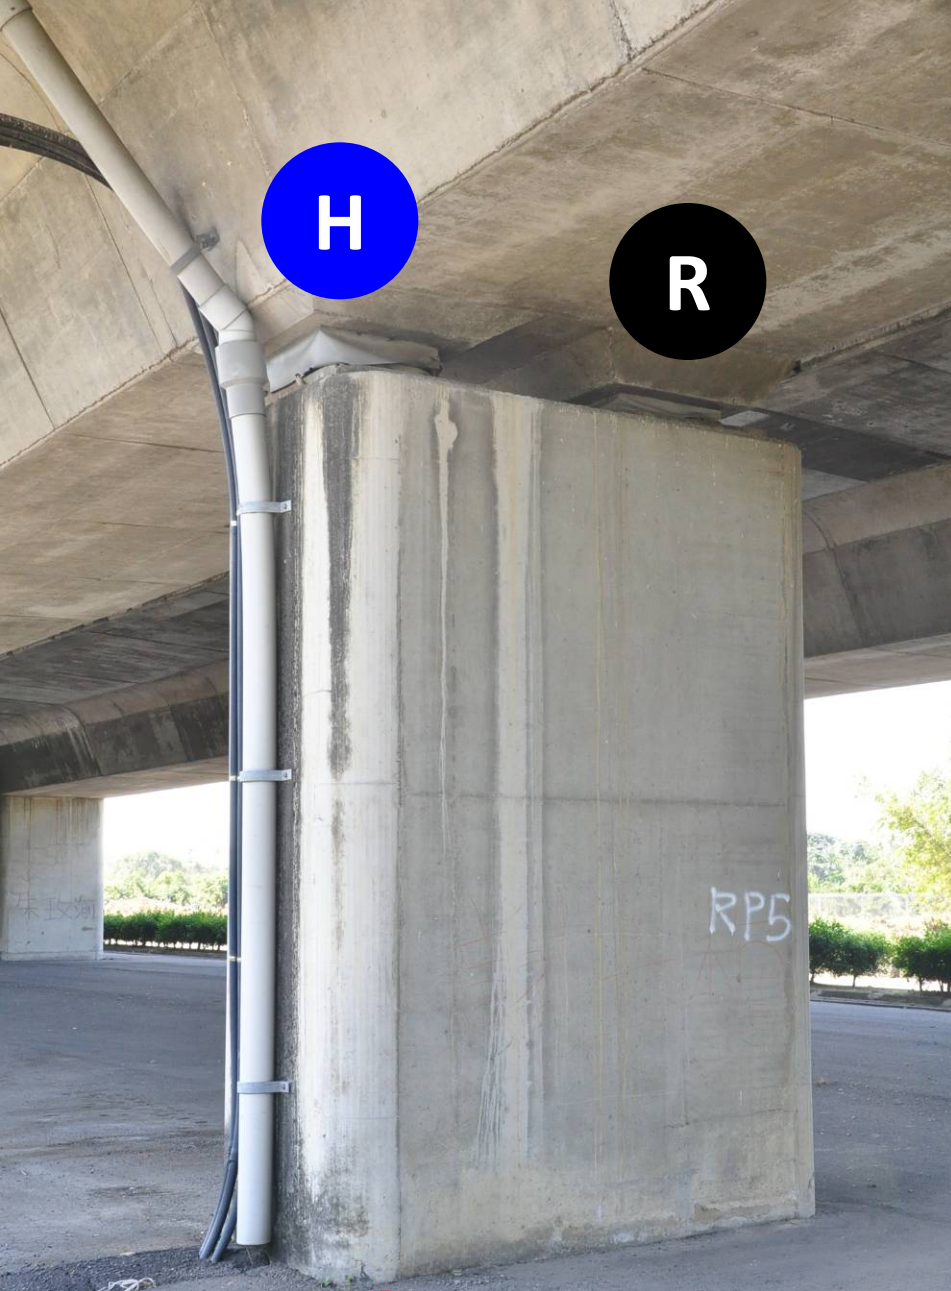
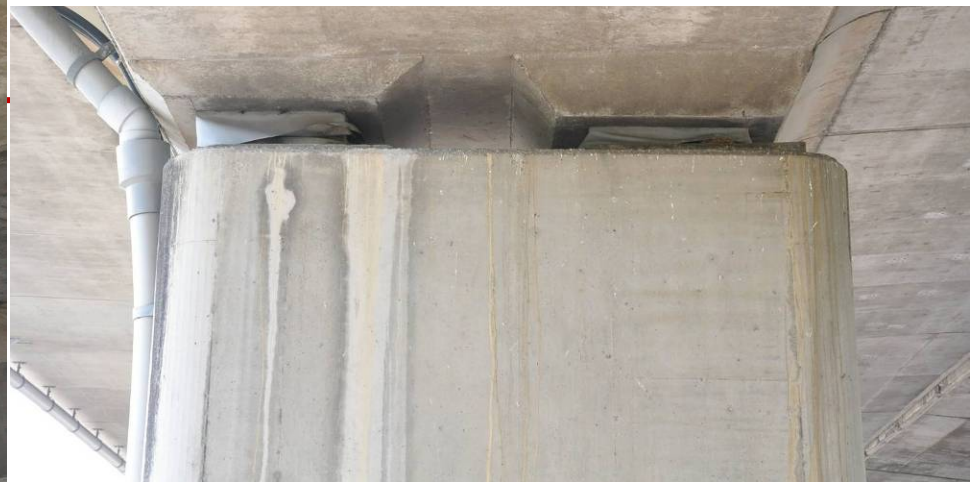
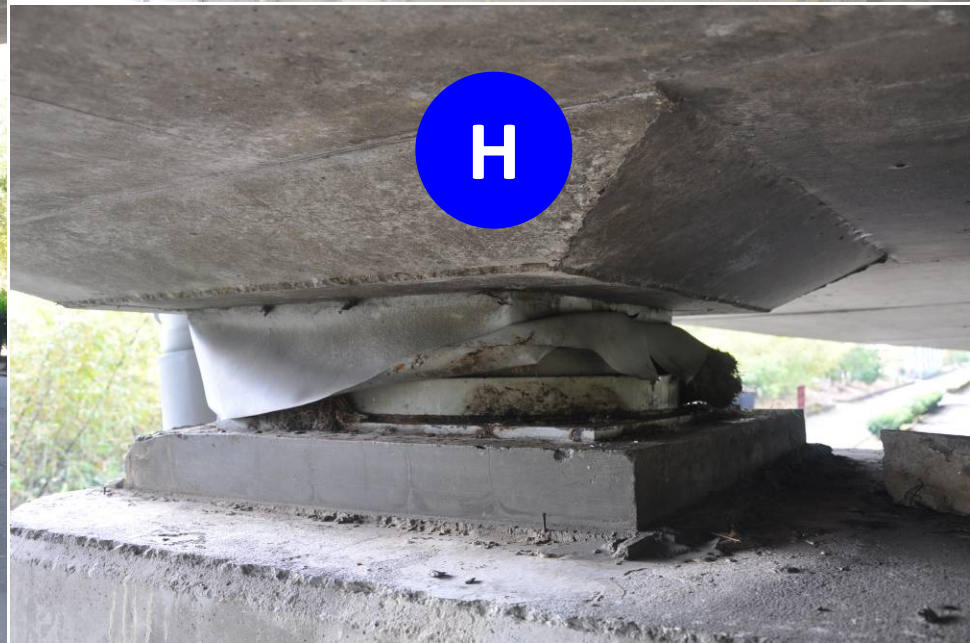
**RP5**

# Residual lateral displacement

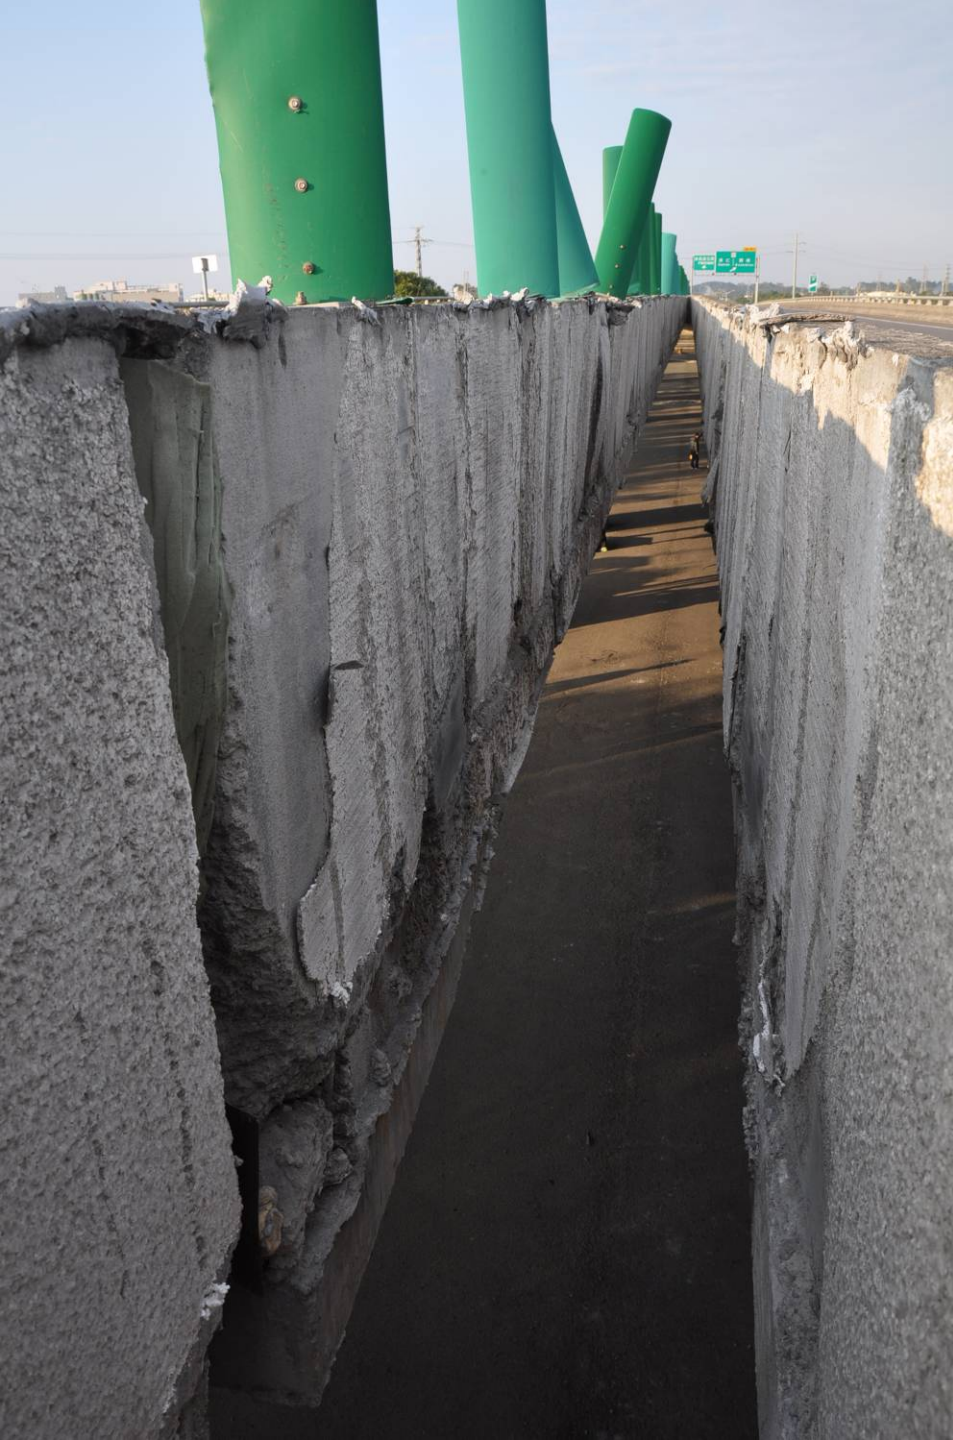
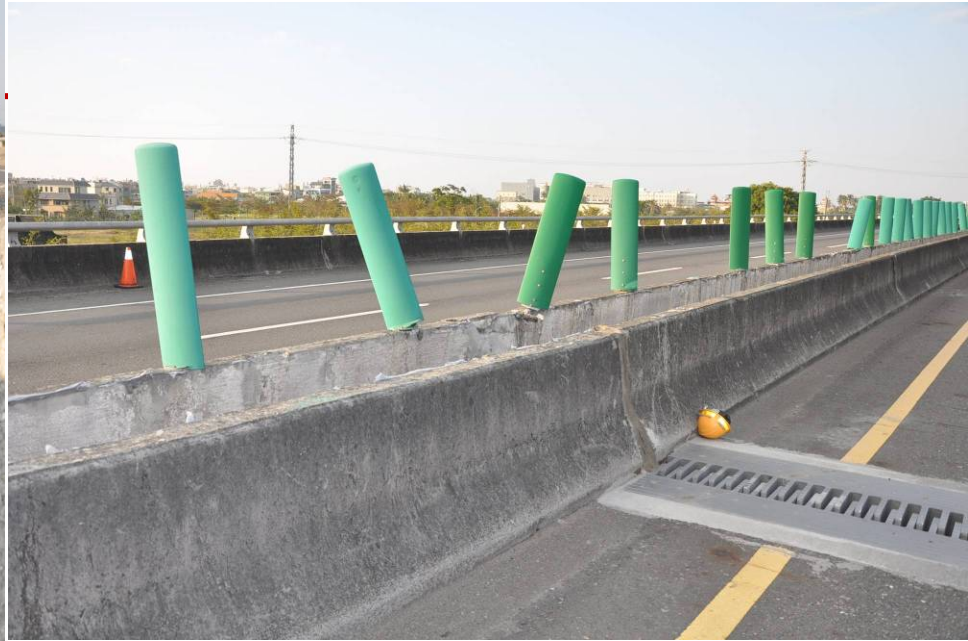
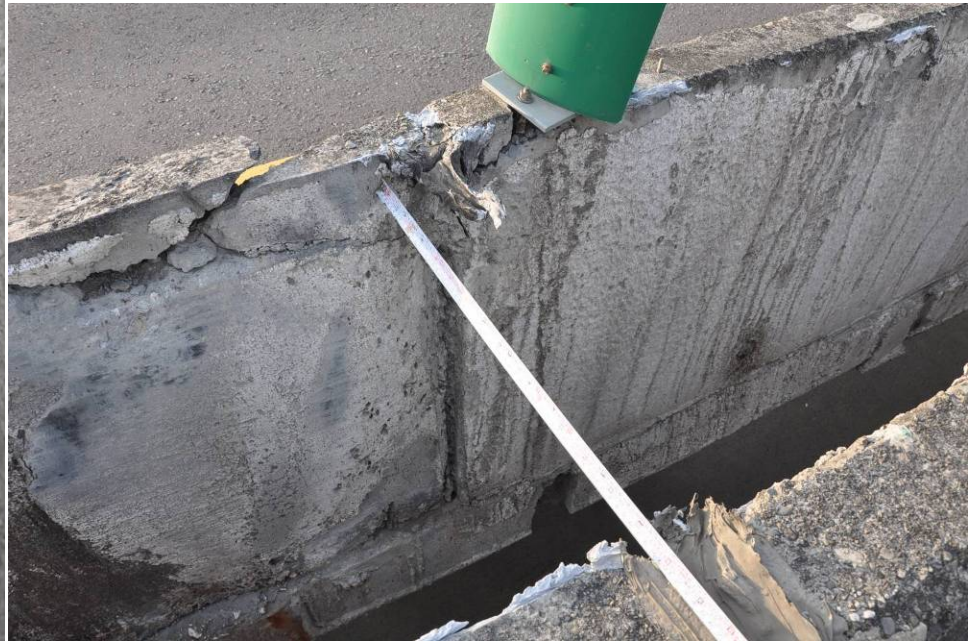
**Gap between two bounds @ Exp. Joint**

**Gap @exp. Jt. 59cm**
