Reconnaissance Report on Seismic Damage Caused by Guanshan Earthquake and Chihshang Earthquake, Taiwan, 2022 (third edition, v3.0)

Chung-Che Chou, Chiun-Lin Wu, Juin-Fu Chai, George C. Yao

**NCREE, Taiwan
September 23, 2022**

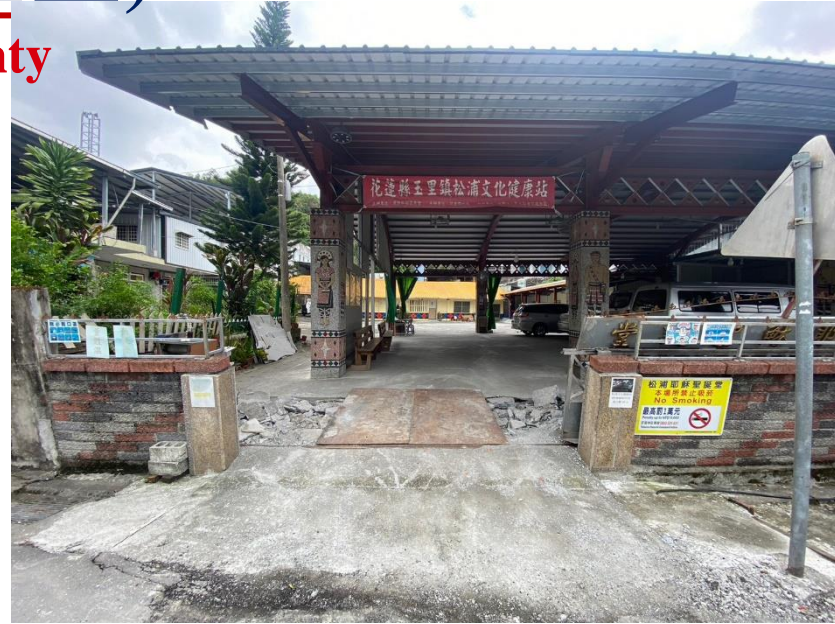
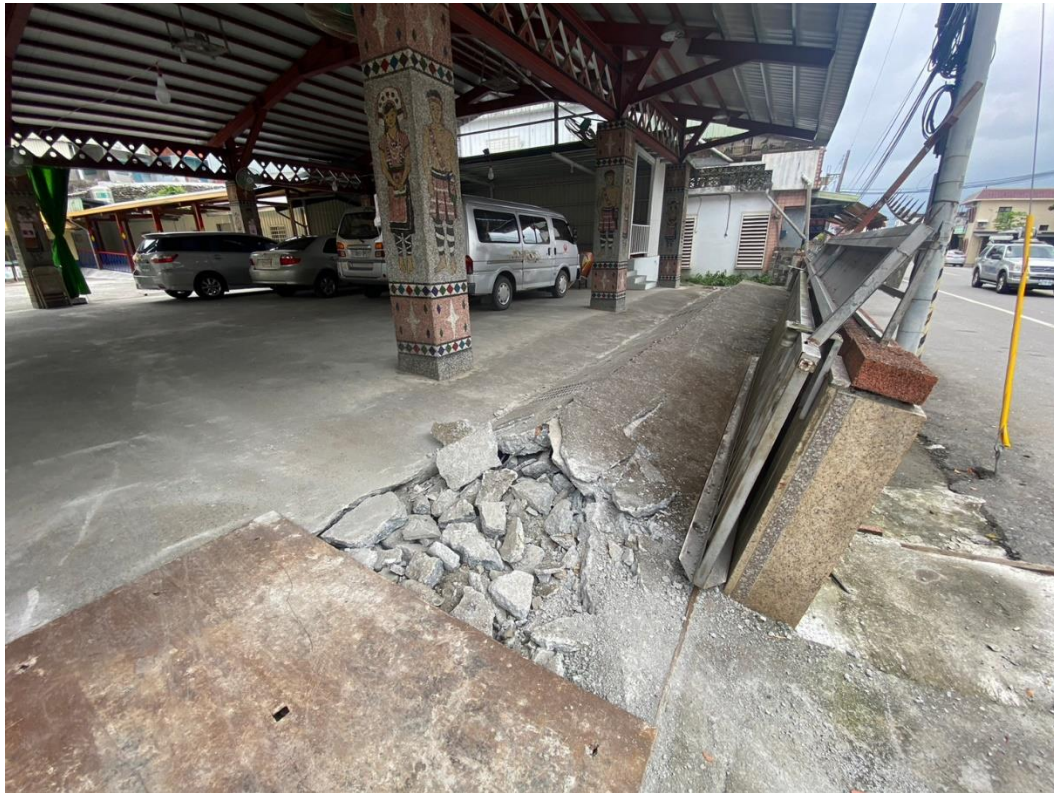
Songpu Church (松浦天主堂)

- Ground Uplift about 20 cm
- Crack Length about 7 m
- Exterior Wall Sloping

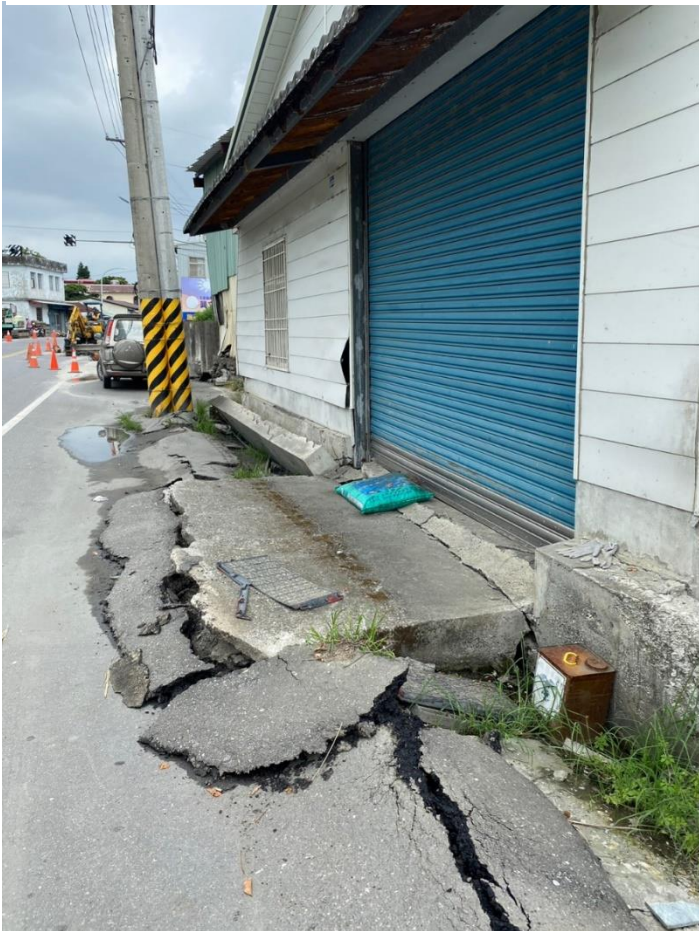
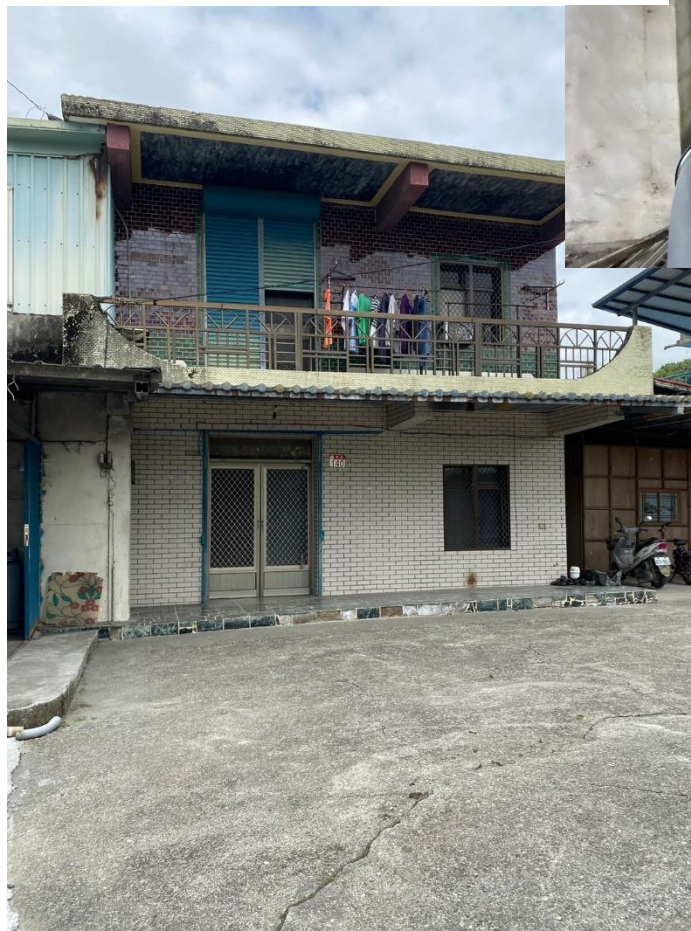
Residential in Songpu (松浦140號)

- Ground Uplift, Cracking, and Slope about 2°
- Brick Wall Collapsed

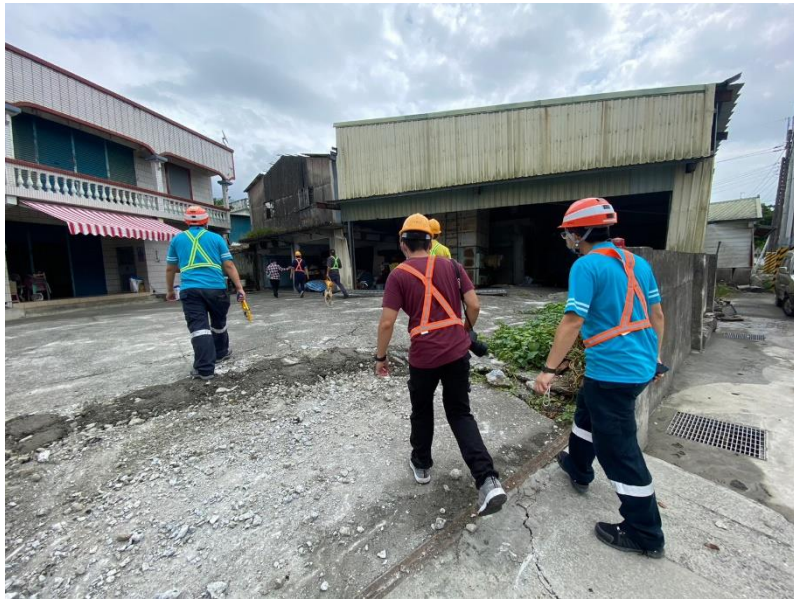
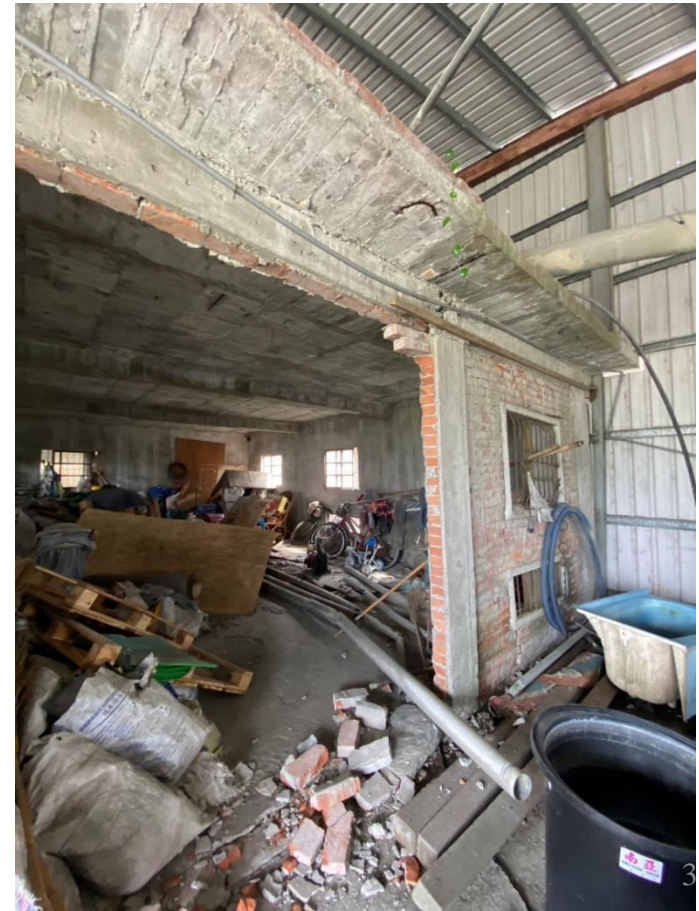
Residential in Songpu (松浦141號)

- Ground Uplift
- Plastic Hinge in Column
- Brick Wall Collapsed
- Rebar rusted

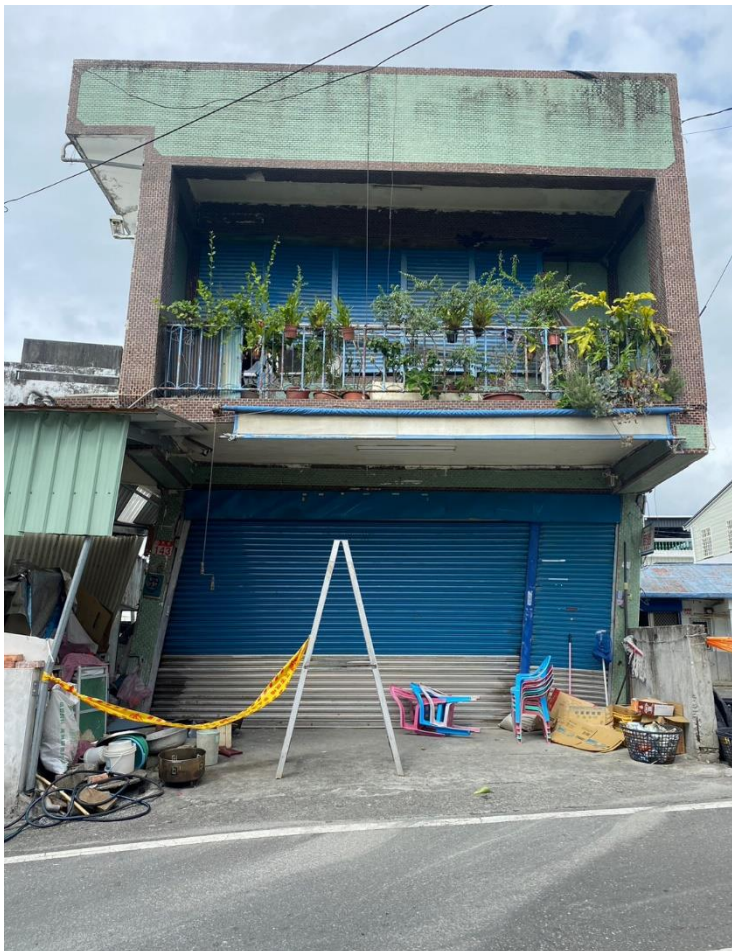
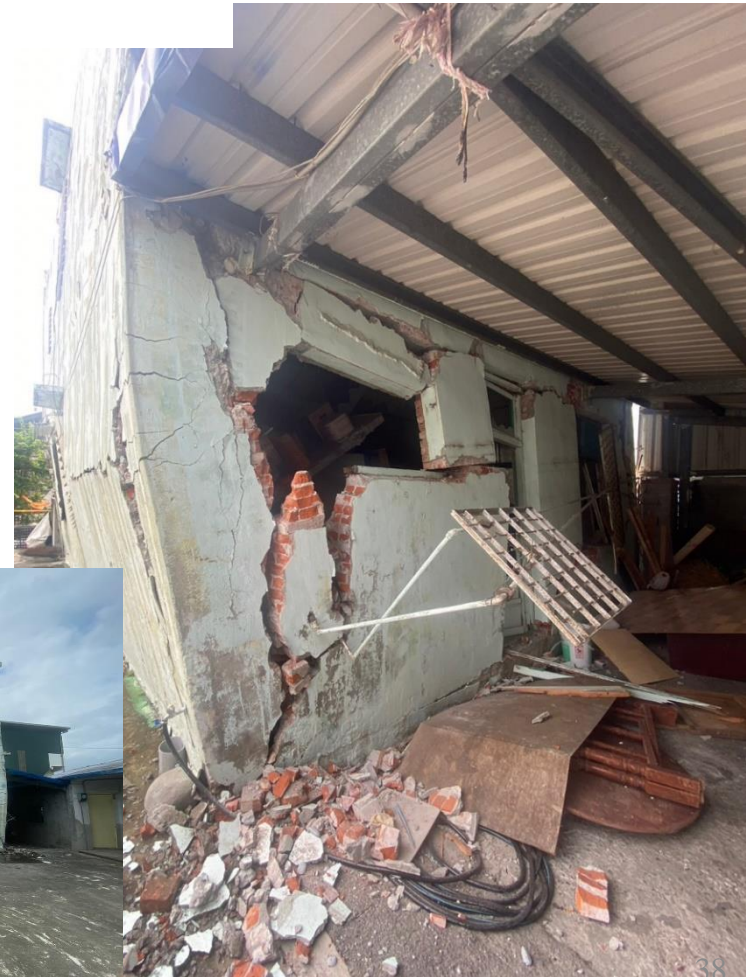
Residential in Fuyin Community (萬麗143號)

- 1F for commercial use, 2F for Residential
- Exterior Cracking, Brick Wall Collapsed

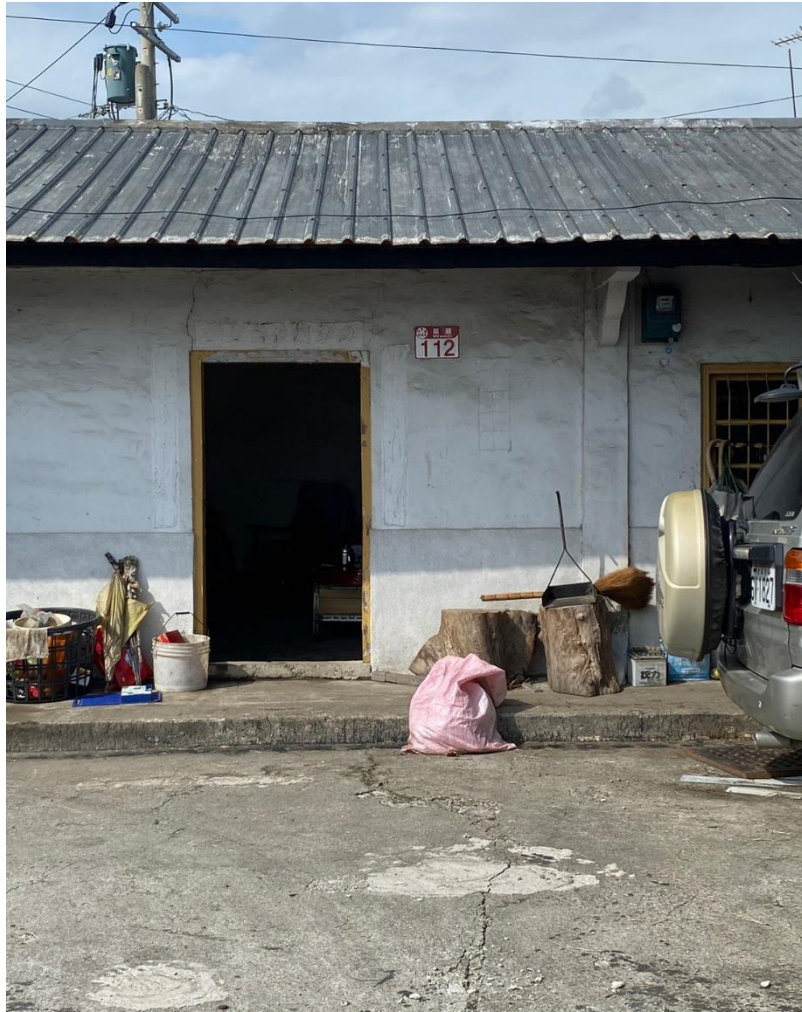
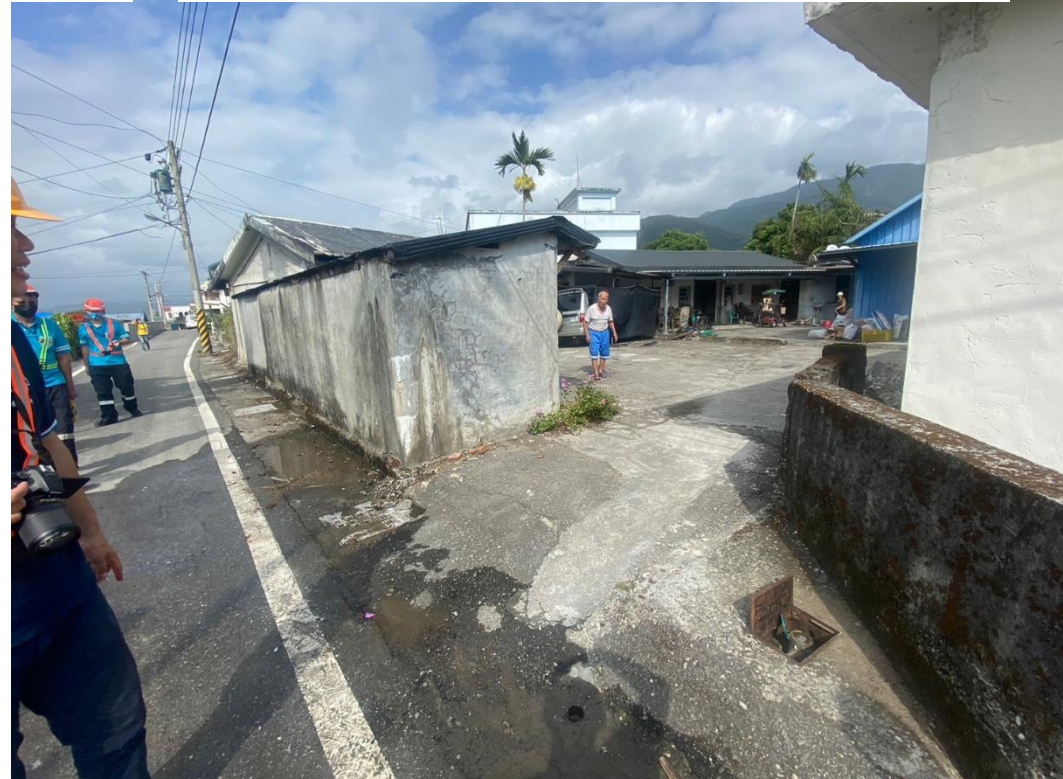
Residential in Fuyin Community (萬麗112號)

● Ground Uplift and Cracking

● Water Pipe Breakage

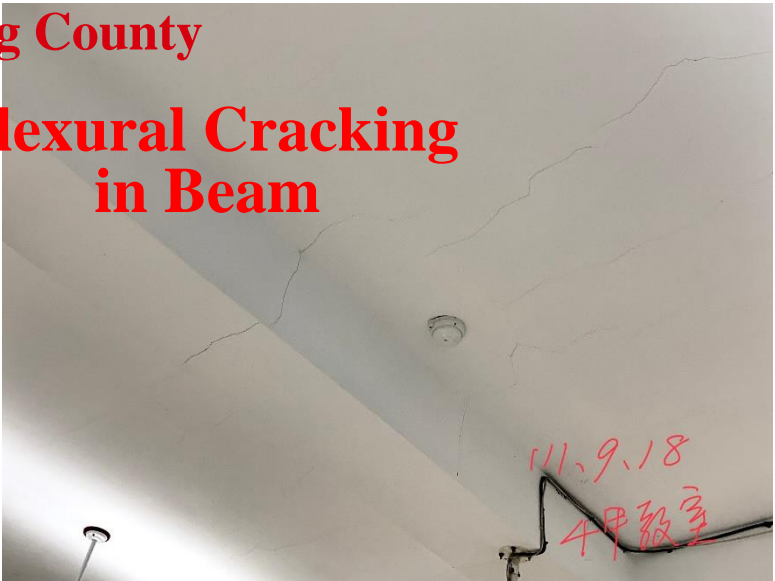
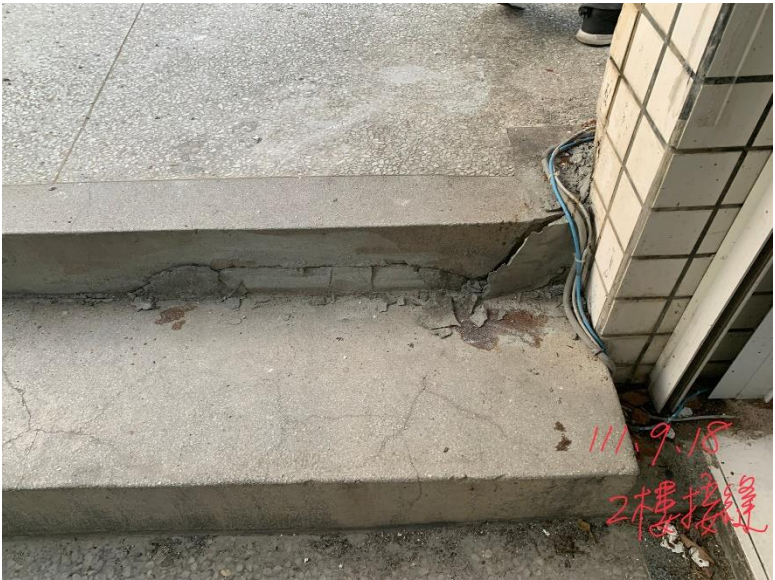
Flexural Cracking in Beam

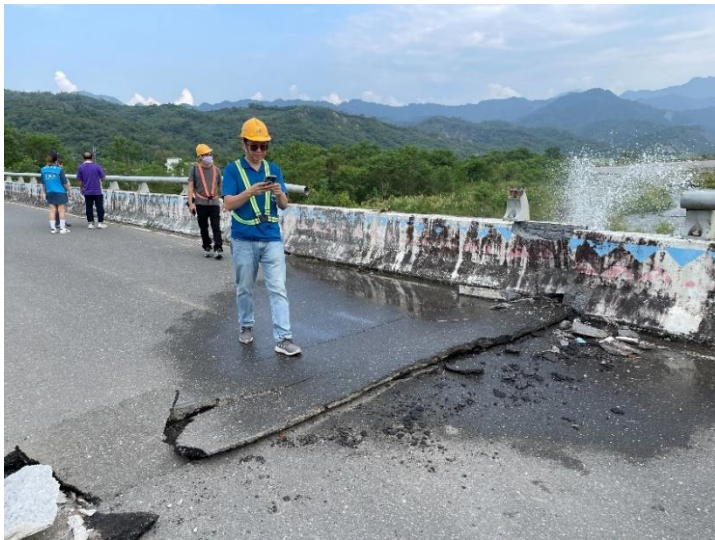
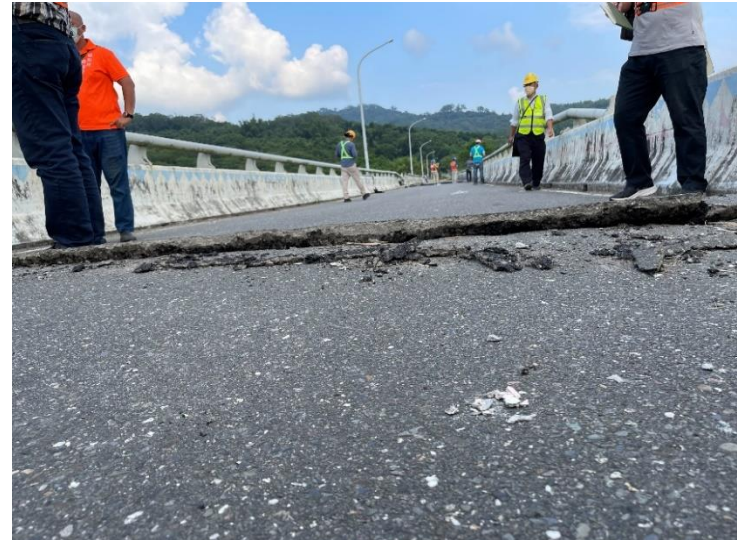
1. Baohua Bridge(2/2)

large displacement at expansion joint, support serious damage

Deck displacement, guardrail and attached pipe broken

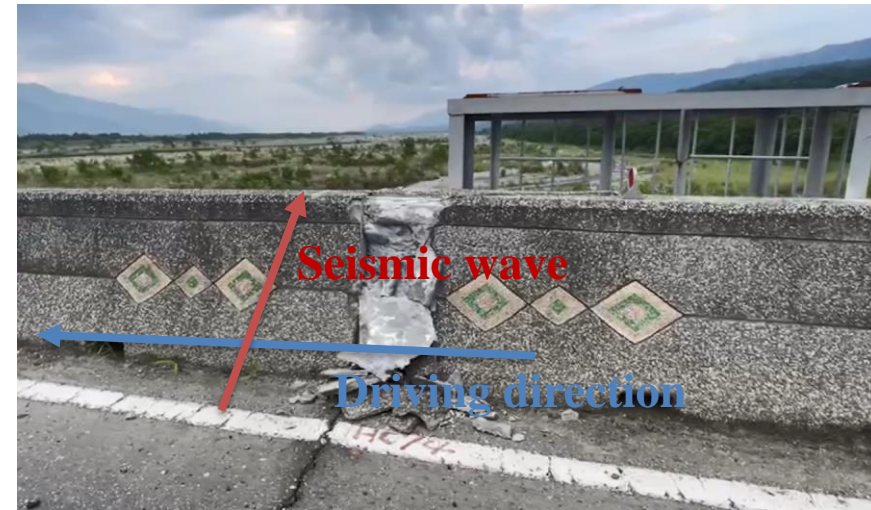
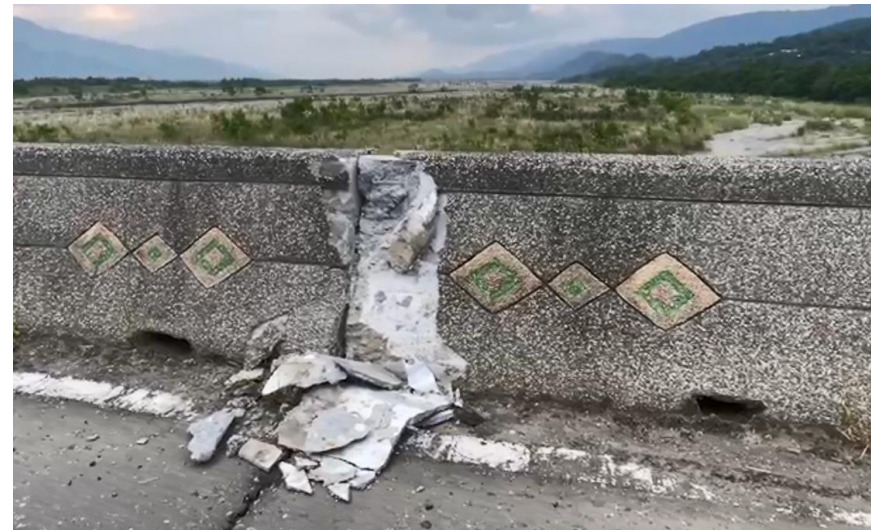
2. Dianguang Bridge

Guardrail damage

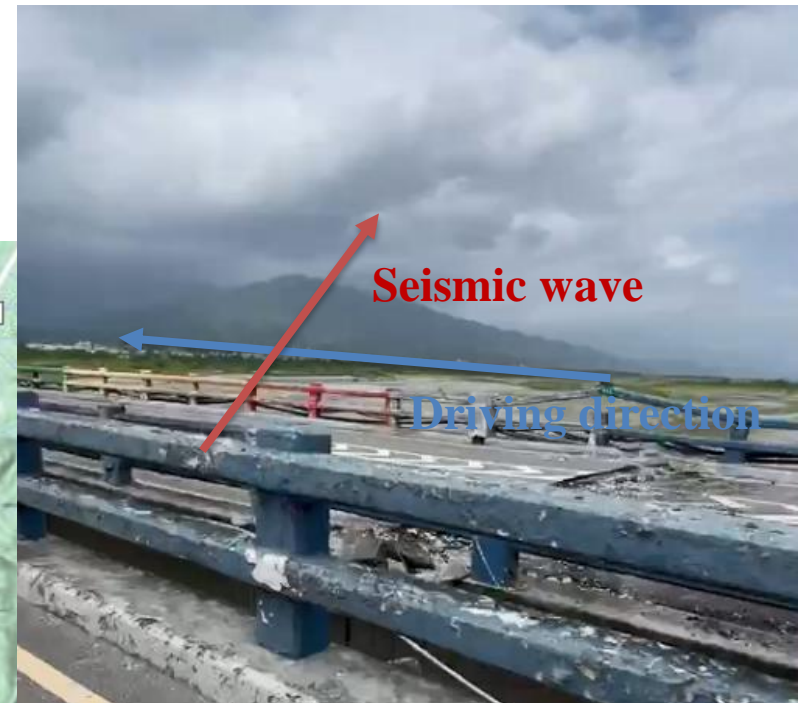
Damage at expansion joint

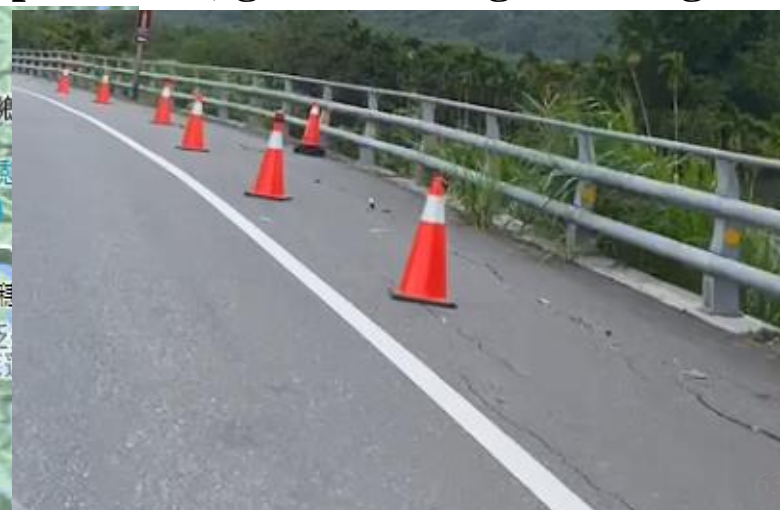
pavement, guardrail slight damage

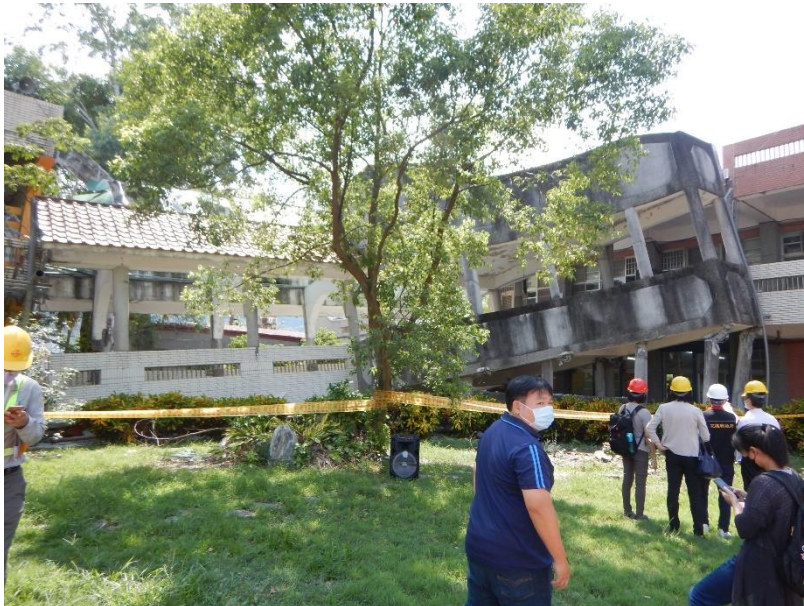
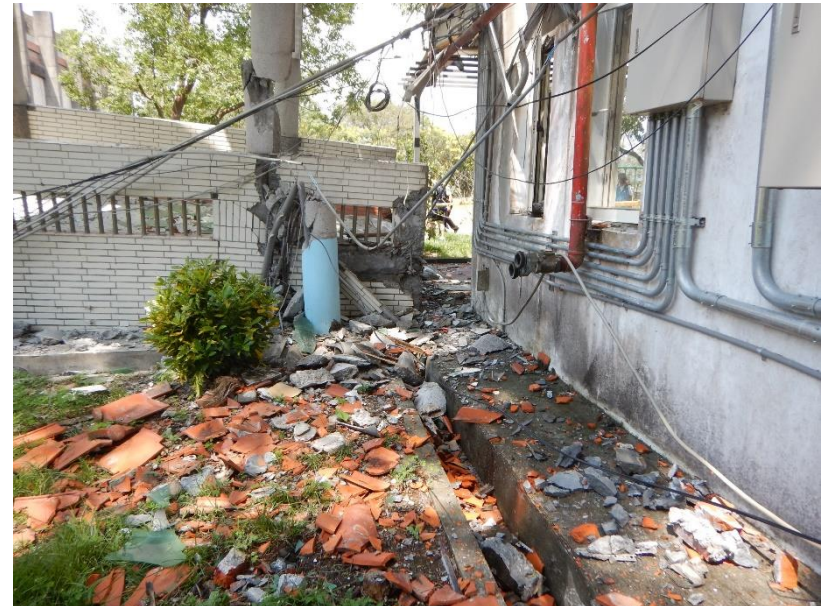
Chun-Rih Elementary School

- The building did not collapse when the M_L 6.4 earthquake occurred on 9/17.
- The M_L 6.8 earthquake on 9/18 caused the collapse of the connecting corridor, and the entire wall was tilted.
- There are many cracks in the kindergarten classrooms, toilets, and kitchens adjacent to the collapsed corridor.

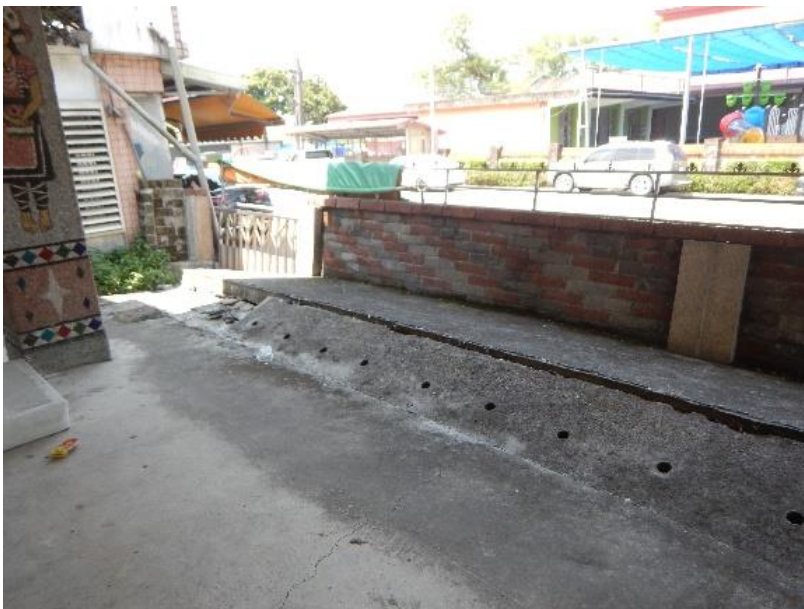
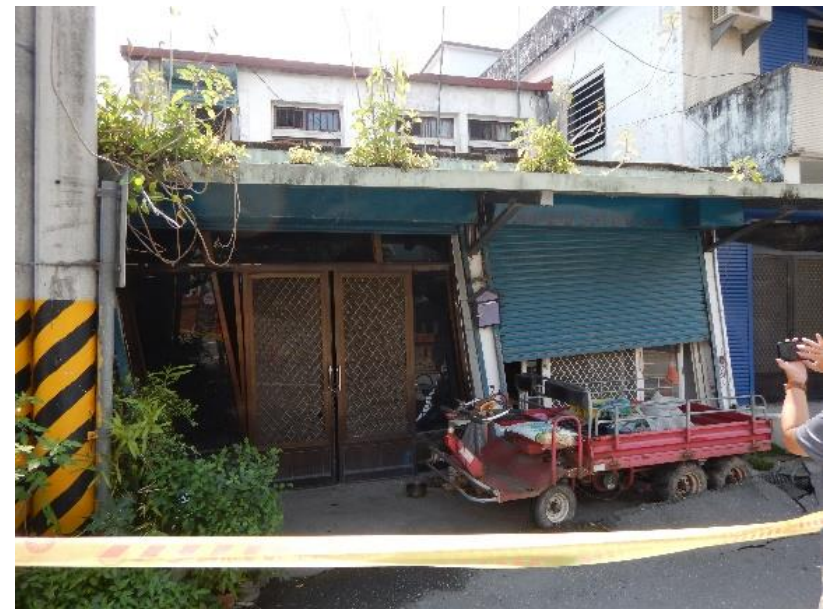
Song-Pu Elementary School

- The buildings and roads opposite to the elementary school were pushed towards Song-Pu elementary school, and the pushing direction was from southeast to northwest.
- Opposite to the elementary school, the concrete floor was squeezed and raised by about 40 cm.

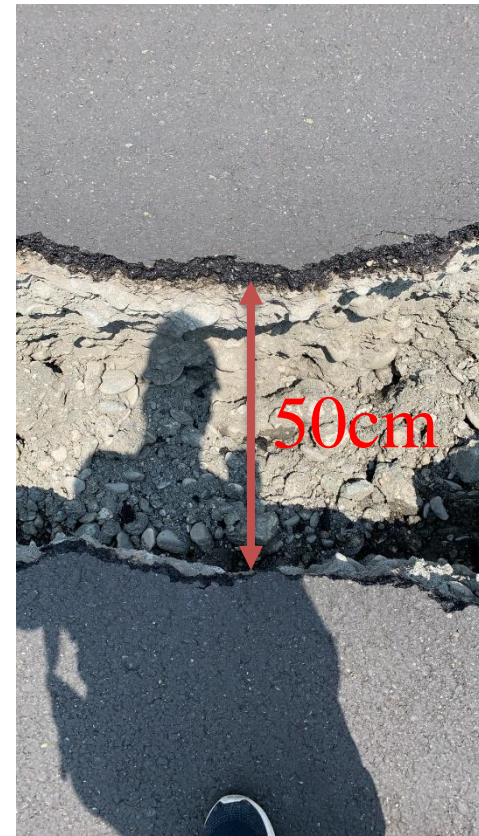
Gao-Liao Bridge (East side)

- Abutment damage camber, bridge deck subsidence.
- The water pipeline is damaged resulting in water service outage to the downstream residents.
- Retaining wall is without reinforcements.

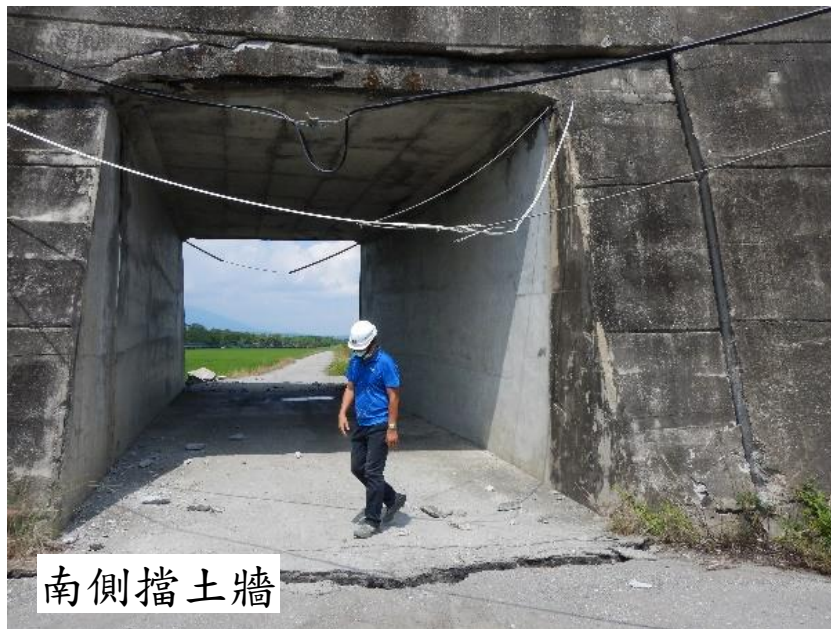
Gao-Liao Bridge (East side)

- Compared with the south and north retaining walls on the outside of the culvert under the abutment, there is an inward shrinkage.
- The difference between the south retaining wall and the culvert is about 15 cm. The difference between the north retaining wall and the culvert is about 45 cm.

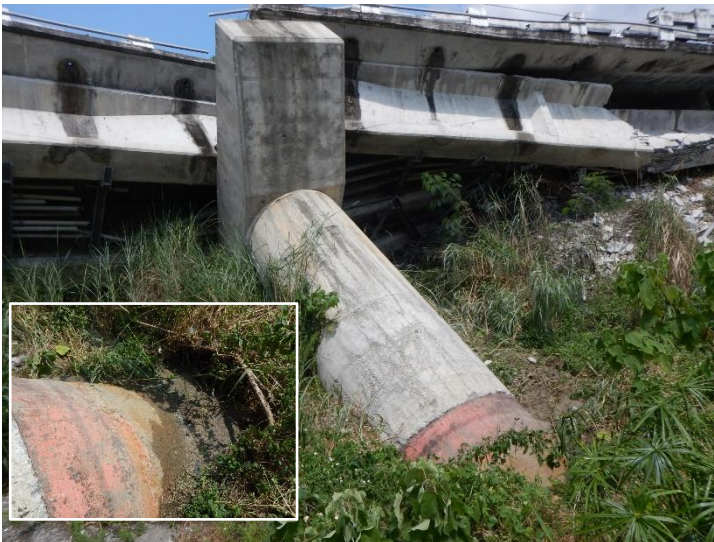
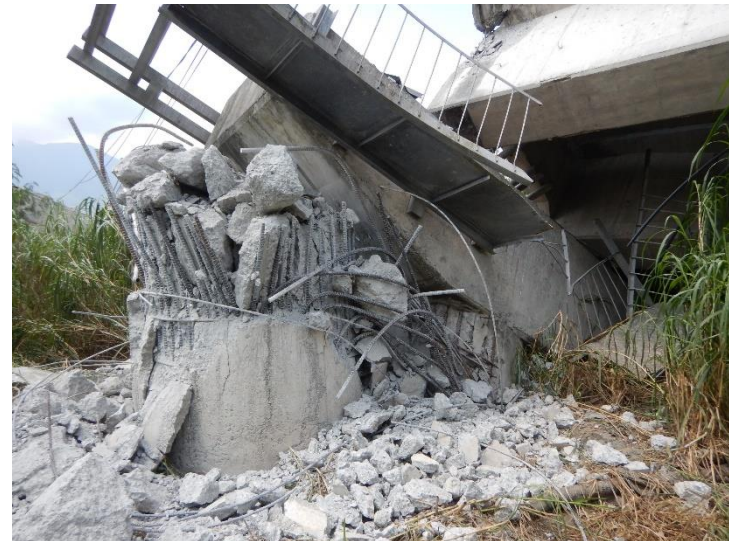
Gao-Liao Bridge (East side)

- Three piers from the east abutment were completely destroyed.
 - The first pier is located at the border of the bridge deck and is covered with steel plates. The pier is completely collapsed, but there is no obvious structural damage.
 - The second pier was located in the middle of the deck and was damaged by shear force.
 - The third pier was not clad with steel plates, and the damage was similar to the first pier.

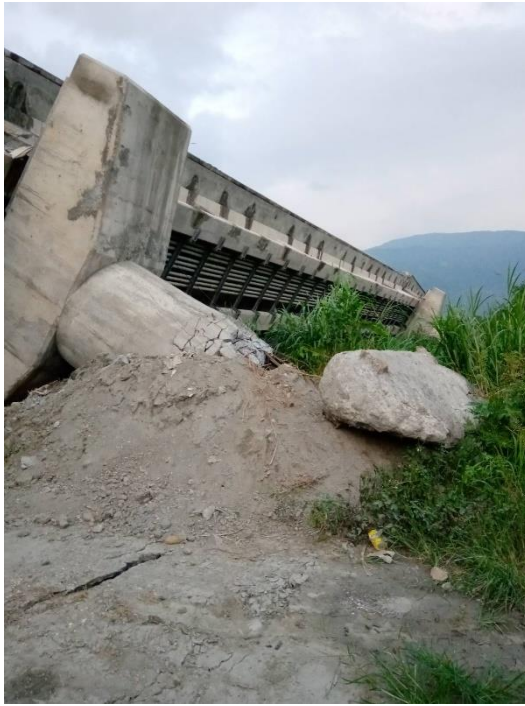
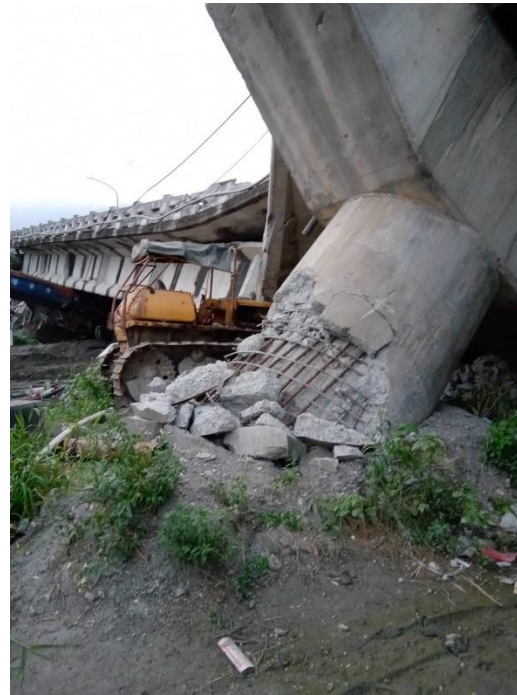
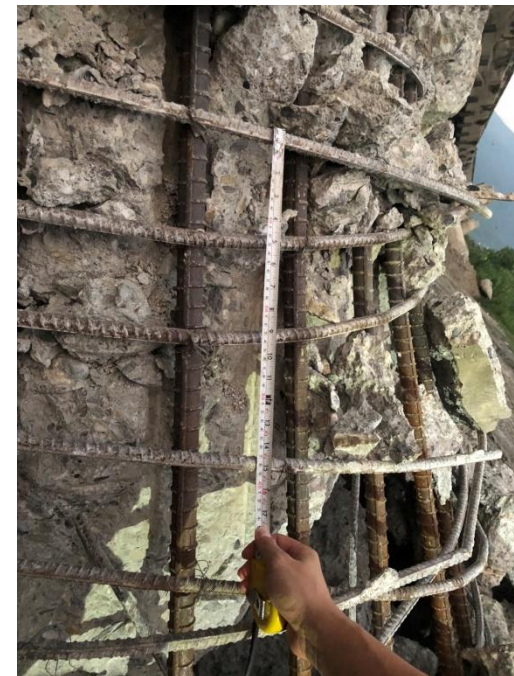
Gao-Liao Bridge (West side)

- The spacing between the main rebar is about 13-20cm.
- Stirrup spacing is about 12-15cm.
- Caisson foundation under the pier.

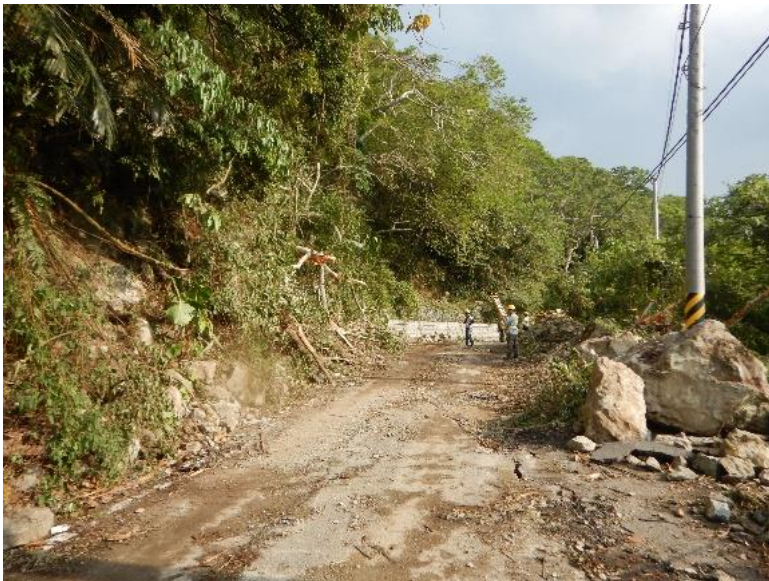
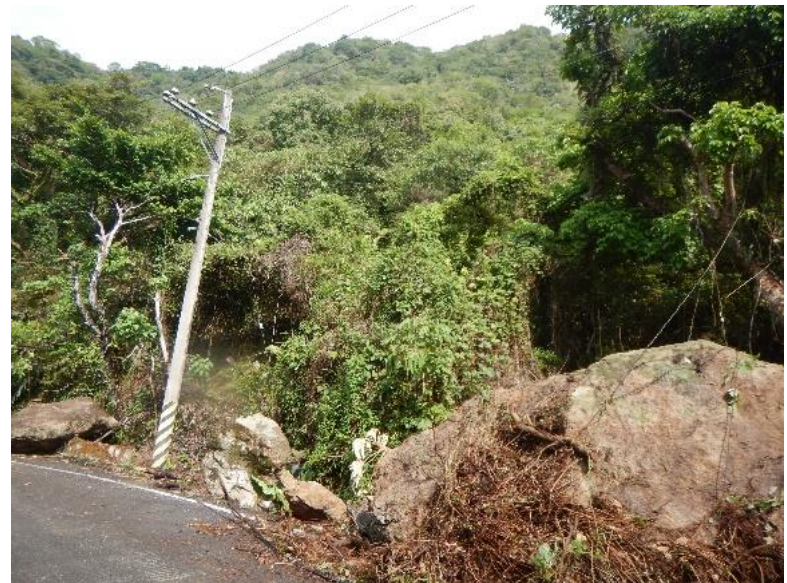
Sixty Stone Mountain

- The mountain road is damaged by many rock falls and there are signs of continuity of such.
- It is estimated that the largest area may be 100 meters long and 30 meters wide, and the largest diameter of the rock block may be up to 5 meters.

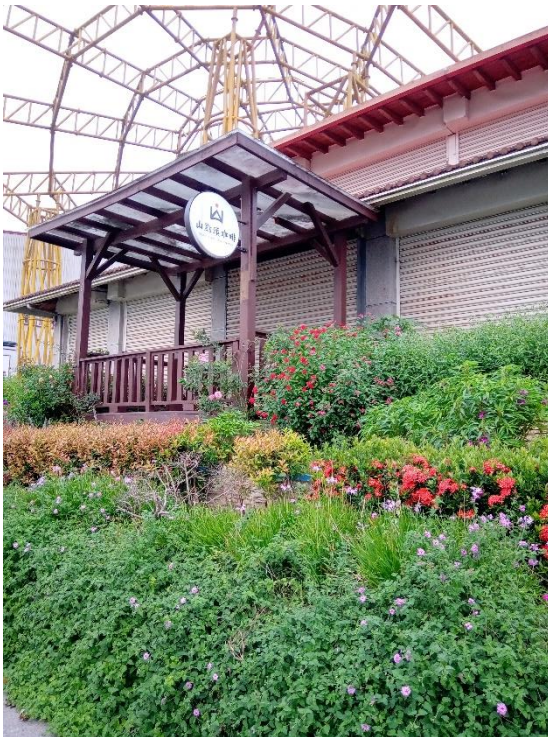
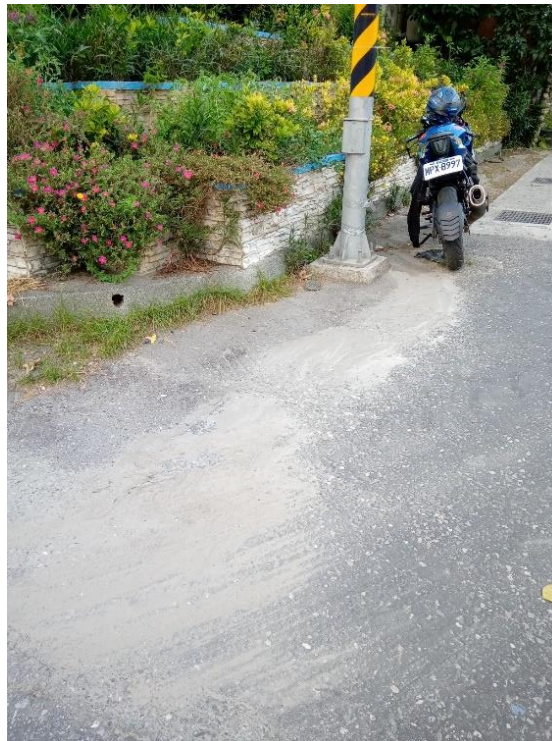
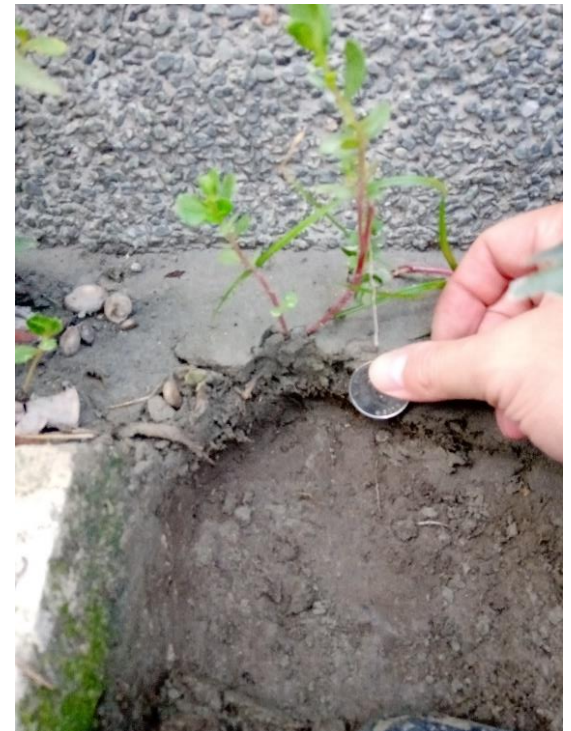
Fu-Li

- A suspected liquefaction phenomenon found in Fu-Li.
- No building damage due to soil liquefaction was observed.

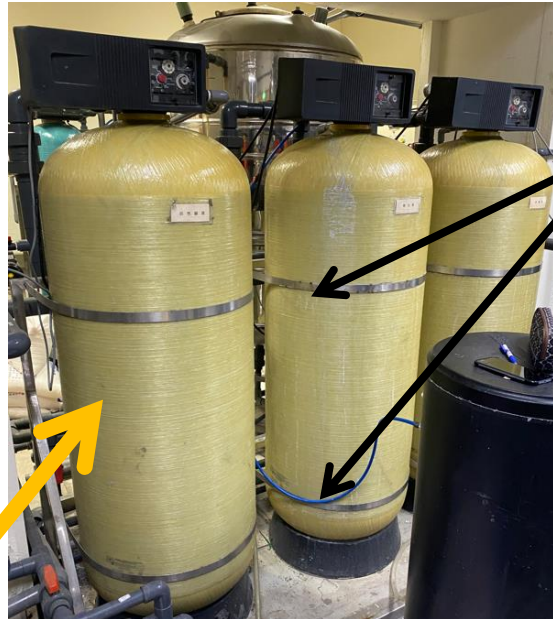
RO water filters are girdled and fixed by metal rings
(No damage to filters and connected pipes)

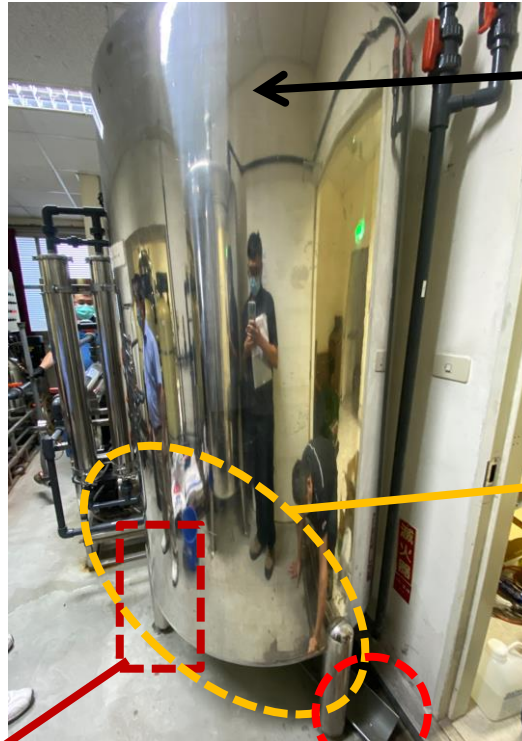
Freestanding RO water tank
(without any anchorage)

Originally, the two ends marked with green circles were connected to each other with a pipe. After earthquake, the pipe was broken and a transparent hose connection was temporarily used to keep its functionality.

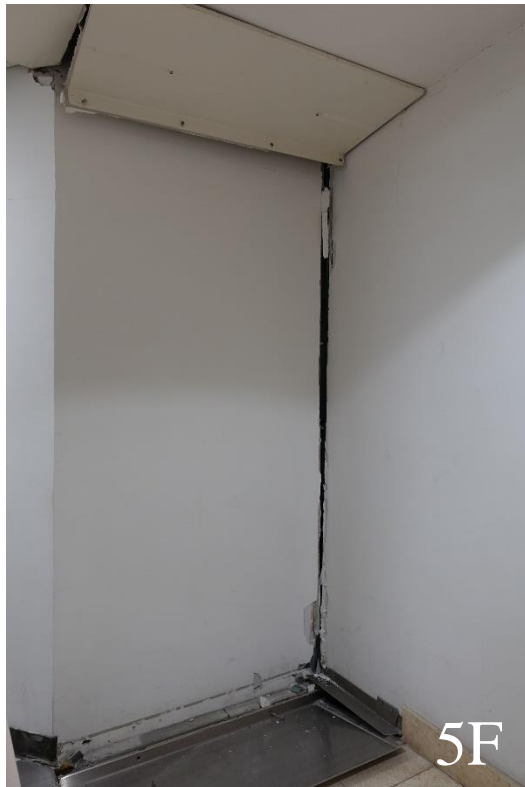
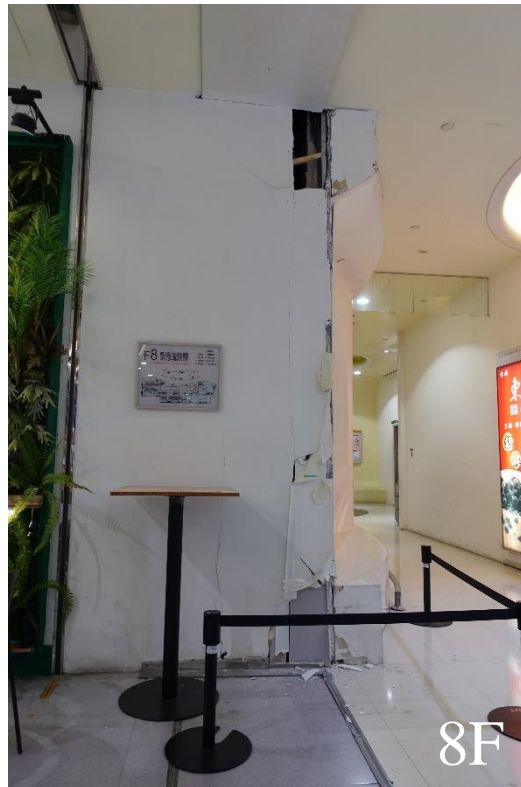
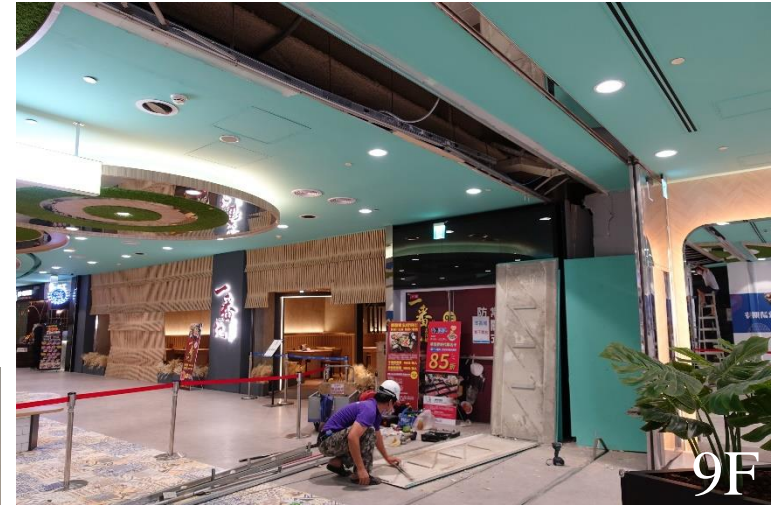
Damage to the interior veneer and ornamentations was investigated due to the relative displacement of expansion joint on 5th, 8th and 9th floor.

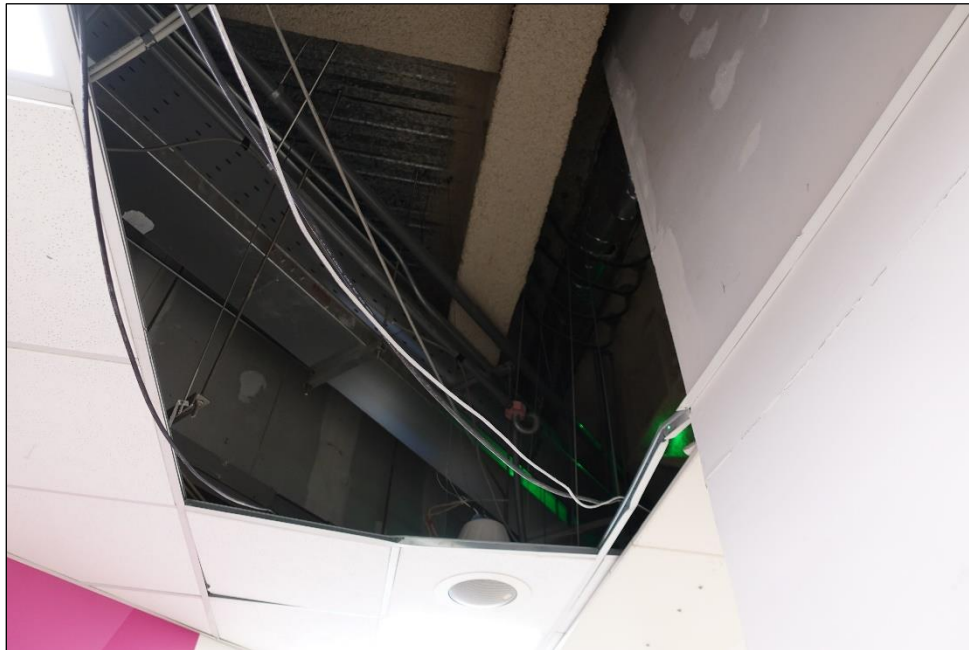
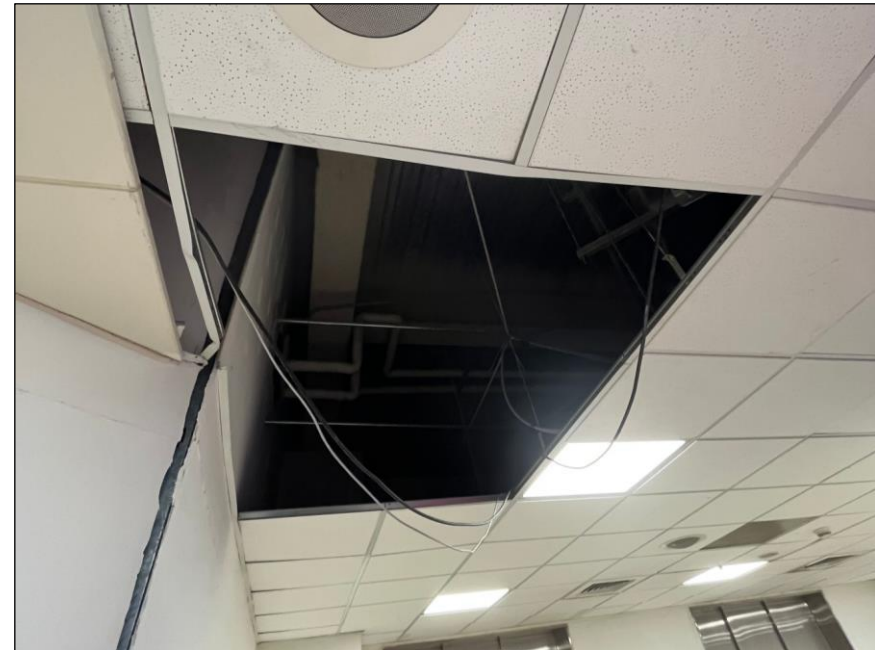
- The boundary, an unbraced gypsum board, on the side of the ceiling is adjacent to the expansion joint, which was damaged during the earthquake.
- Damage to the unbraced gypsum panel led to fallen ceiling panels and deformed ceiling runners.
- Rods are used as the suspension system. The suspension length of the ceiling is approximately 2.5 m to 3.0 m.

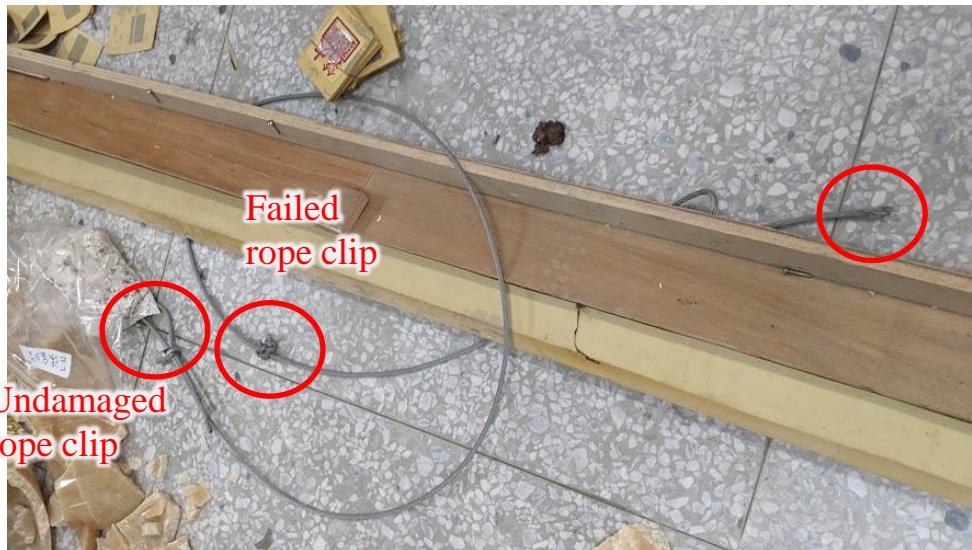
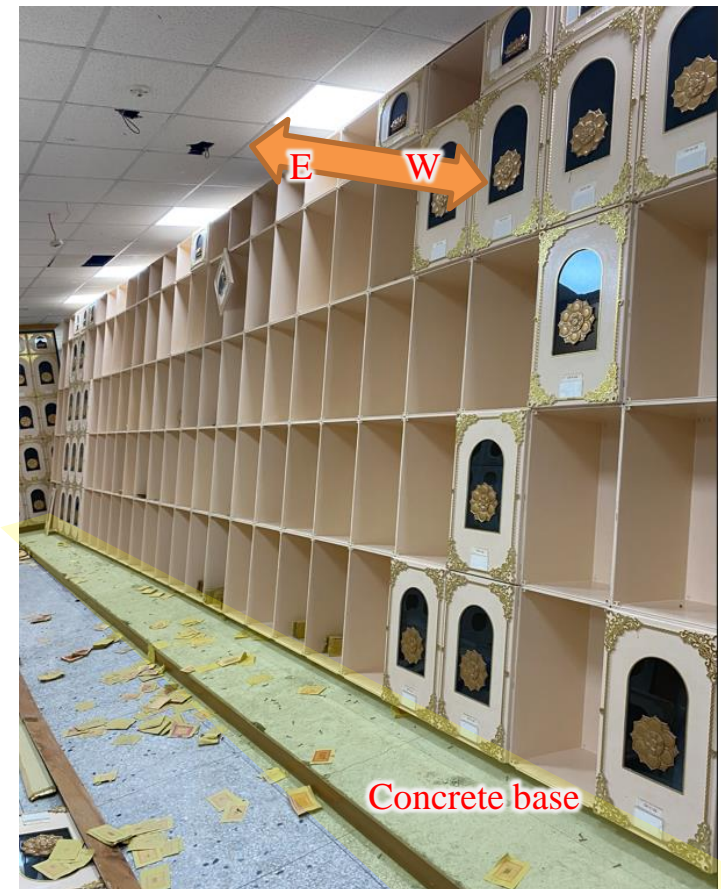
- **On the first floor**, one of the ossuary cabinets, not attached to any other structural components, was collapsed westward.
- **No anchorage observed** at the bottom of the cabinet.
- The steel wires connecting to the top of the cabinet and the above slab failed during Guan-Shan Earthquake.
