Reconnaissance Report on Seismic Damage Caused by Guanshan Earthquake and Chihshang Earthquake, Taiwan, 2022 (third edition, v3.0)

Chung-Che Chou, Chiun-Lin Wu, Juin-Fu Chai, George C. Yao

**NCREE, Taiwan
September 23, 2022**

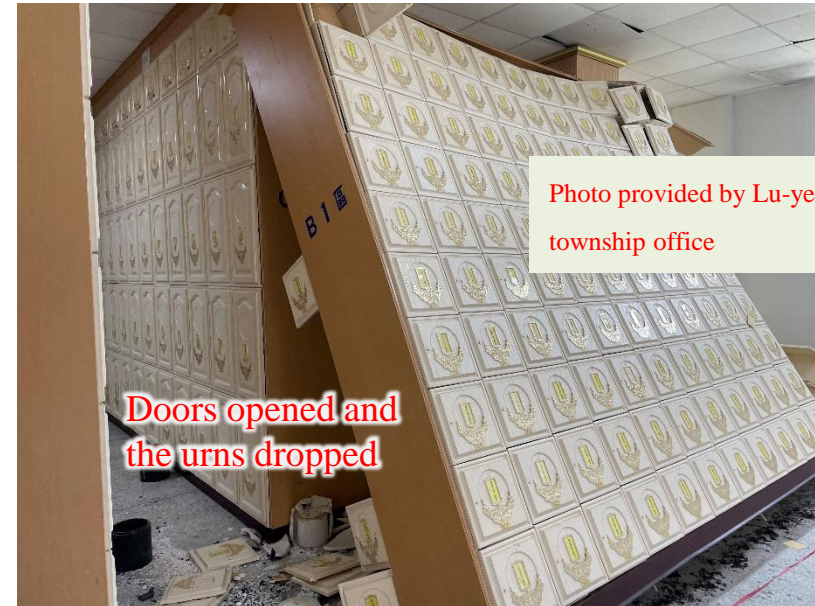
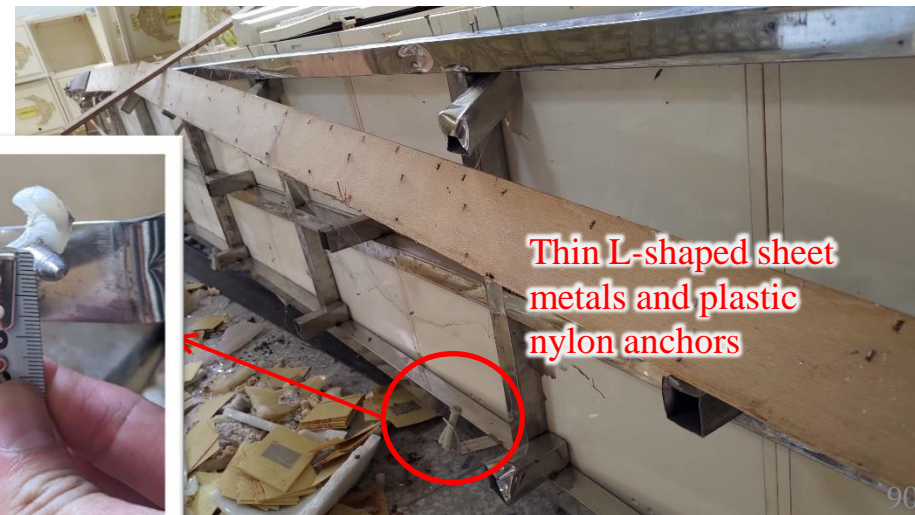
- **On the second floor**, one of the ossuary cabinets, which was not attached to any other structural components, **was collapsed westward**.
- The **bottom steel supporting frame** secured to the floor by **thin L-shaped sheet metals and plastic nylon anchors** failed.
- The **steel wires** connecting the above slab and the top of the cabinet failed.
- **Doors opened and the urns dropped**.

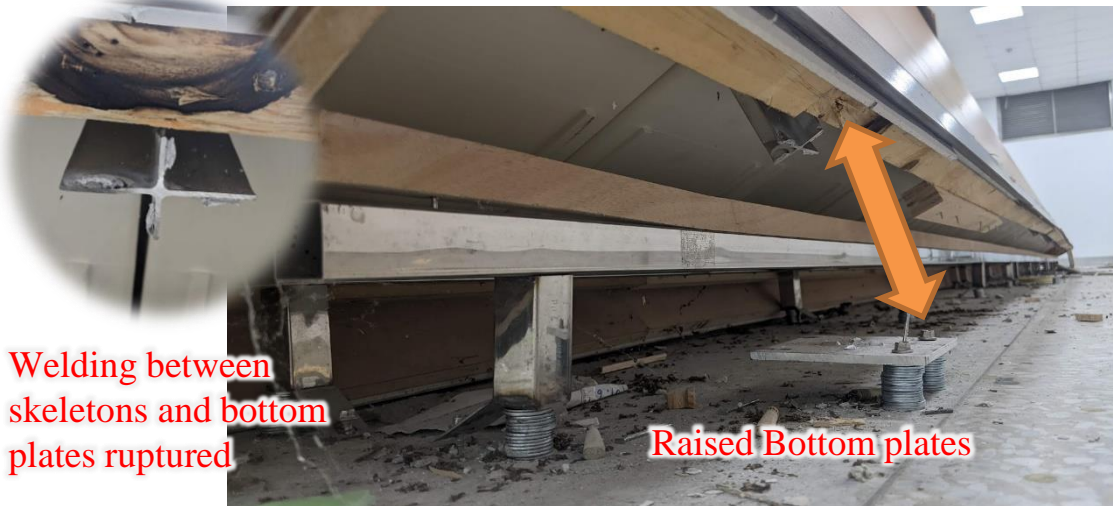
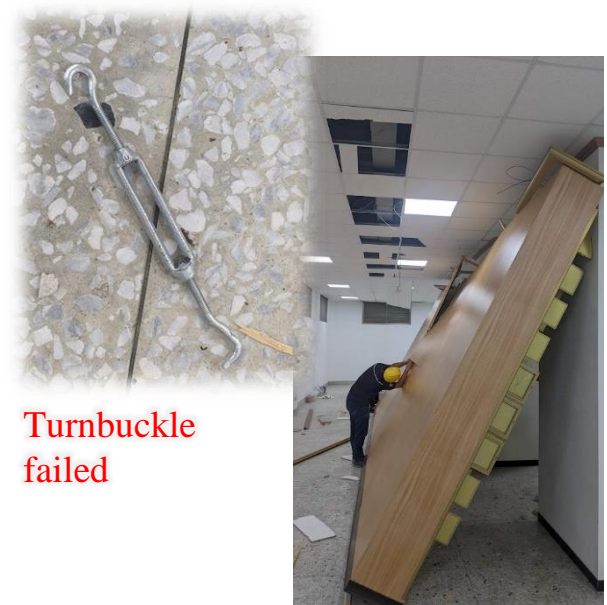
- The cabinets **on the third floor** were built recently.
- One of the ossuary cabinets, which was not attached to any other structure components, **was collapsed eastward**.
- **Failure of the hook of a turnbuckle** was observed. This may lead to the failure of the cable system above the cabinet.
- **Aluminum skeletons with cross section behind the cabinet ruptured** from the aluminum bottom plate, which was supposed to be fixed on the floor.

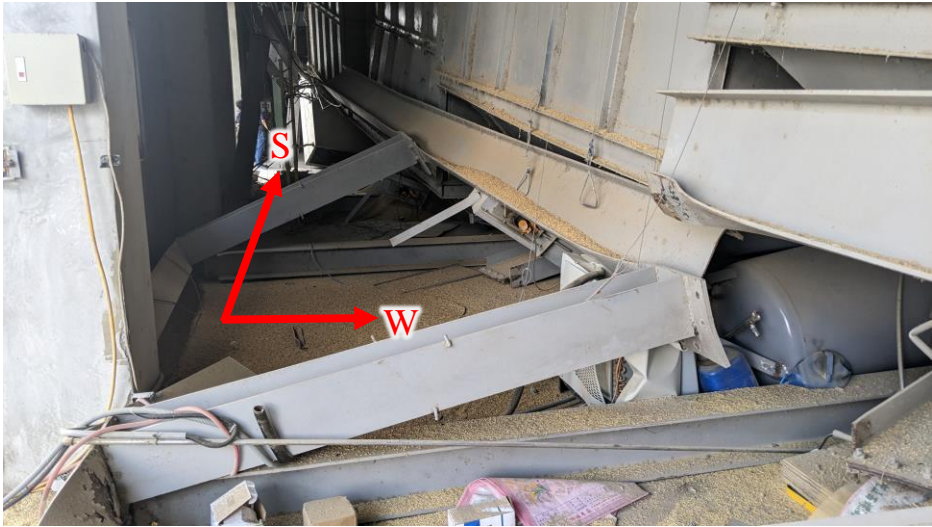
The failure of the supporting frame underneath the tanks led to the grain tanks collapsed toward southwest in 9/17 event.

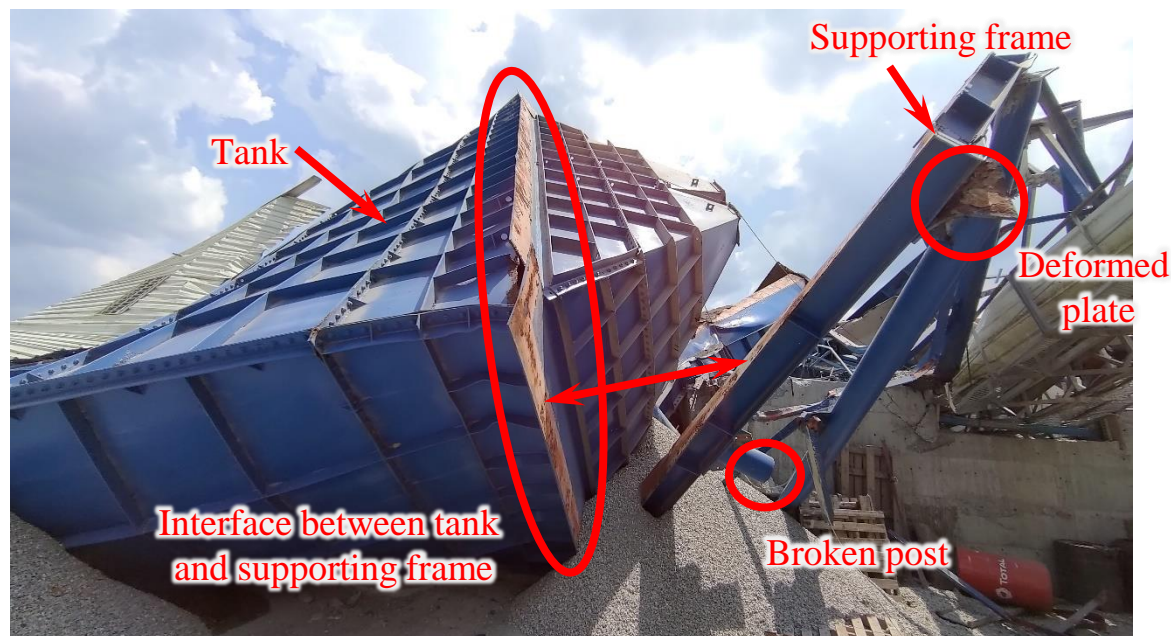
Sand and gravel tank

- The tank was supported by a steel frame, and there were 12 steel posts underneath it.
- The bolts pulled off due to the tensile force.
- The posts ruptured at the welding spots.

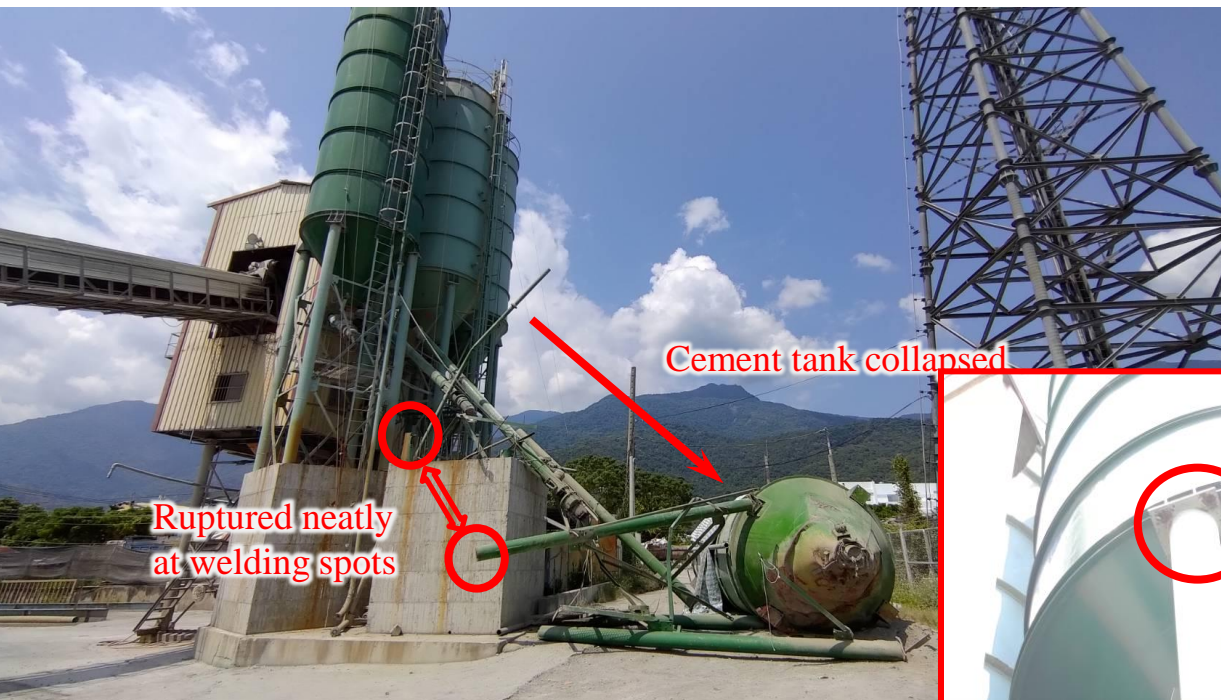
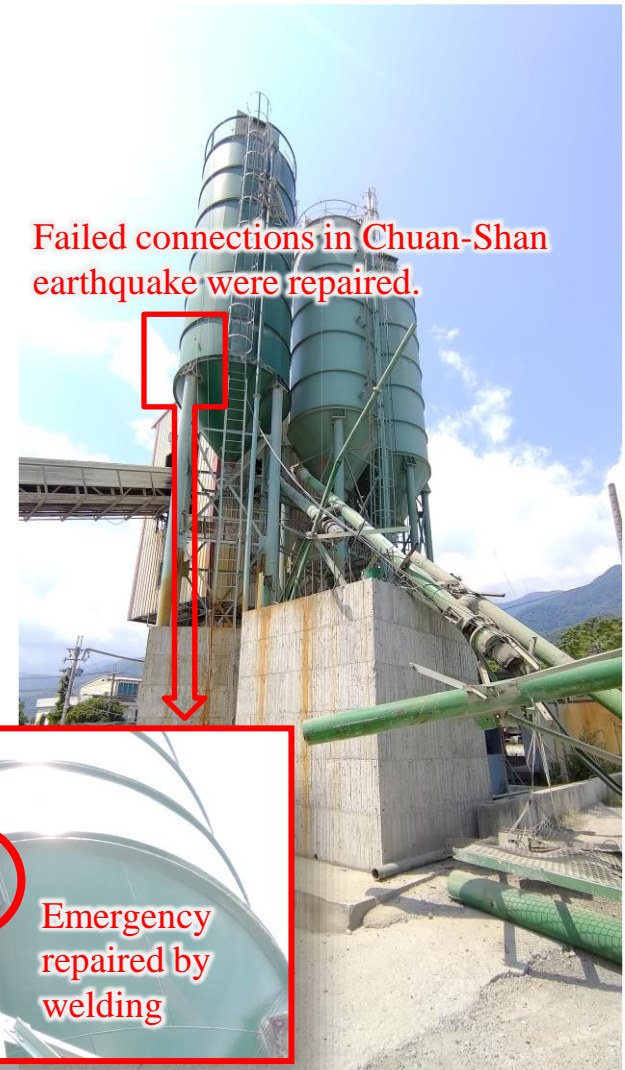
Cement tank

- One of the cement tanks collapsed in the Guan-Shan Earthquake. Shear failure of bolts of another tank occurred as well.
- The tank was emergency repaired by welding and survived in ChihShang Earthquake.
