國家地震工程研究中心

2023-02-06土耳其地震事件 彙整報告 (Version 3.0)

2023/02/14

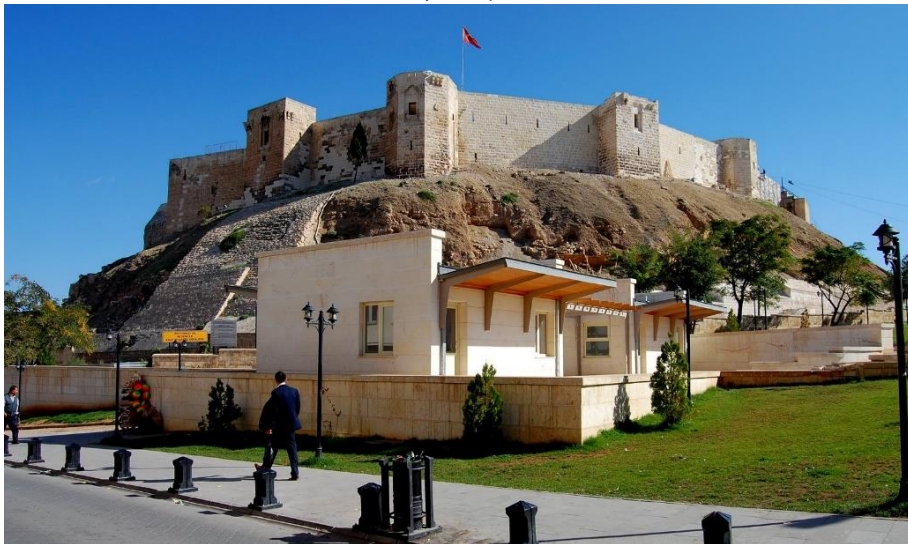
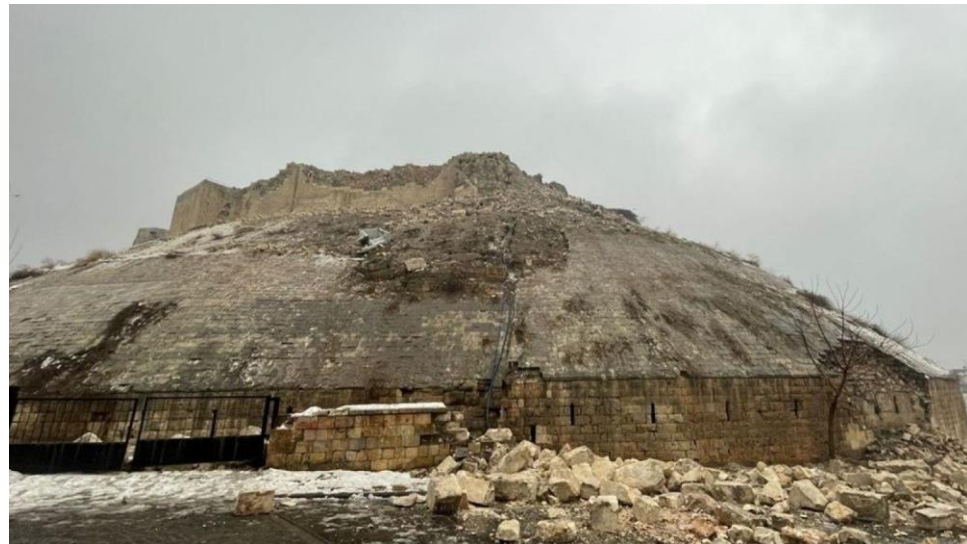
Mw 7.8這場地震中，擁有2000多年歷史的世界遺產「加濟安泰普城堡(Gaziantep Castle)」被震垮，不僅擋土牆倒塌，古堡瞬間成了一個個碎石塊，鐵欄杆也散落在周圍的道路上。

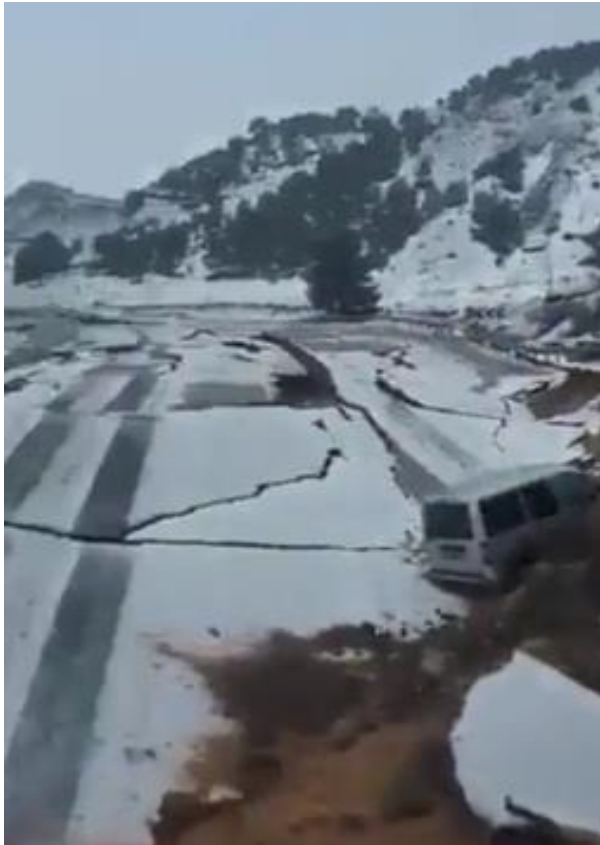
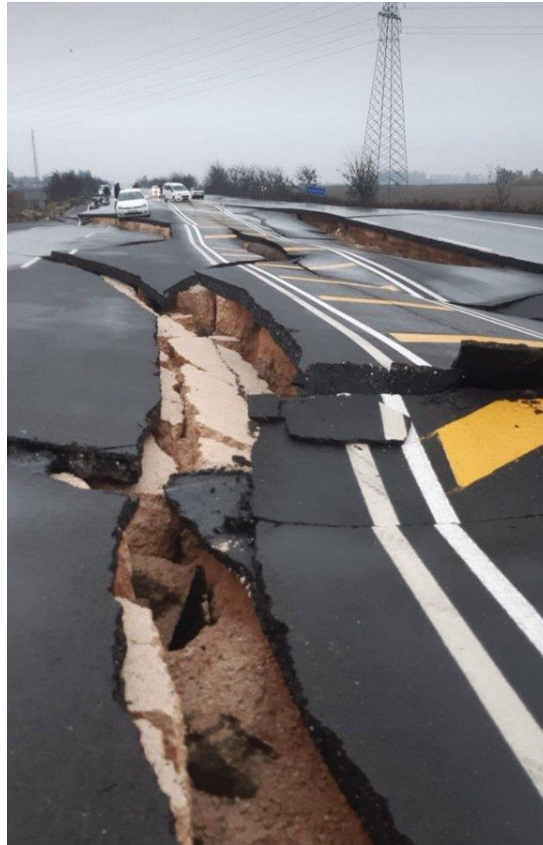
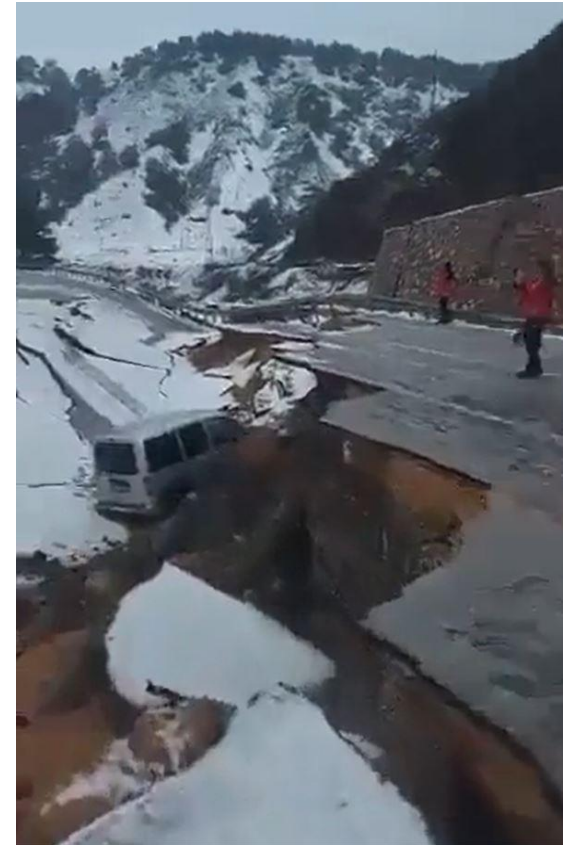
大規模山崩導致路基嚴重損壞陷落

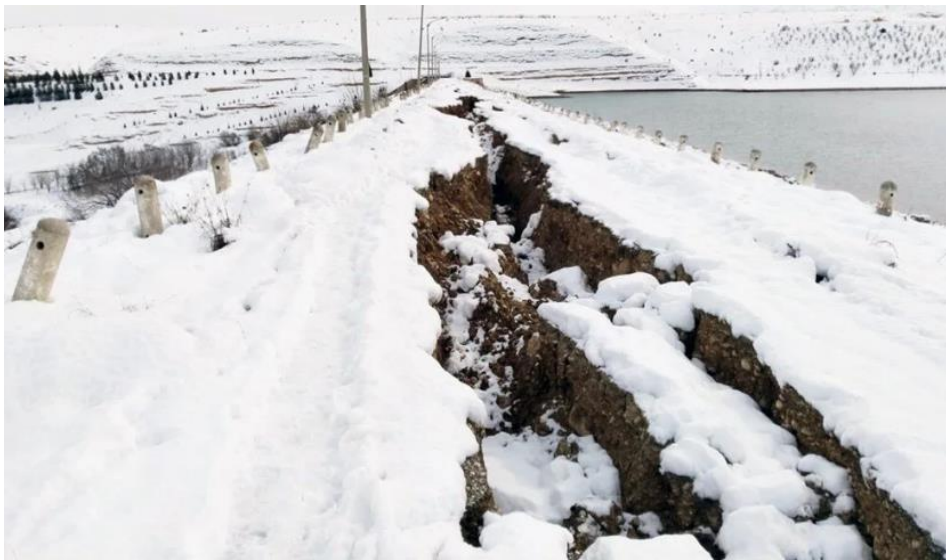
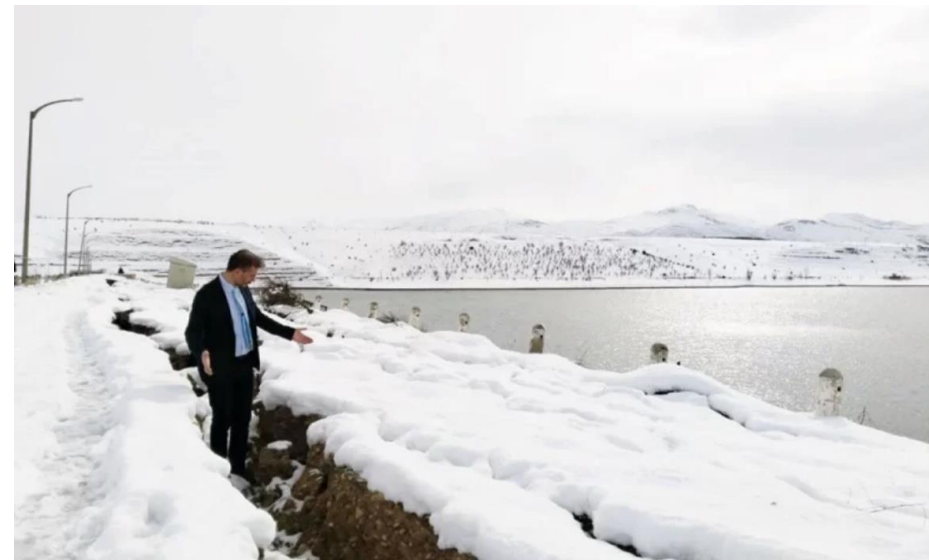
Sultansuyu水庫壩體受震裂損

Sultansuyu Dam in Malatya 水庫因地震而裂損，水位因此下降1.5公尺。

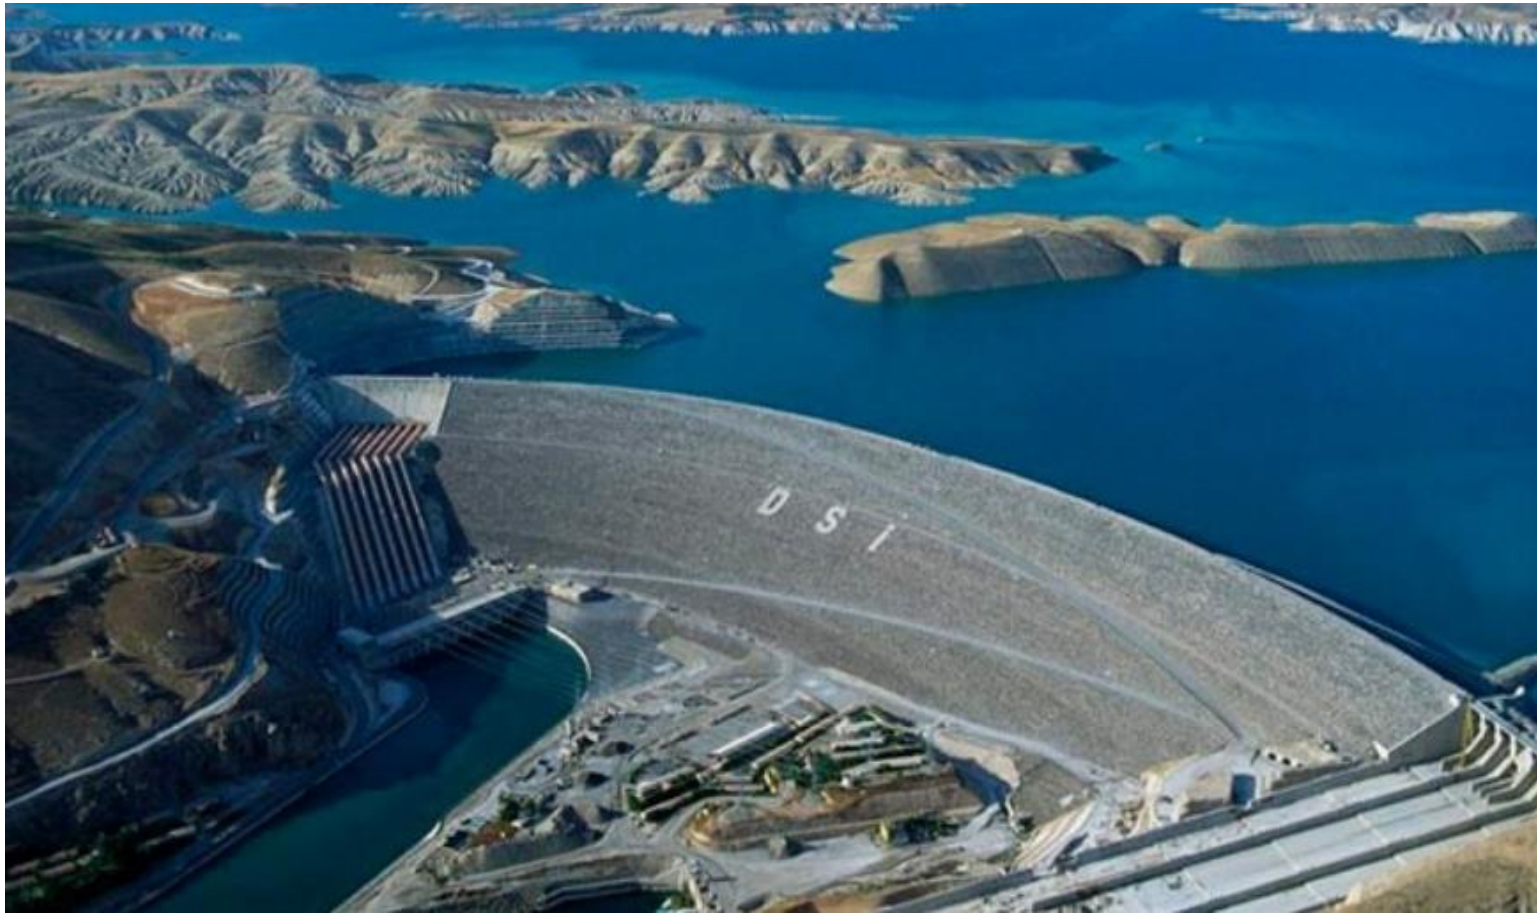
Ataturk水庫壩體受震裂損

土耳其東南邊的Ataturk Dam 因地震有許多裂損，目前已疏散附近居民，專家表示水壩可能在任何時間點破裂，影響範圍將及30平方公里。

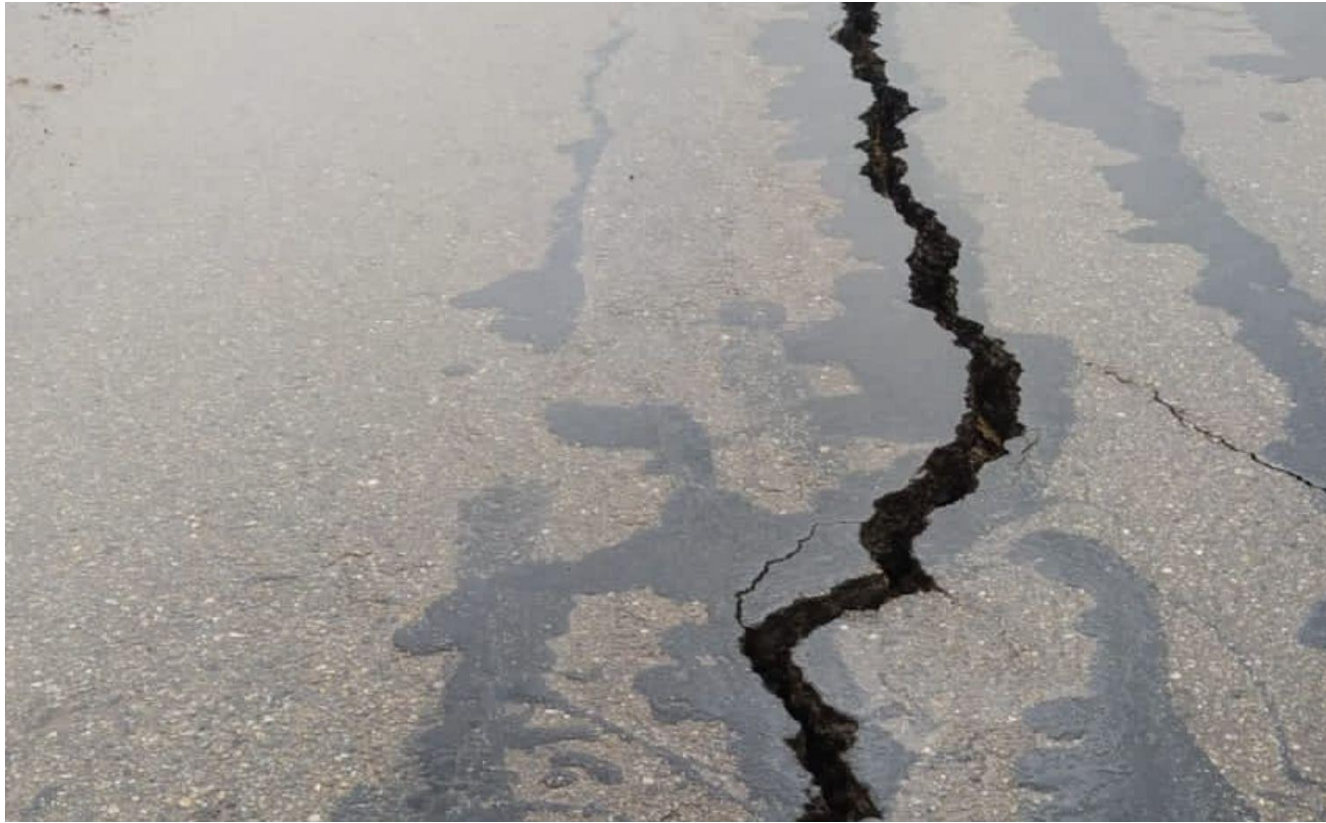
Maydanki水庫壩體受震裂損

敘利亞北部城市Afrin的 Maydanki 大壩出現了巨大的縱向和橫向裂縫。

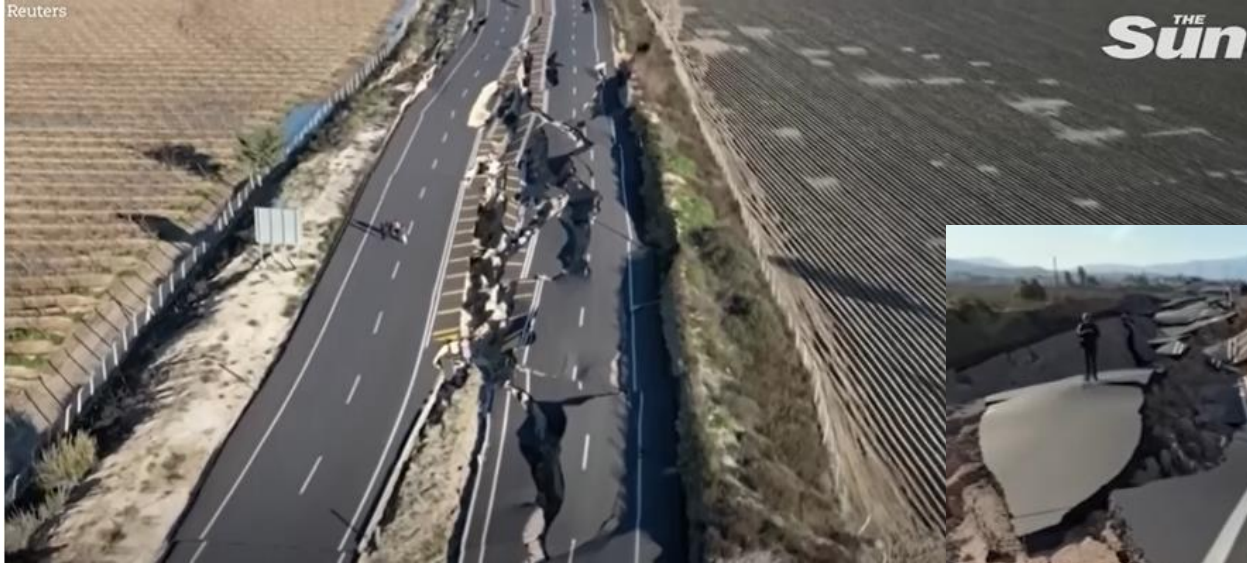
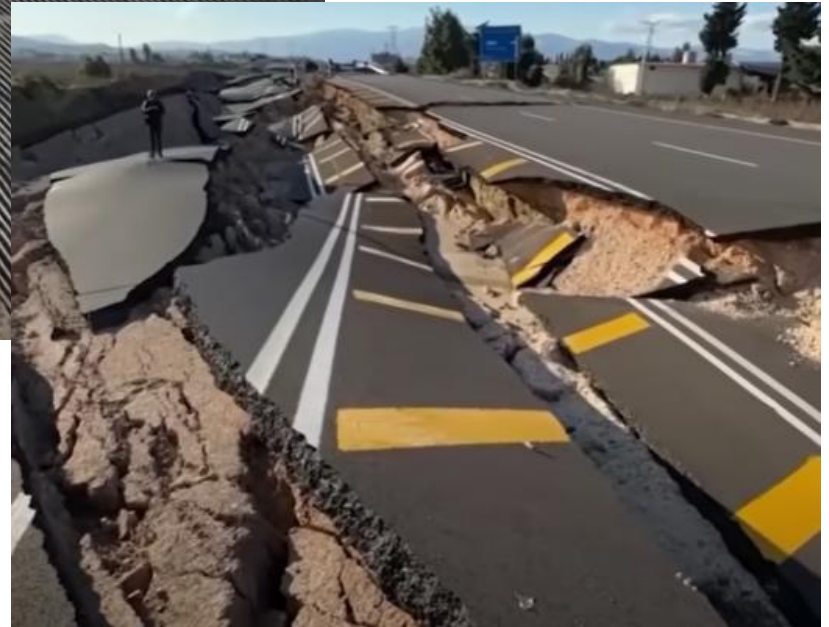
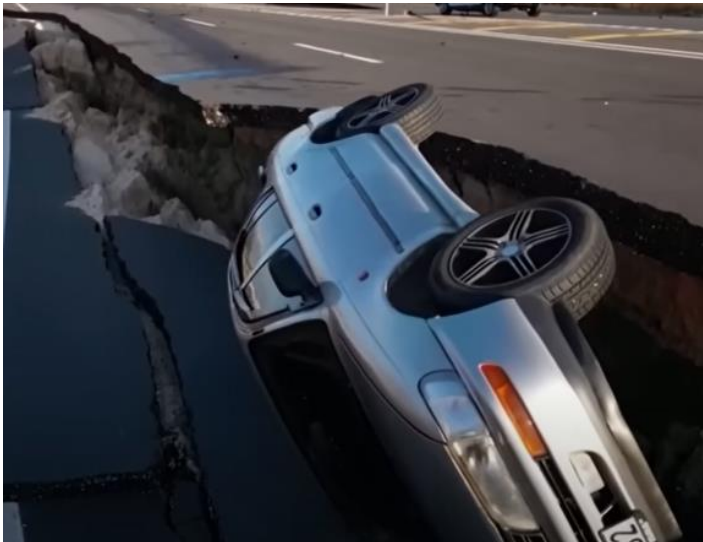
高速公路大規模破壞

高速公路因地震破壞嚴重，導致車輛翻覆。

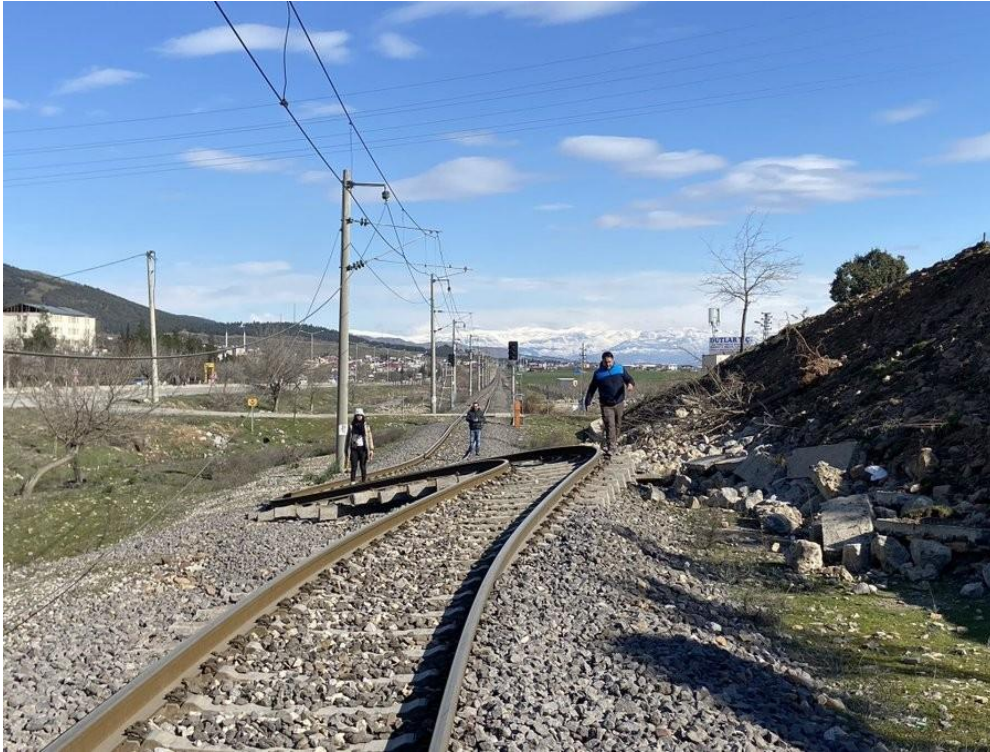
位於 Kahramanmaraş 以南約 35 公里處，
出現嚴重扭曲鐵軌。

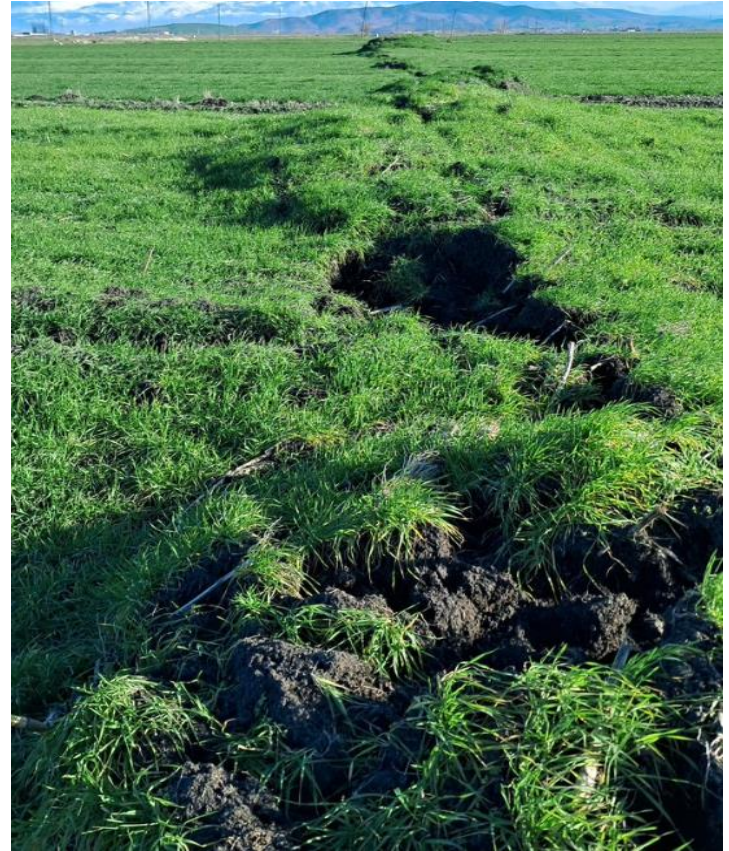
在Türkoglu東邊觀察到的地表破裂。

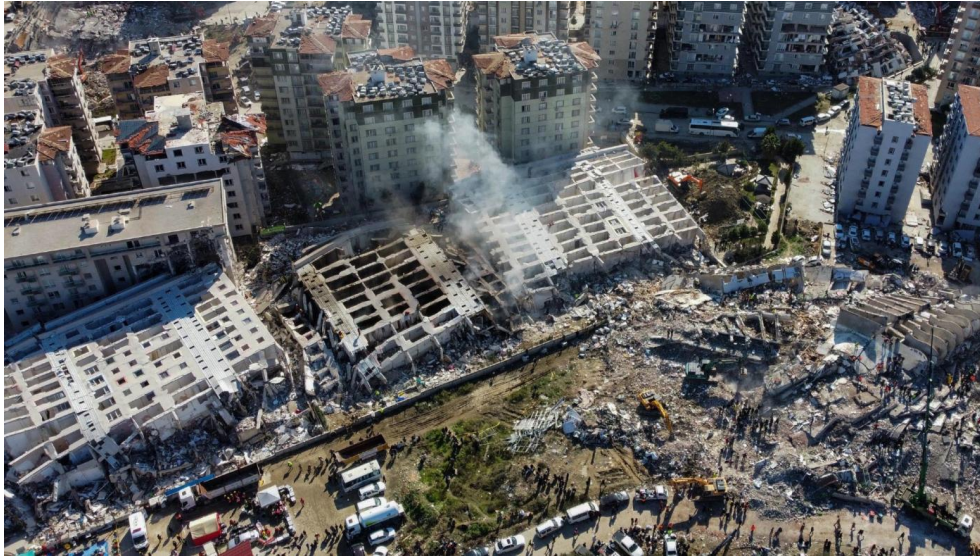
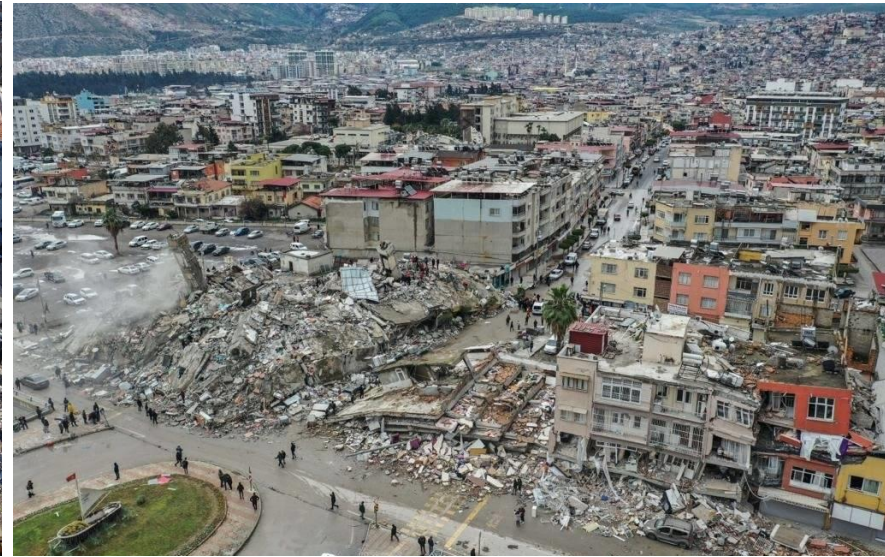
土耳其東南部哈泰省（Hatay）災區現場

建築物受震嚴重損傷與倒塌

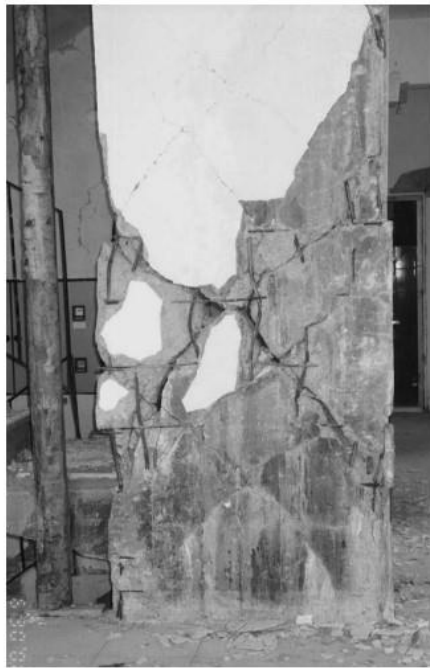
Brittle behavior was a consequence of **poor reinforcement detailing** (Figures 7 and 8), **presence of captive columns** (Figure 9), **soft stories**, and **torsional response**.

Figure 7. Column failure, Bolu government hospital.

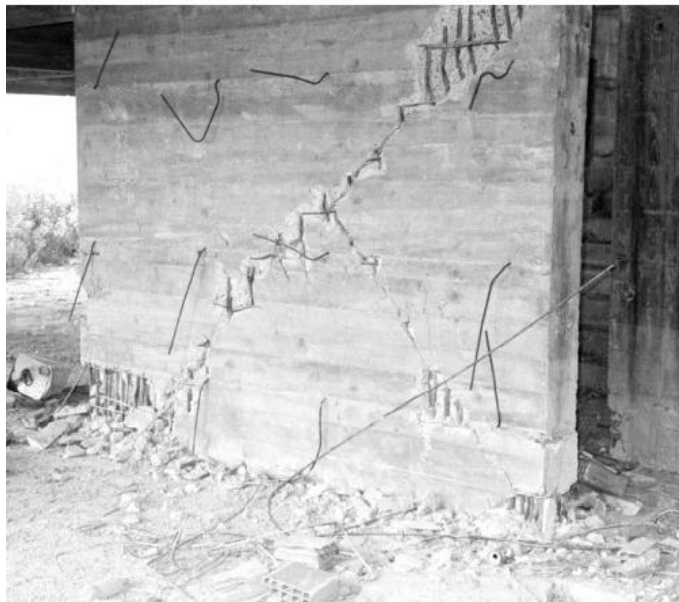
Figure 8. Failure of a shear wall in Bolu.

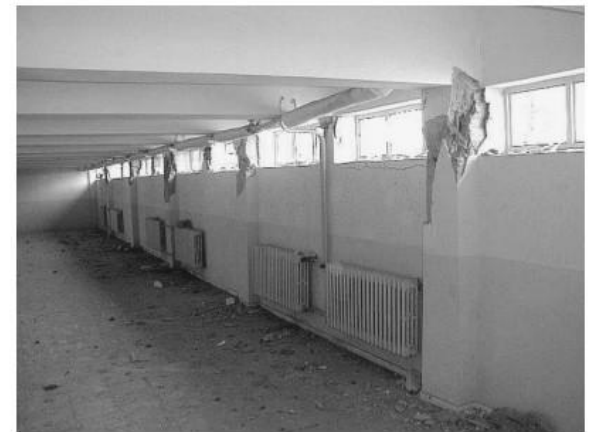
Figure 9. Typical example of captive columns. (Photograph by Mete Sözen)

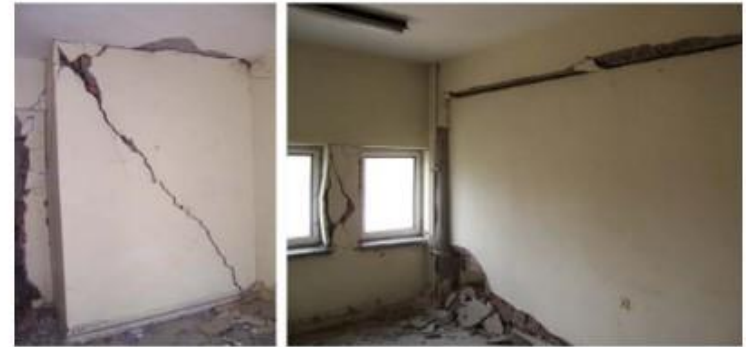
Figure 9. Failure of infill walls.

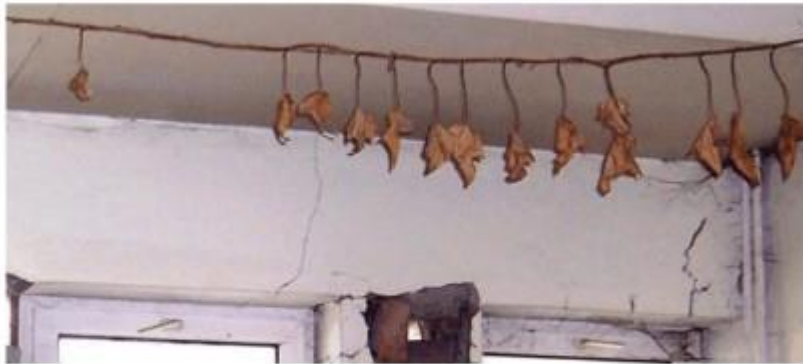
Figure 10. Flexural beam cracks.

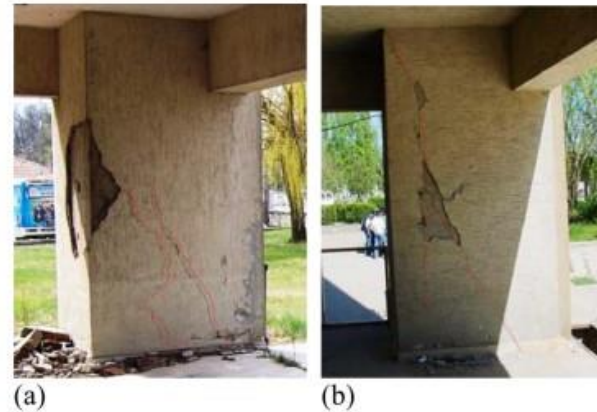
Figure 11. Diagonal shear cracks developed in ground story L-shaped corner columns (C16) in (a) Bolu and (b) Bingöl.

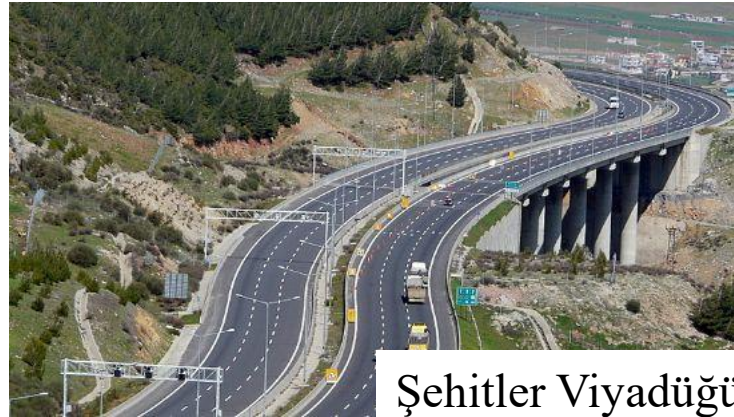
- 截至臺灣時間2月10日9點50分，尚無中文或英文報導關於橋梁損傷的新聞，故僅能藉由土耳其當地官方道路封閉新聞找出下列震損橋梁
- Bulam 3 Köprüsü
- Balıkburnu köprüsü
- Tohma köprüsü
- Başpınar Viyadüğündeki
- Şehitler Viyadüğü
- Recepbey Köprüsü

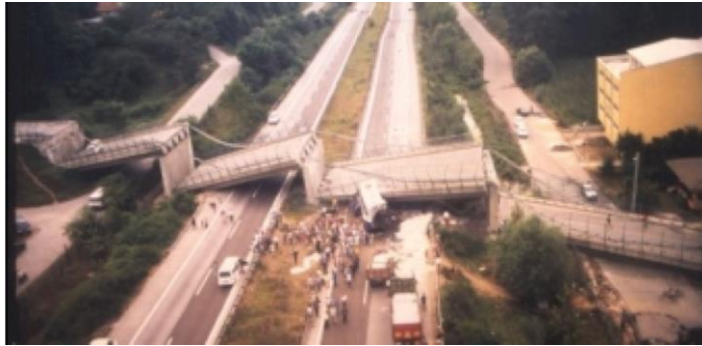
Arifiye 跨越橋(1)

- Arifiye 跨越橋，結構型式為多跨連續橋，於土耳其Kocaeli 地震(Mw 7.4) 產生剪力樁破壞導致落橋。

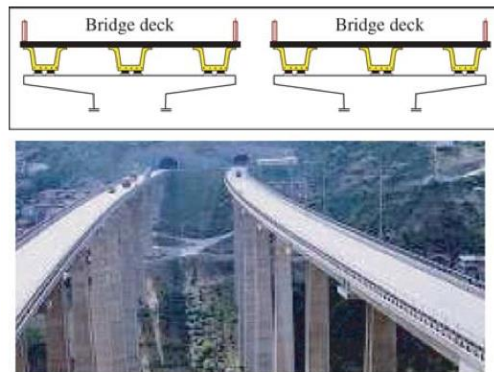
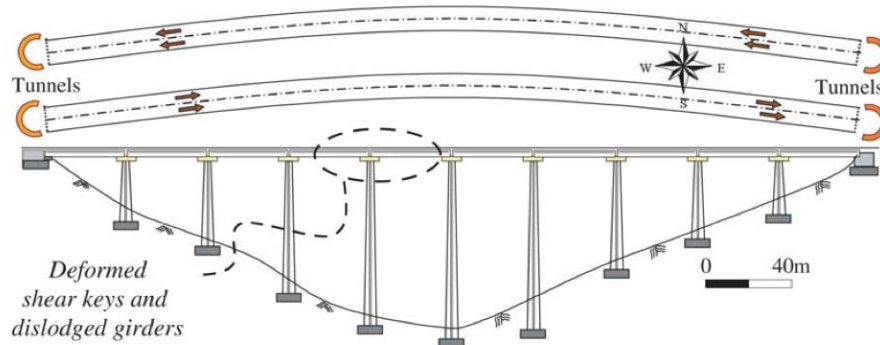
Mustafa Inan 高架橋

- Mustafa Inan高架橋及Sakarya 高架橋，結構型式皆為多跨連續橋，於土耳其Kocaeli地震(Mw 7.4) 產生剪力樑破壞。

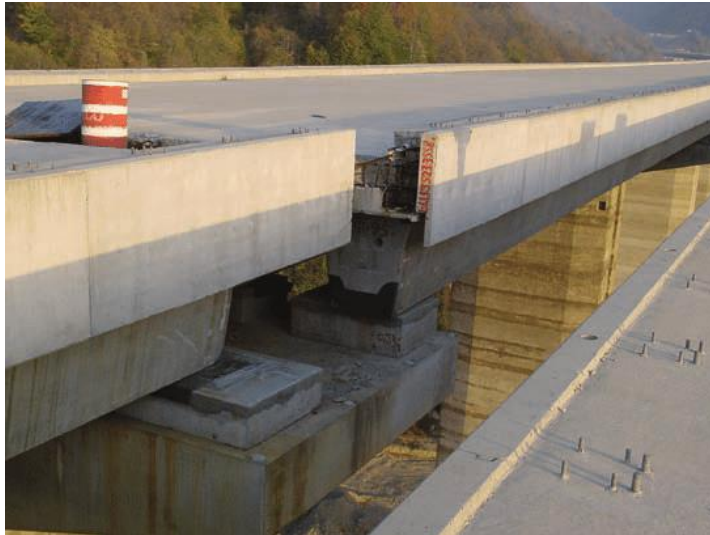
- #1 高架橋及位於Kaynasl的E-5高速公路，結構型式皆為多跨連續橋，於Düzce地震(Mw 7.2) 產生橋墩連接螺栓剪切破壞。

位於Kaynasl的E-5高速公路
橋墩連接螺栓剪切破壞(1)

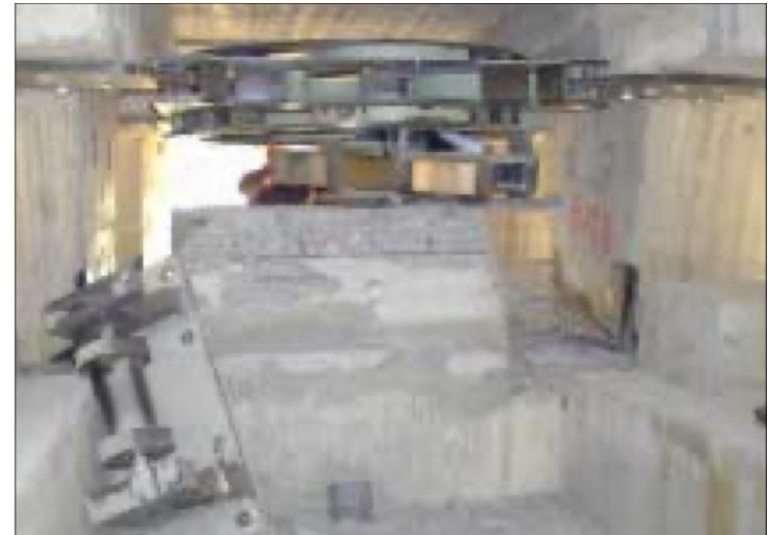
#1 高架橋
橋墩連接螺栓剪切破壞(2)

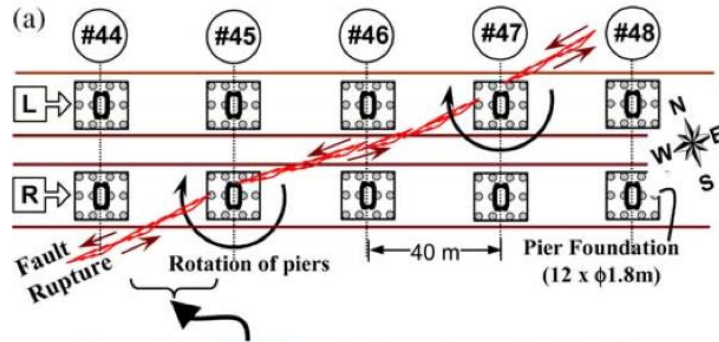
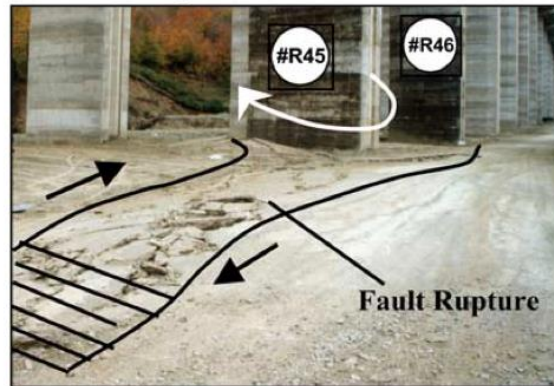
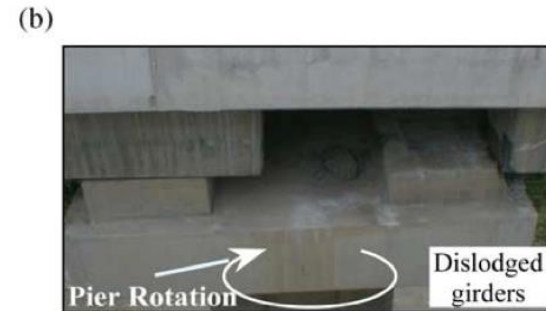
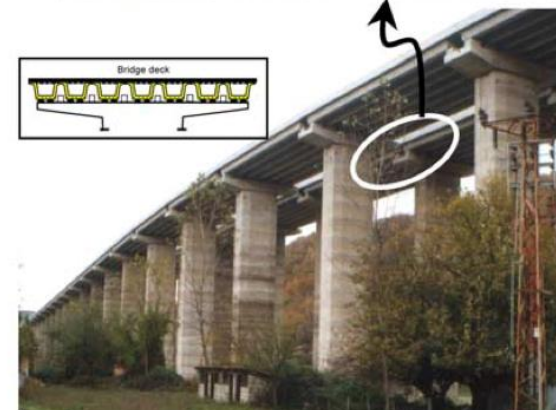
- Bolu高架橋，結構型式皆為多跨連續橋，於Düzce地震(Mw 7.2)因斷層錯動產生橋墩扭轉導致上部結構破壞。

Bolu高架橋因斷層錯動產生橋墩扭轉導致上部結構破壞
