Summary Report of Hualien Earthquake in Taiwan on April 3, 2024 (first edition, v1.0)

Chung-Che Chou, Chiun-Lin Wu, Juin-Fu Chai, George C. Yao

NCREE, Taiwan

April 05, 2024

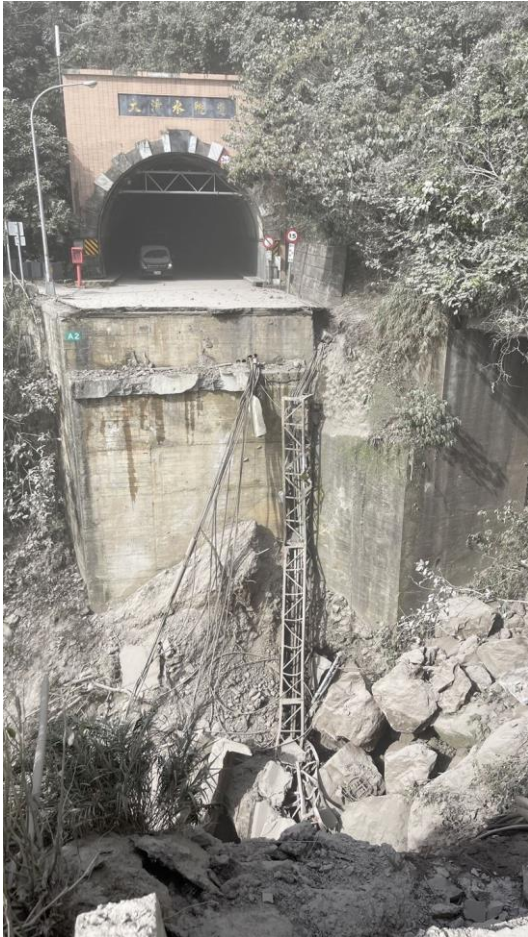
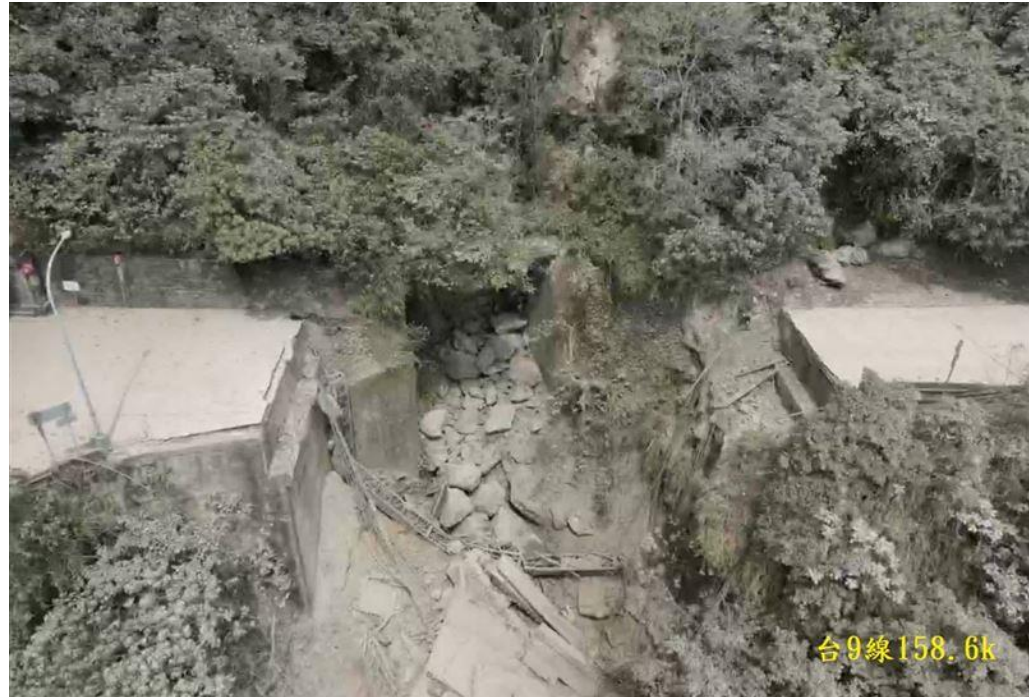
The Xiaqingshui Bridge fractured with falling rocks.

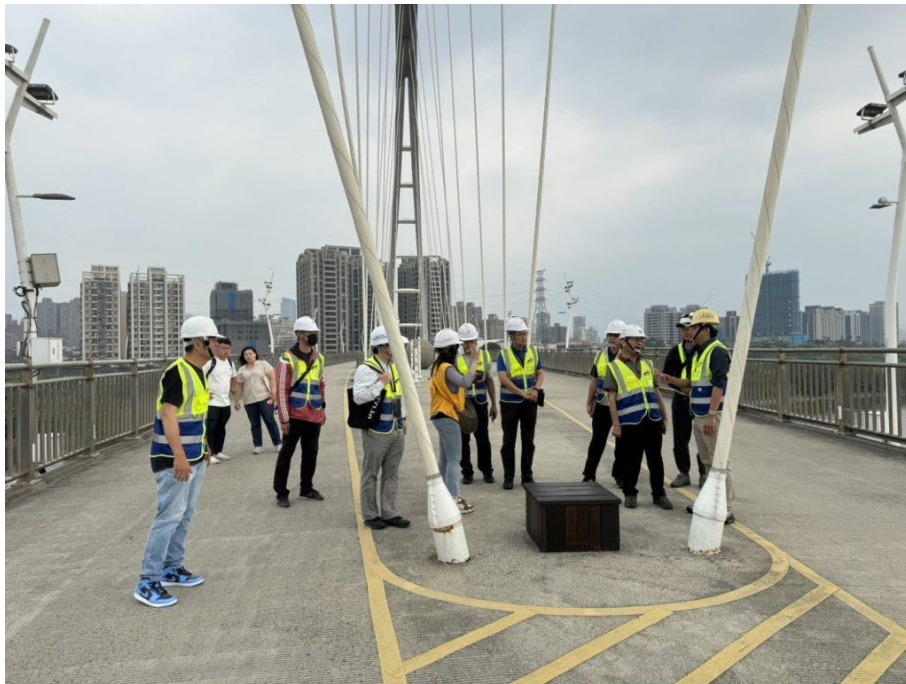
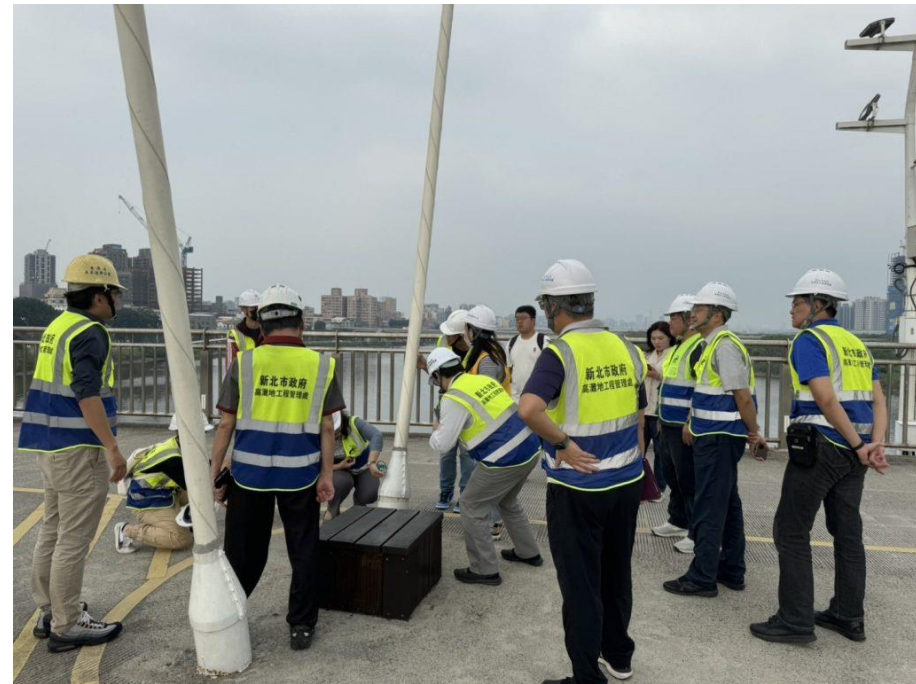
The suspension cables of the New Taipei City Crescent Bridge were loosened. The main section was closed for inspection immediately.

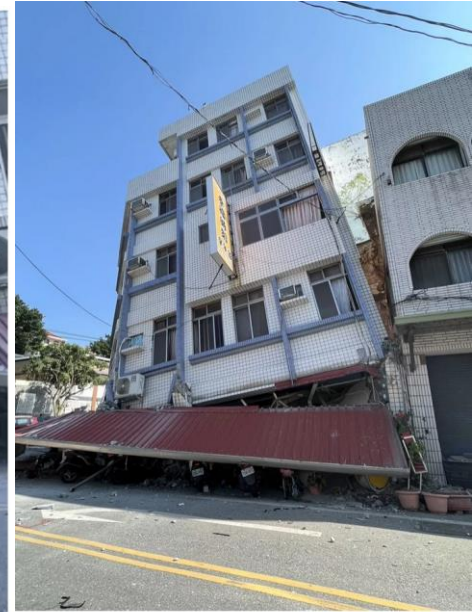
花蓮北濱街房屋傾斜。(記者王淑華/攝影)

**Shear failure of
exterior walls and
beams**

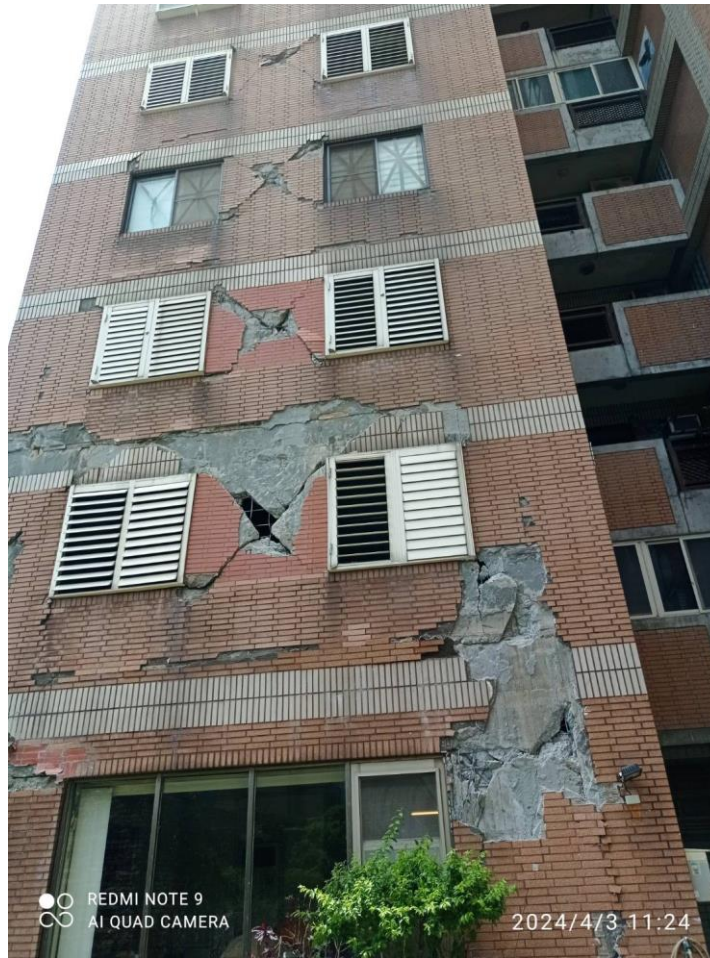
Residential bldg.

Exterior wall shear failure and tile fell off

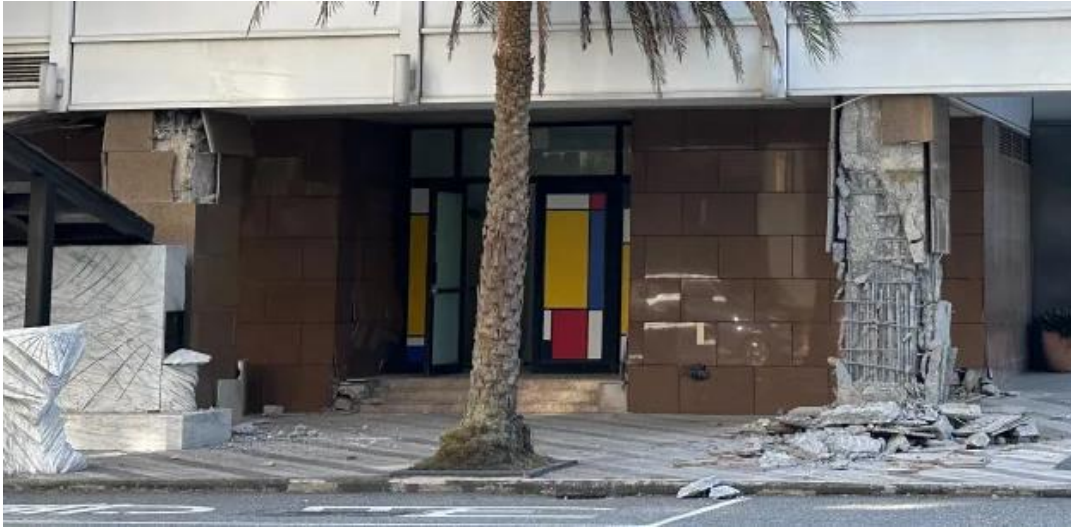
Hotel

The column cladding stone fell off, the protective layer of concrete cracked, and the column stirrup spacing was too large.

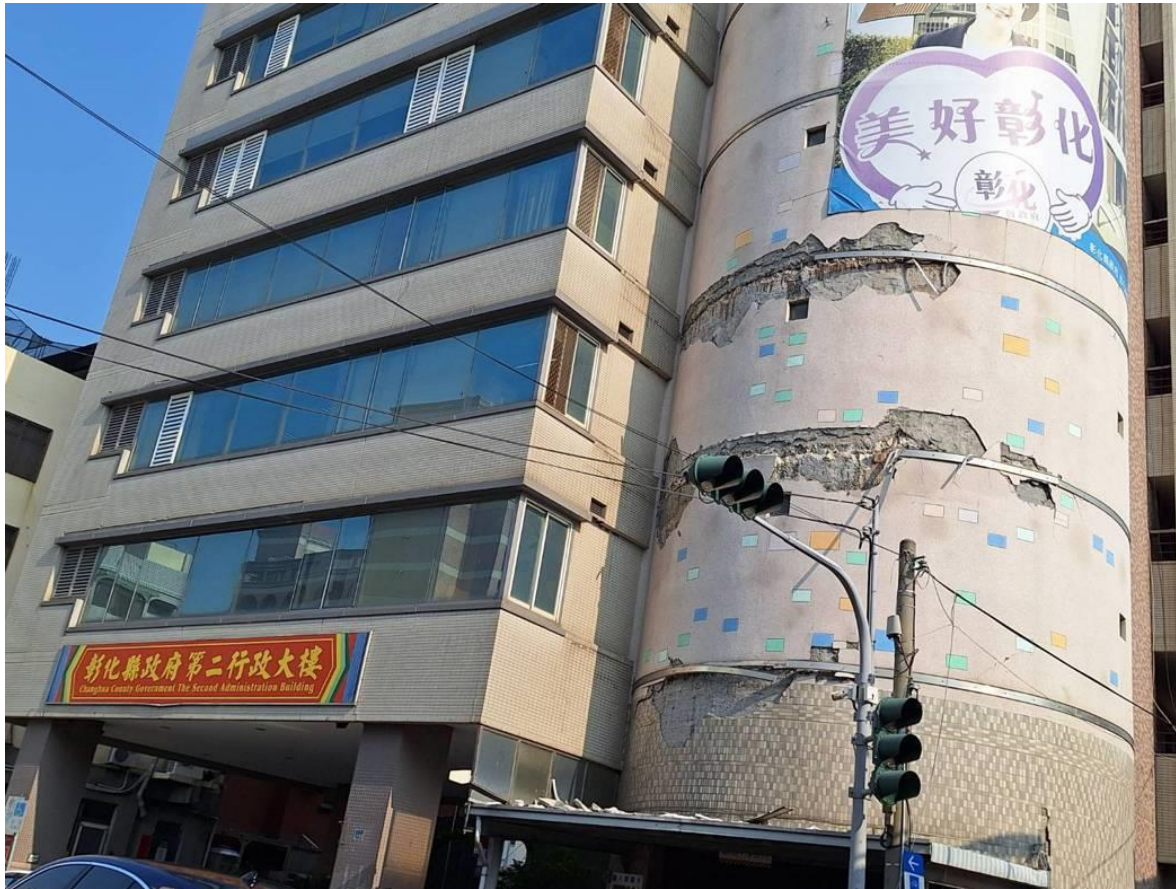
Office bldg.

Tiles fell off

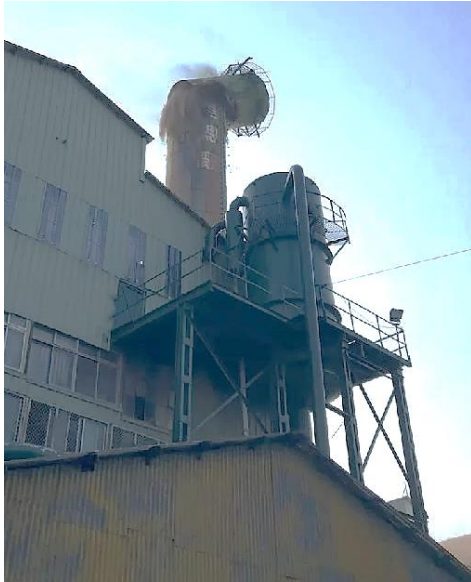
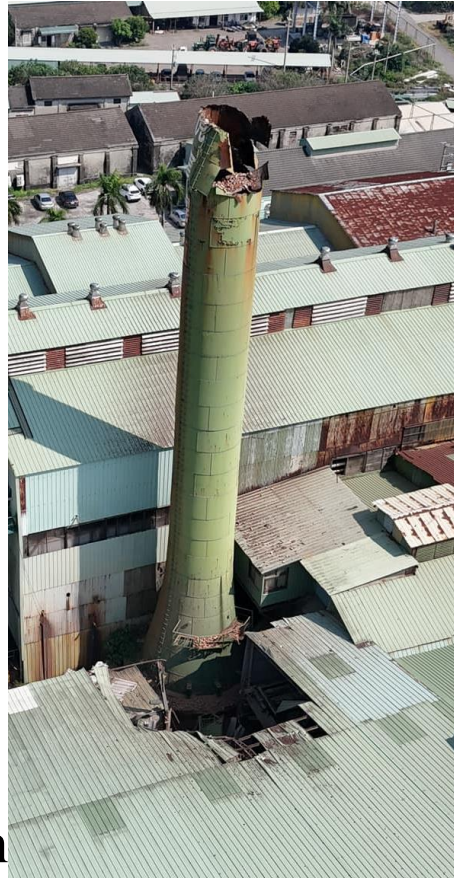
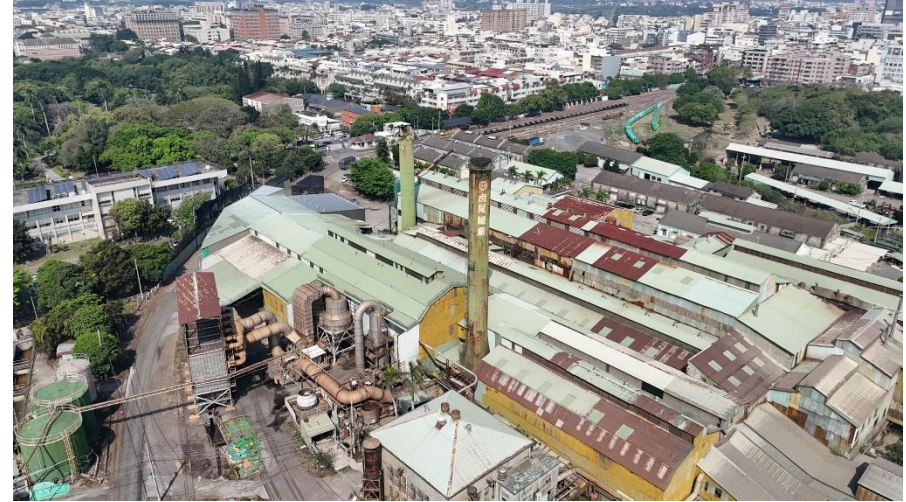
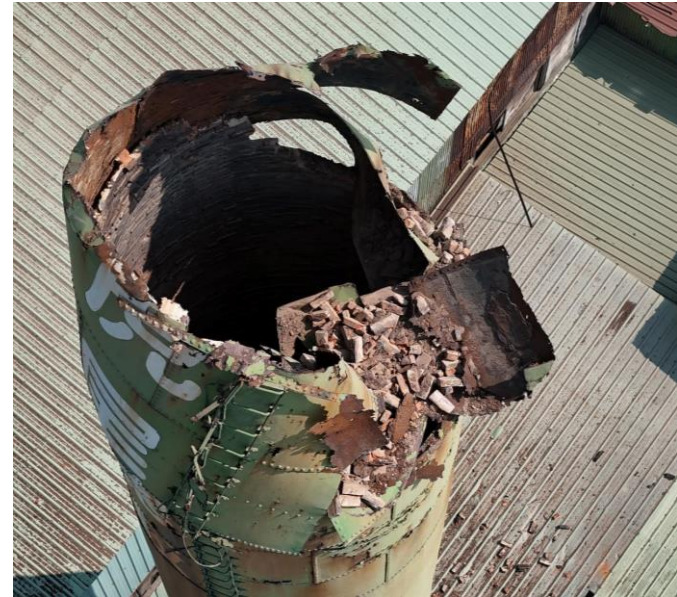
Chimney of Huwei Sugar Factory in Yunlin County

The chimney was damaged by the main earthquake. Collapsed during aftershocks

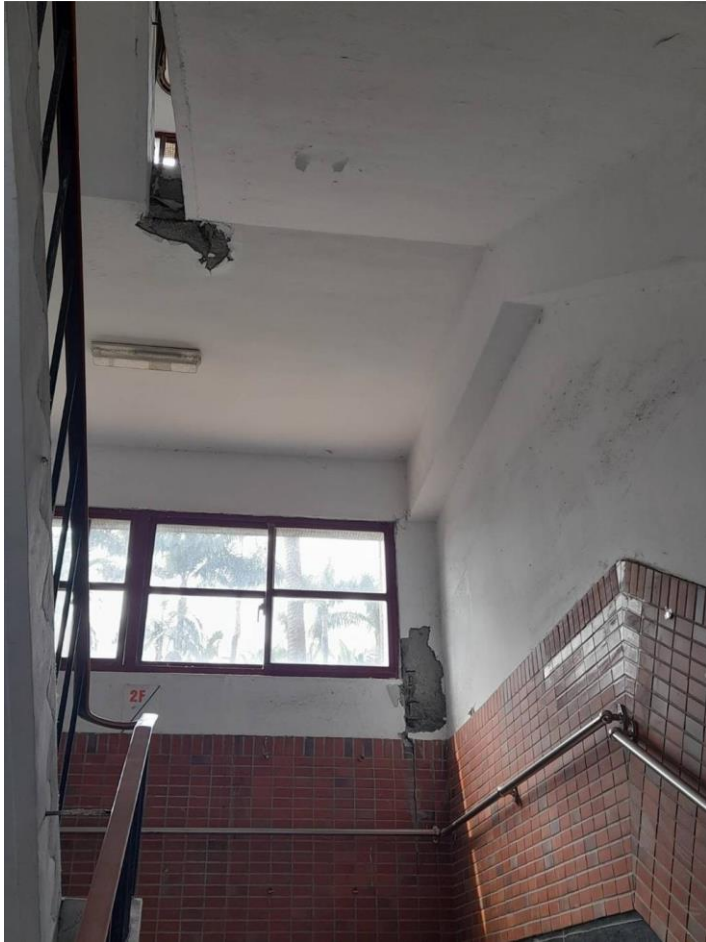
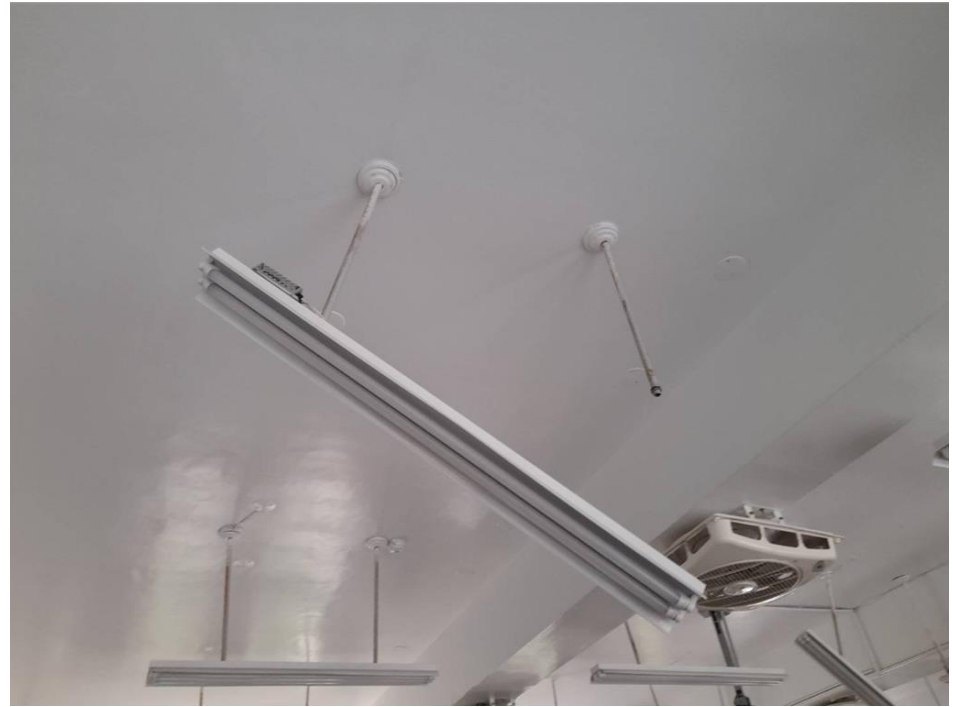
School bldg.

The concrete in the stairwell was peeling off and the light fixtures were damaged.

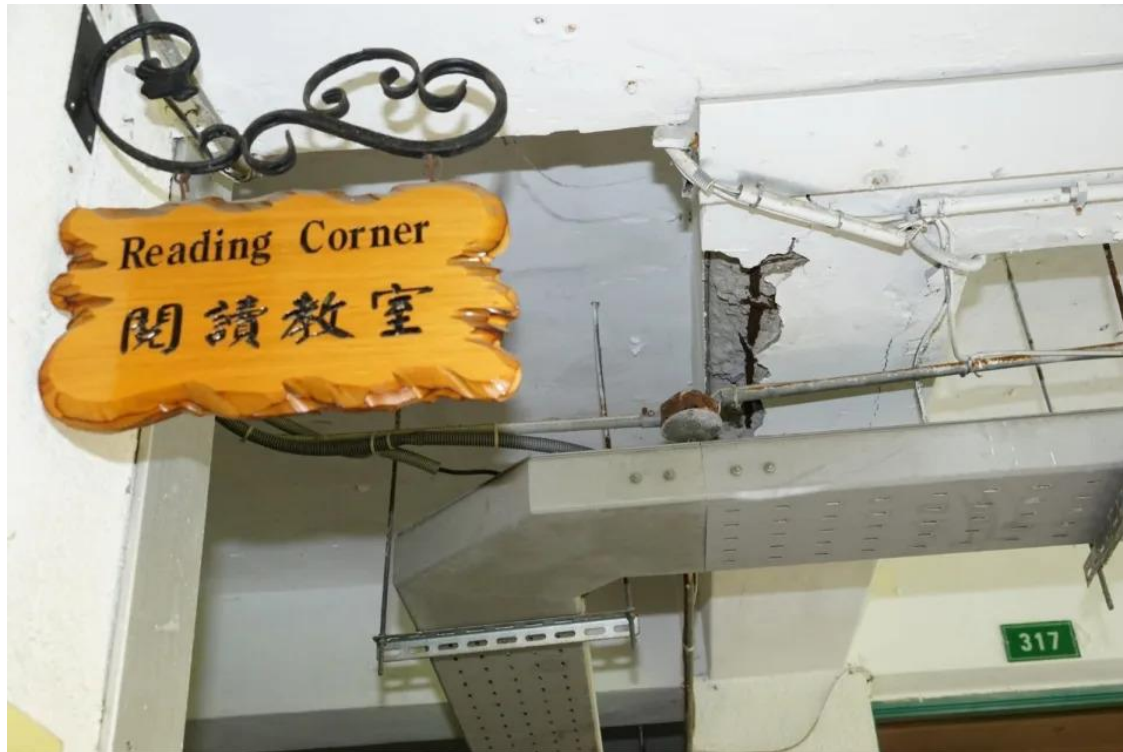
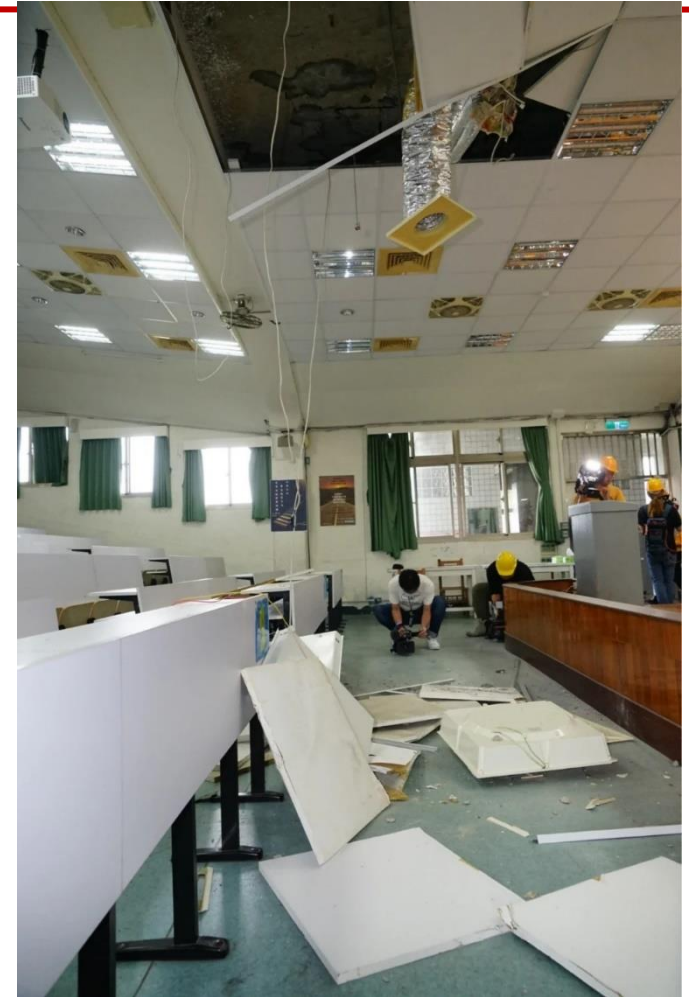
School bldg.

Concrete finish was torn off at the bottom of beams and ceilings fell off

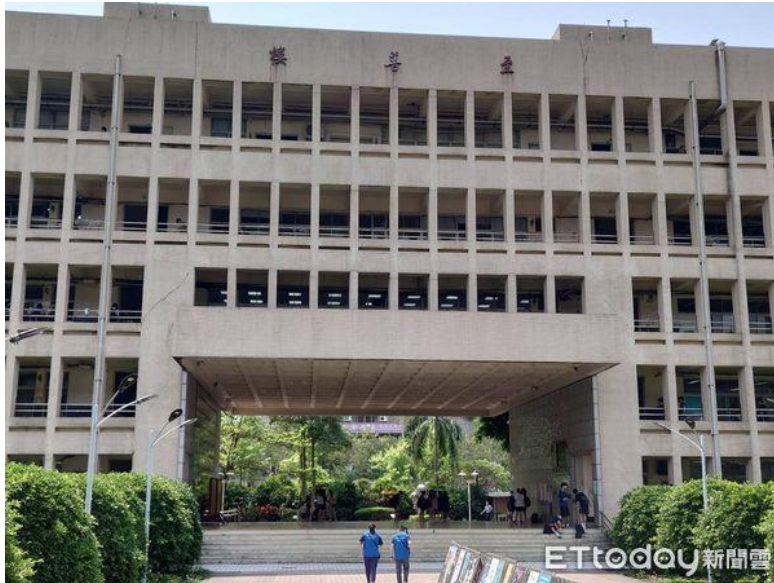
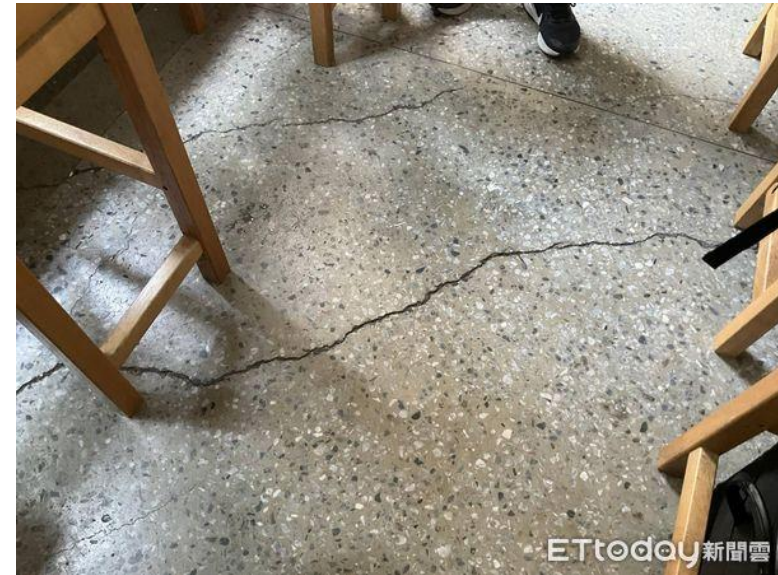
School bldg.

Cracks appear at the discontinuities in the building's structural facade, cracks appear in the floor, and the brick walls were convex and tilted.

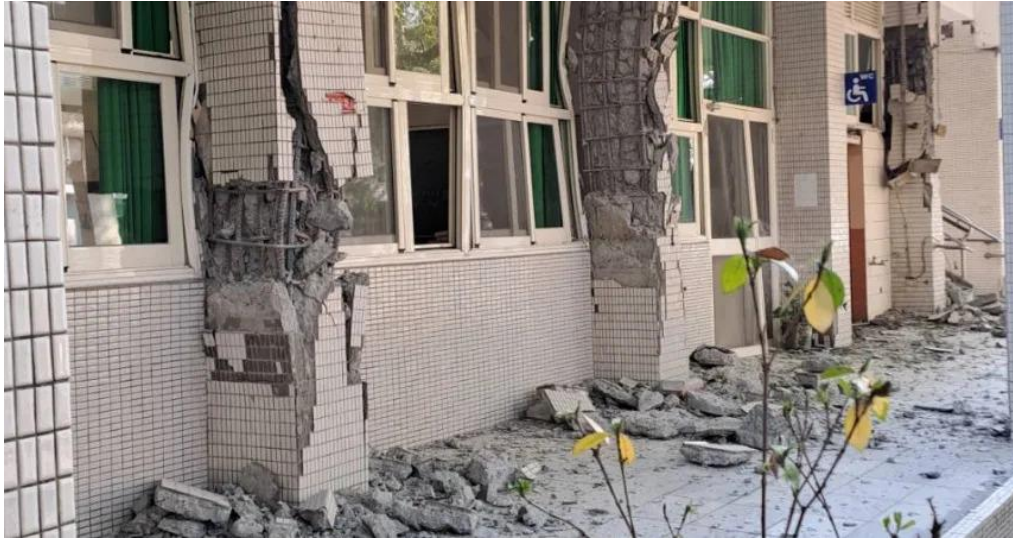
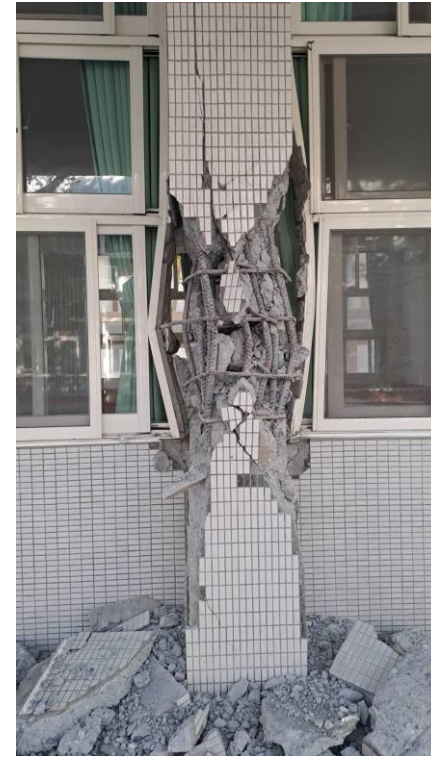
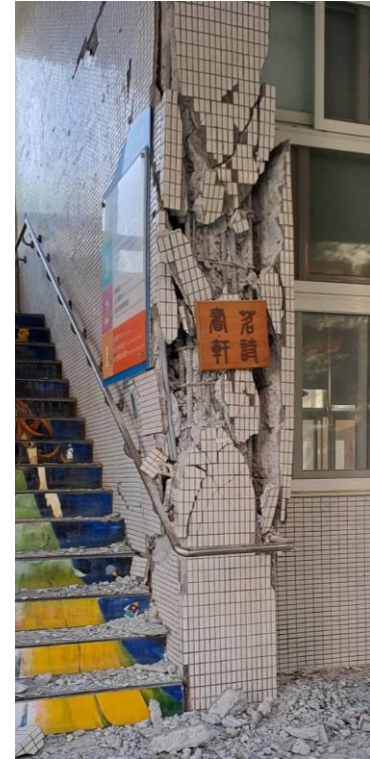
School bldg.

The short column effect caused column shear damage and excessive column stirrup spacing.

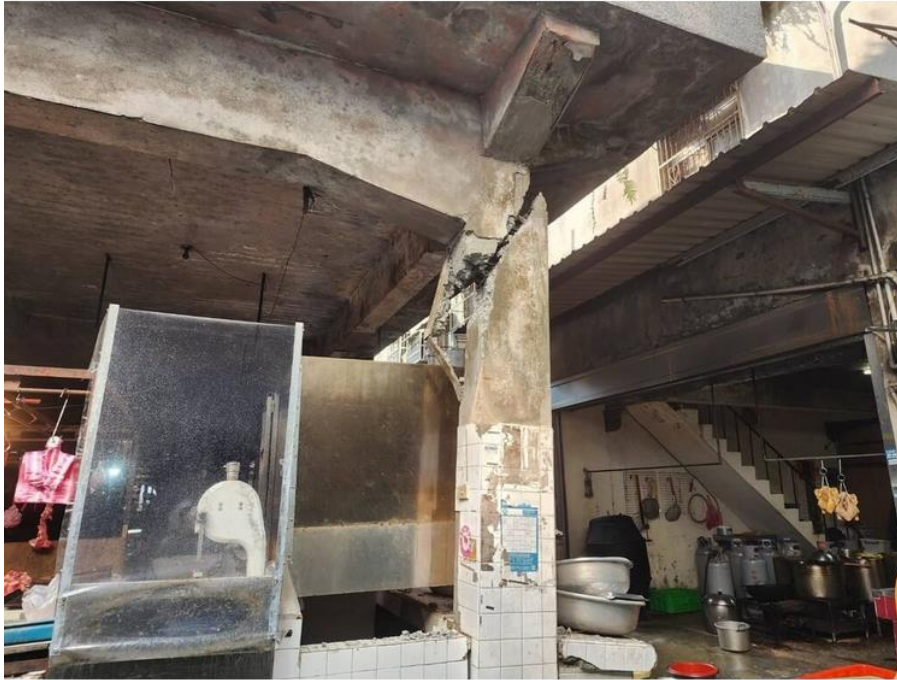
花蓮近海3日上午發生規模7.2地震，桃園大溪區三元二街一處私人市場內梁柱出現明顯裂縫且傾斜。
(大溪區公所提供) 中央社記者吳睿騏桃園傳真 113年4月3日

Column head cut off by shear force

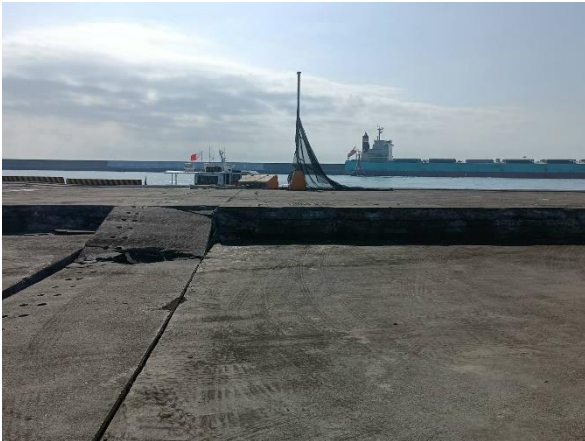
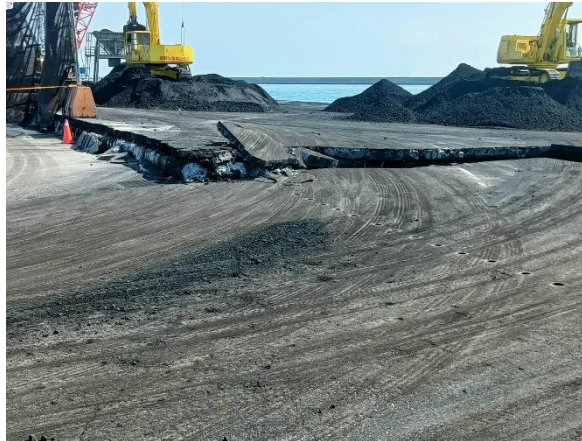
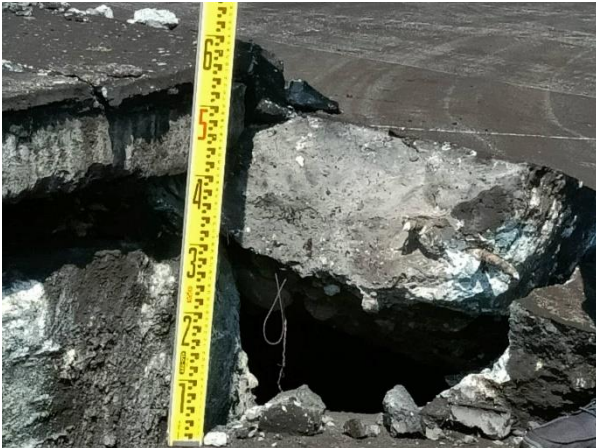
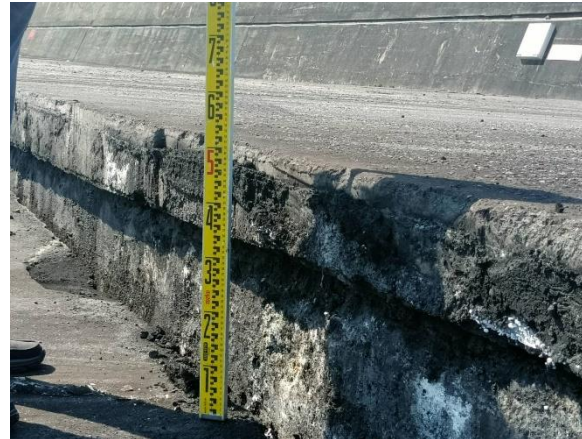
Port of Hualien

- Settlement observed in the caisson backfilled zone, the elevation difference between the caisson and the backfilled zone was approximately 15-50 cm.

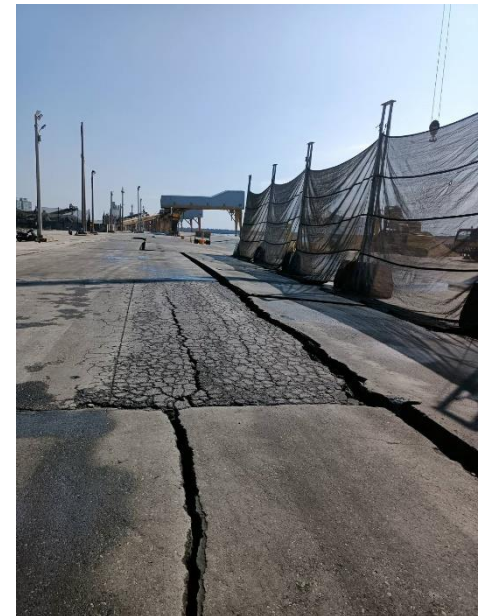
- Displacement observed at the wharf apron; significant cracks observed on the loading dock.

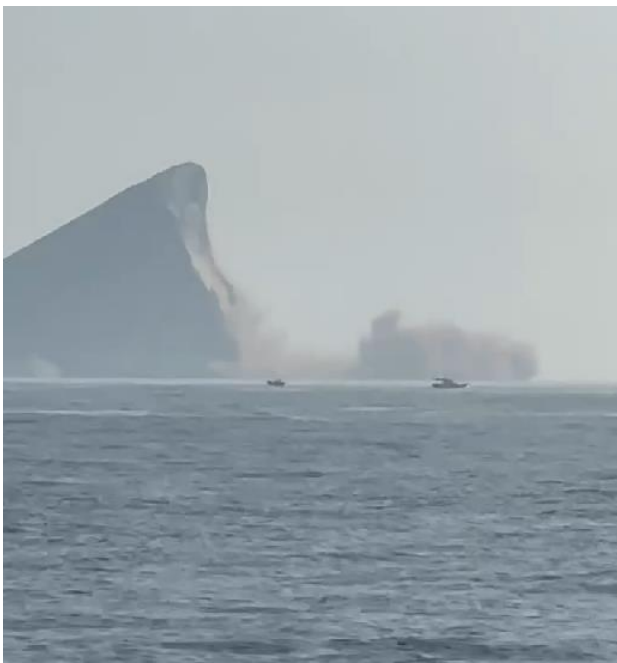
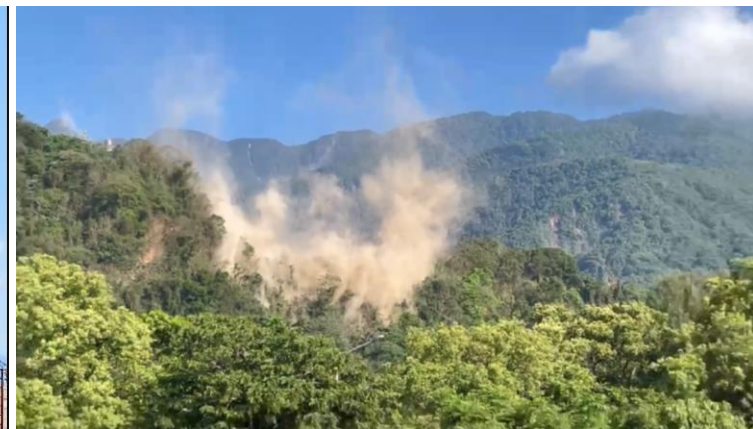
- Severe landslide events occurred at multiple mountains caused transportation disruptions of highways and railways.
- Guishan Island
- Mt. Chongde, Hualien
- Kangle Village, Xincheng, Hualien

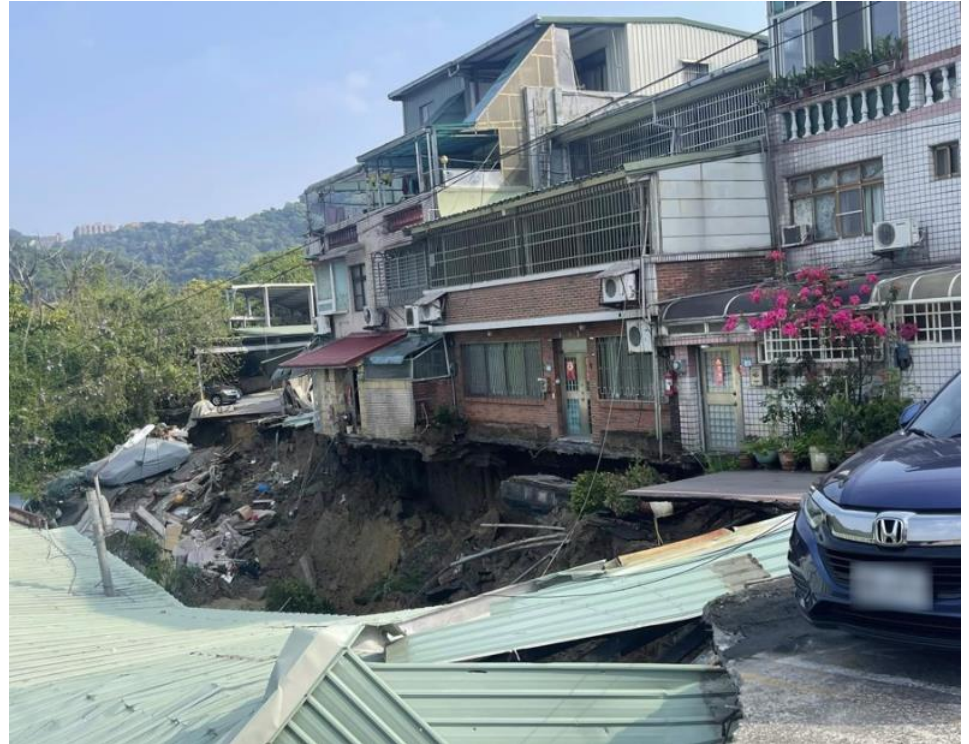
- Roadbed collapsed in front of an apartment complex and caused the loss of the building foundation in Xindian, New Taipei

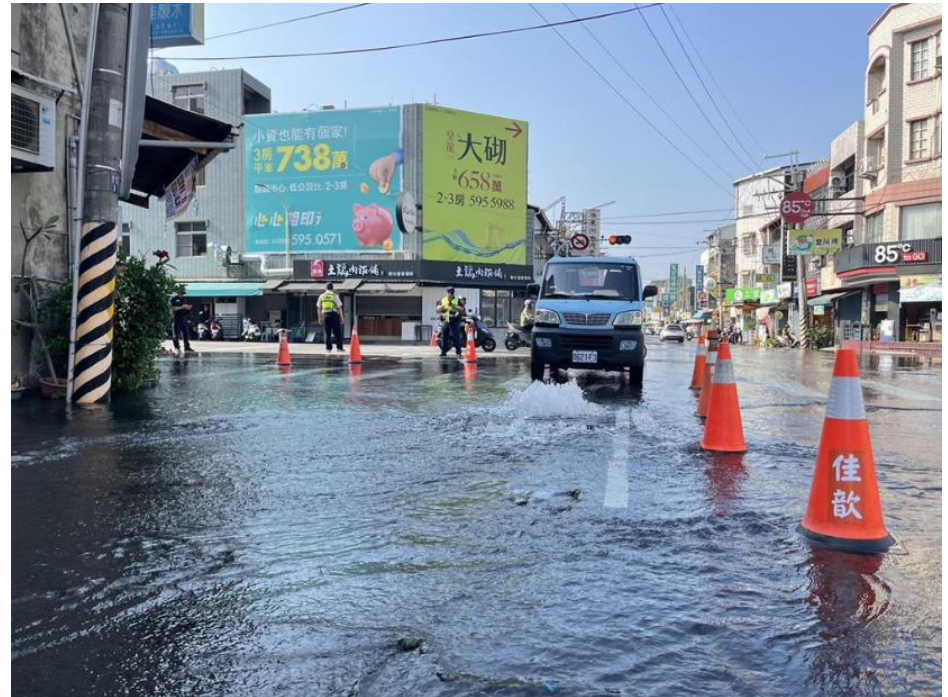
- Flooding occurred in Tainan due to water pipeline damage.

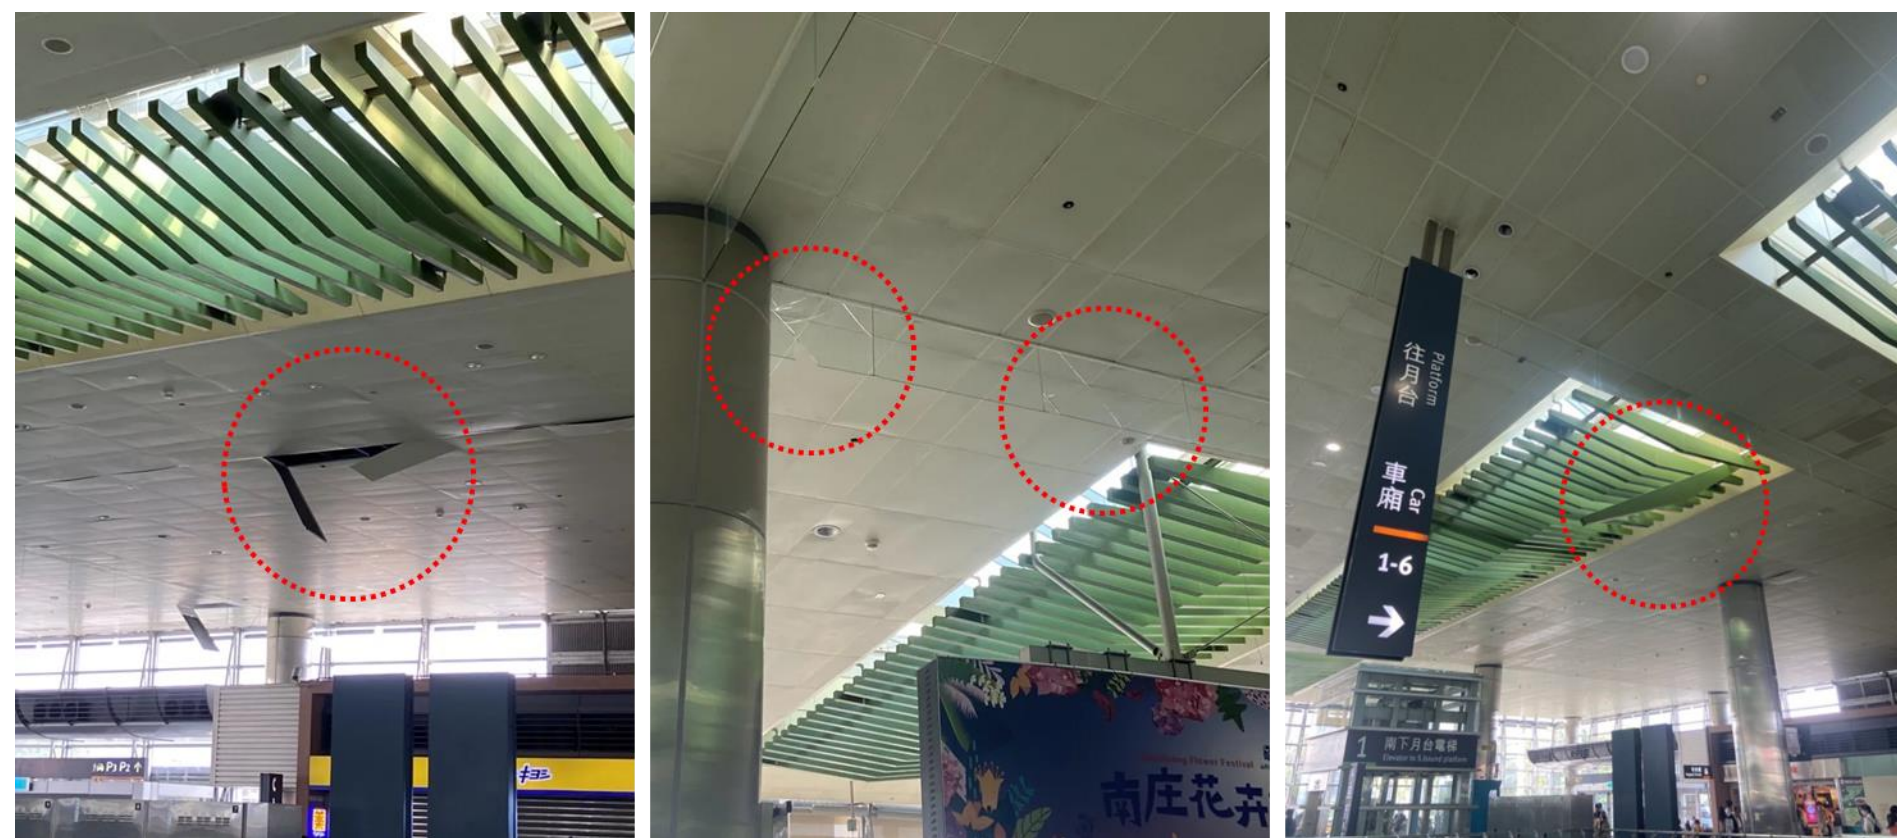
1. Taiwan High Speed Rail (THSR) Taoyuan Station

Dislodged ceiling panels (marked in the left and right photos) and cracked smoke barriers (marked in the middle photo) were observed in the lobby of THSR Taoyuan station.

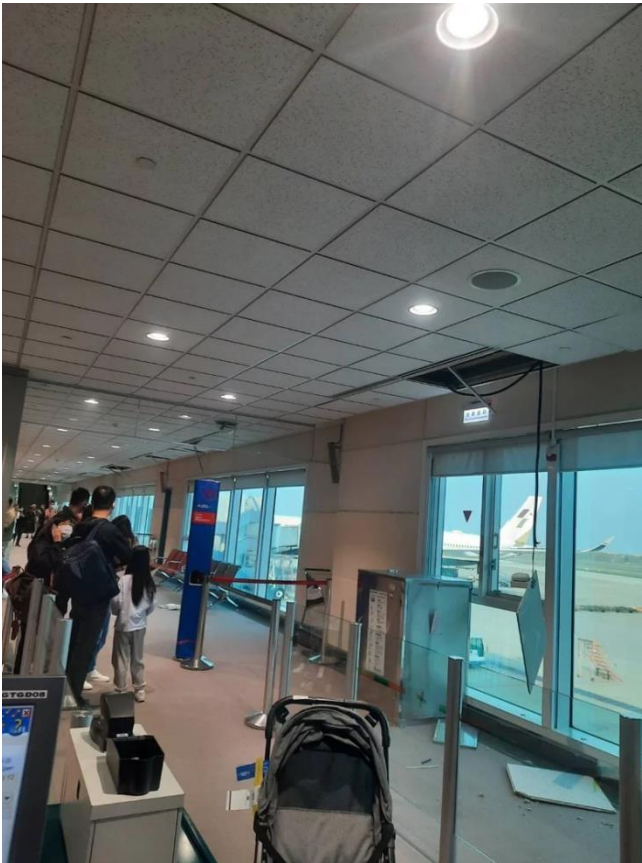
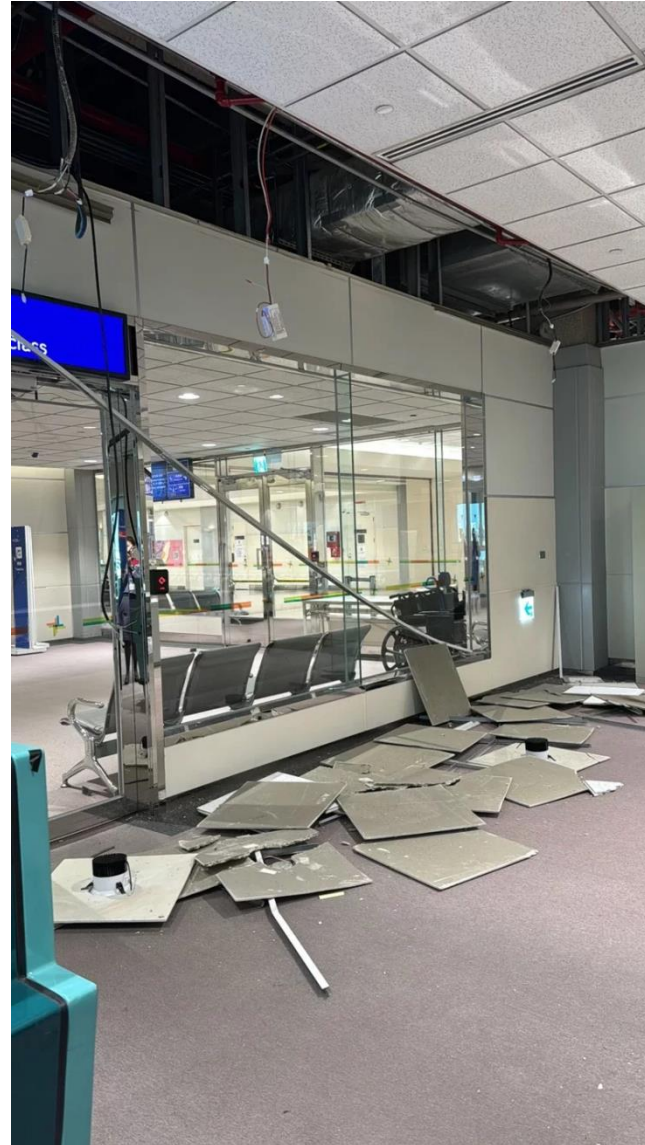
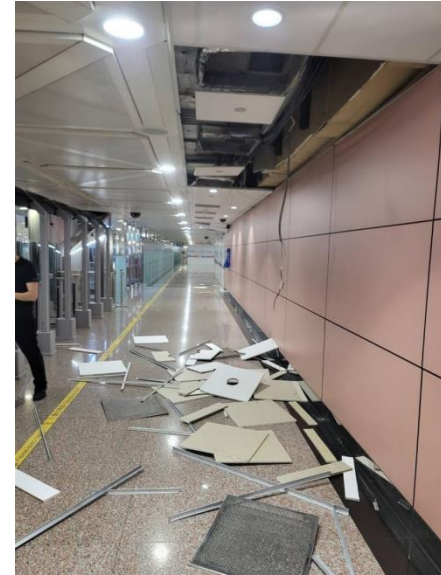
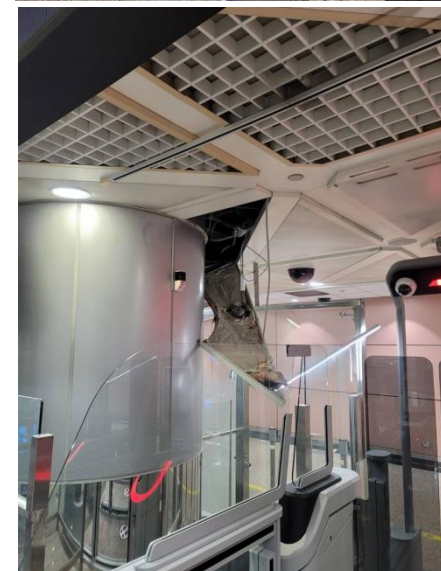
2. Taiwan Taoyuan International Airport

Local collapse of the grids and loss of ceiling panels were found in the airport terminal.

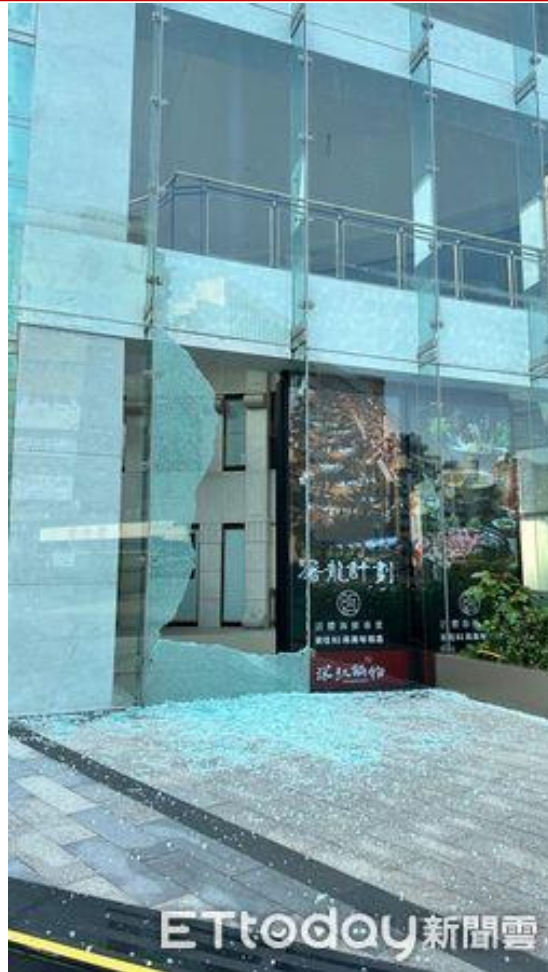
6. SOGO Dunhua Store

A piece of glass facade of SOGO Dunhua Store was broken in Taipei City.

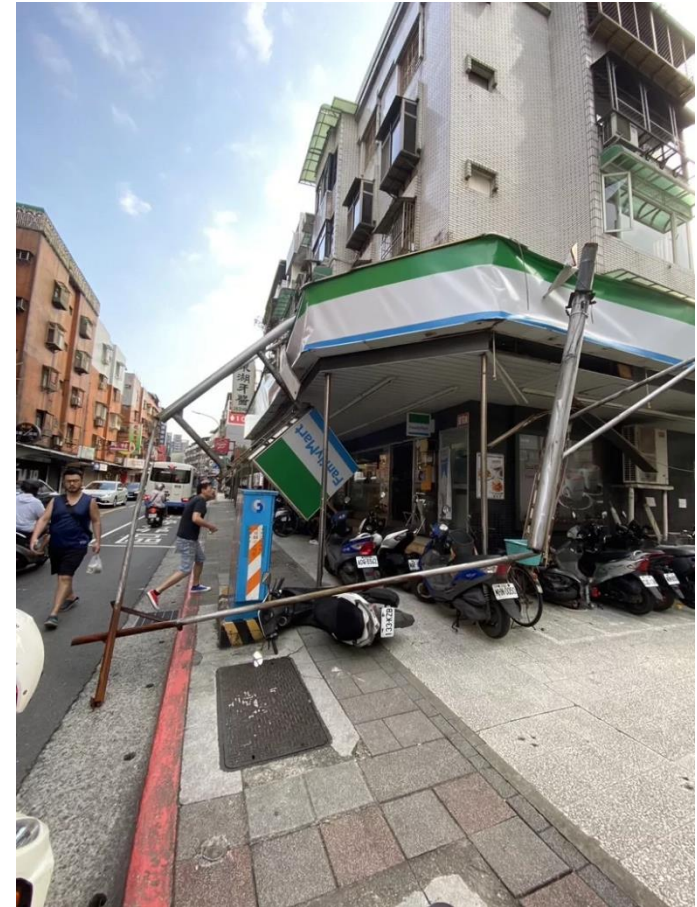
7. Convenience store in Taipei City

Signboards of a convenience store collapsed in Neihu District of Taipei City.

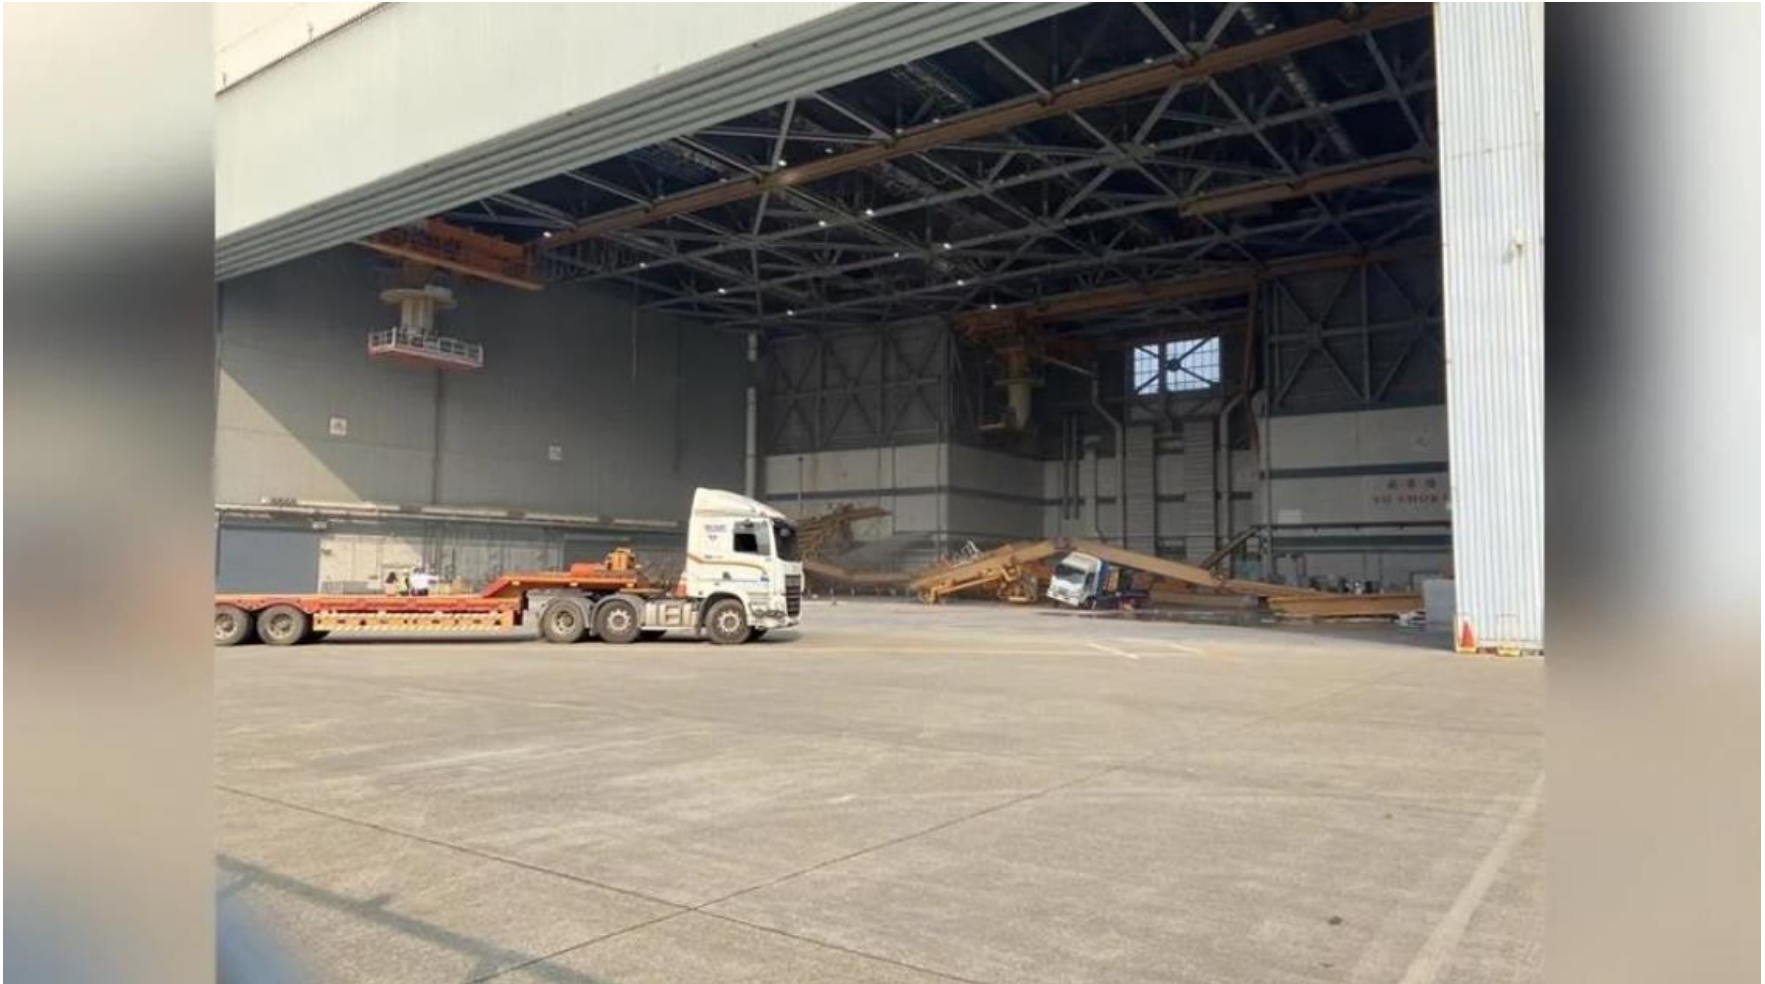
9. Taiwan Taoyuan International Airport

The overhead crane in the maintenance hangar collapsed in Taiwan Taoyuan International Airport (TPE).
