Summary Report of Hualien Earthquake in Taiwan on April 3, 2024 (first edition, v1.0)

Chung-Che Chou, Chiun-Lin Wu, Juin-Fu Chai, George C. Yao

NCREE, Taiwan

April 05, 2024

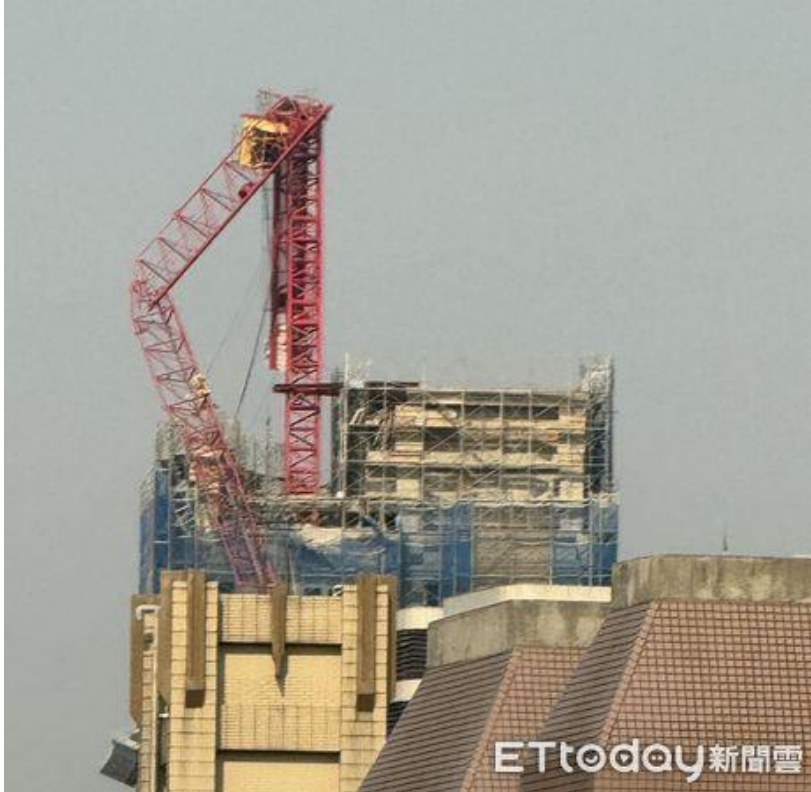
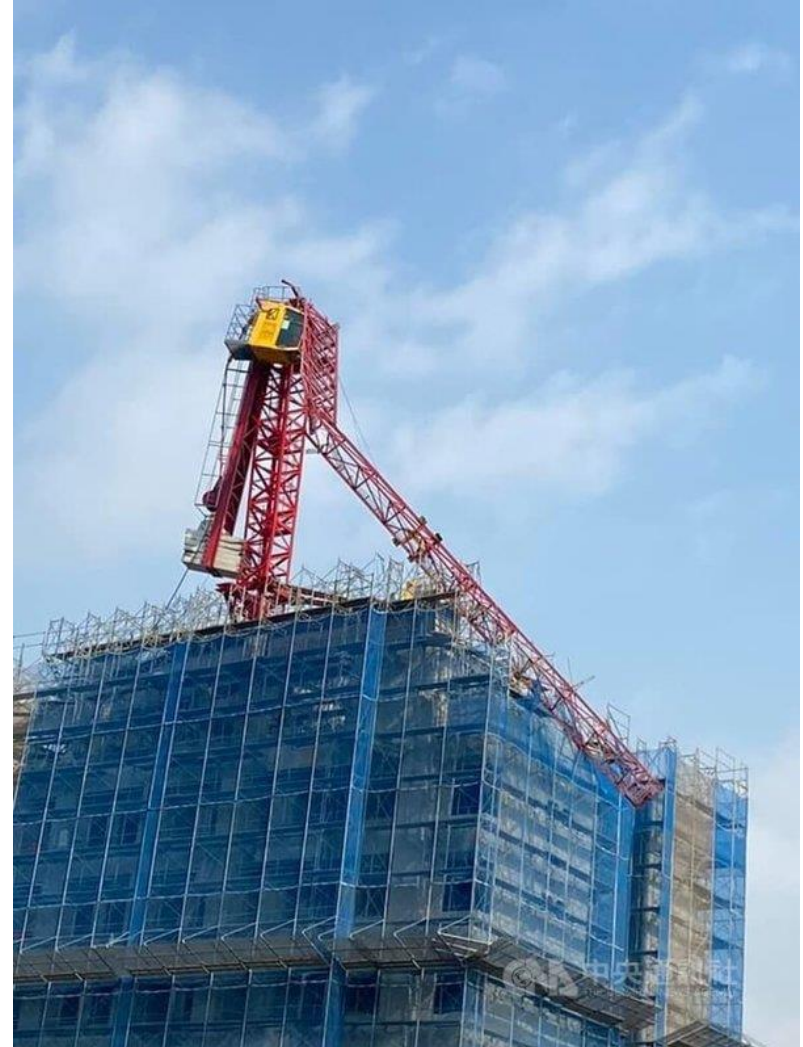
10. Building Under Construction in New Taipei City

The boom of the tower crane on the roof of the building under construction was damaged in Xinzhuang District of New Taipei City.

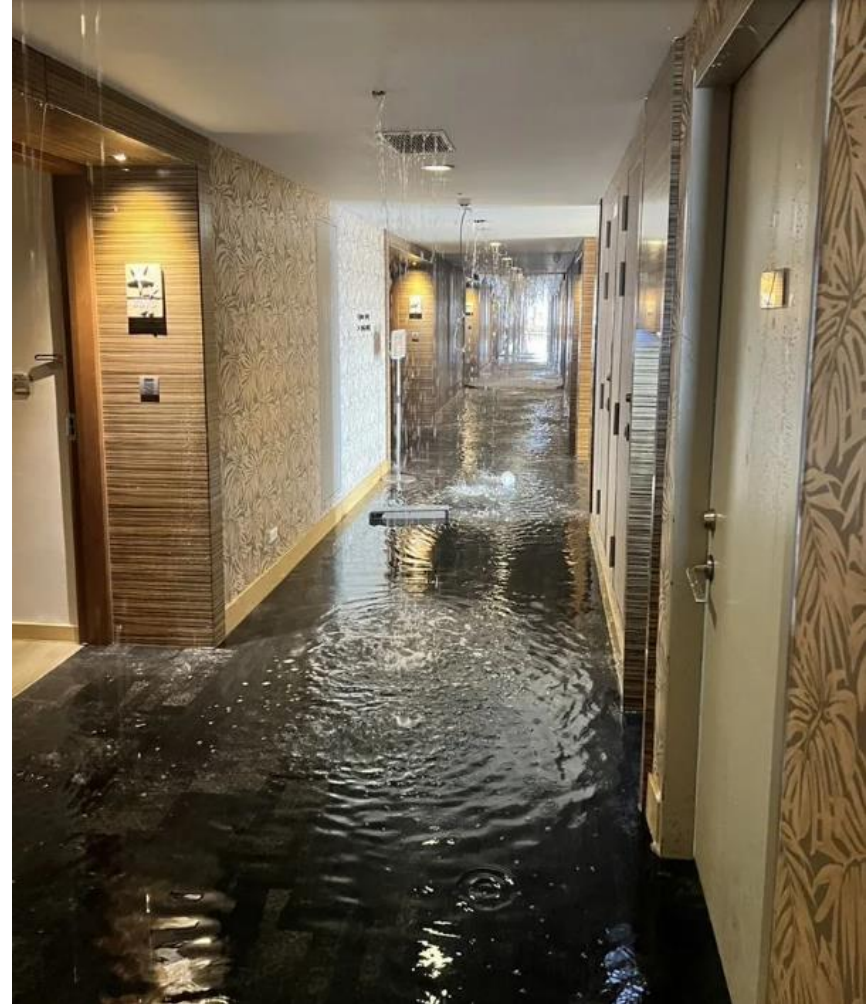
11. Lakeshore hotel Hualien

The suspended piping system failed and led to flooding damage in the corridor in Lakeshore Hotel Hualien.

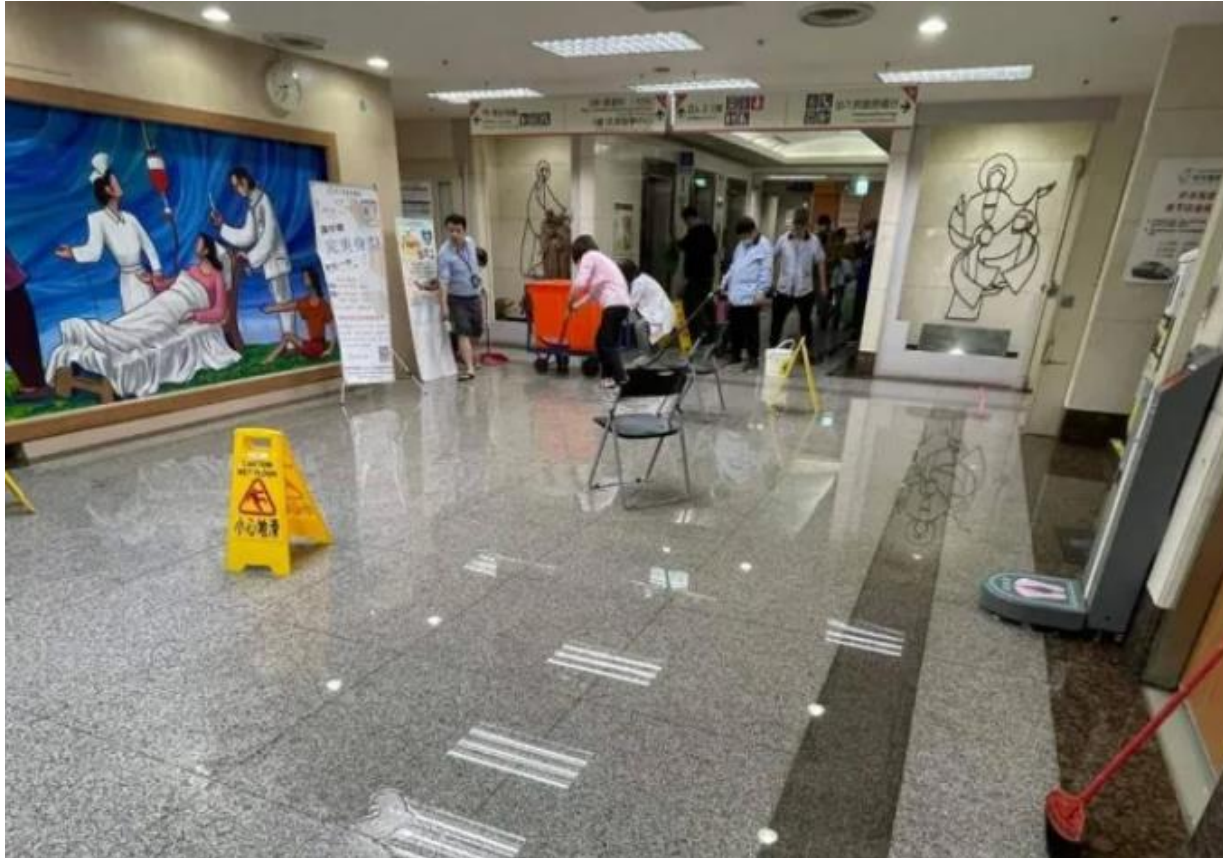
12. Cardinal Tien hospital in New Taipei City

The water piping system failed, causing flooding damage in Cardinal Tien Hospital in the Xindian District of New Taipei City.

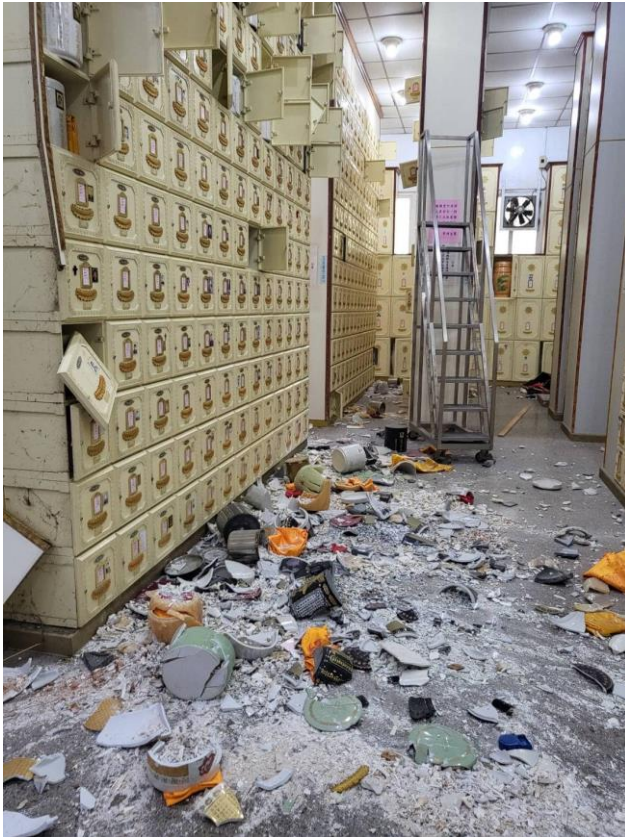
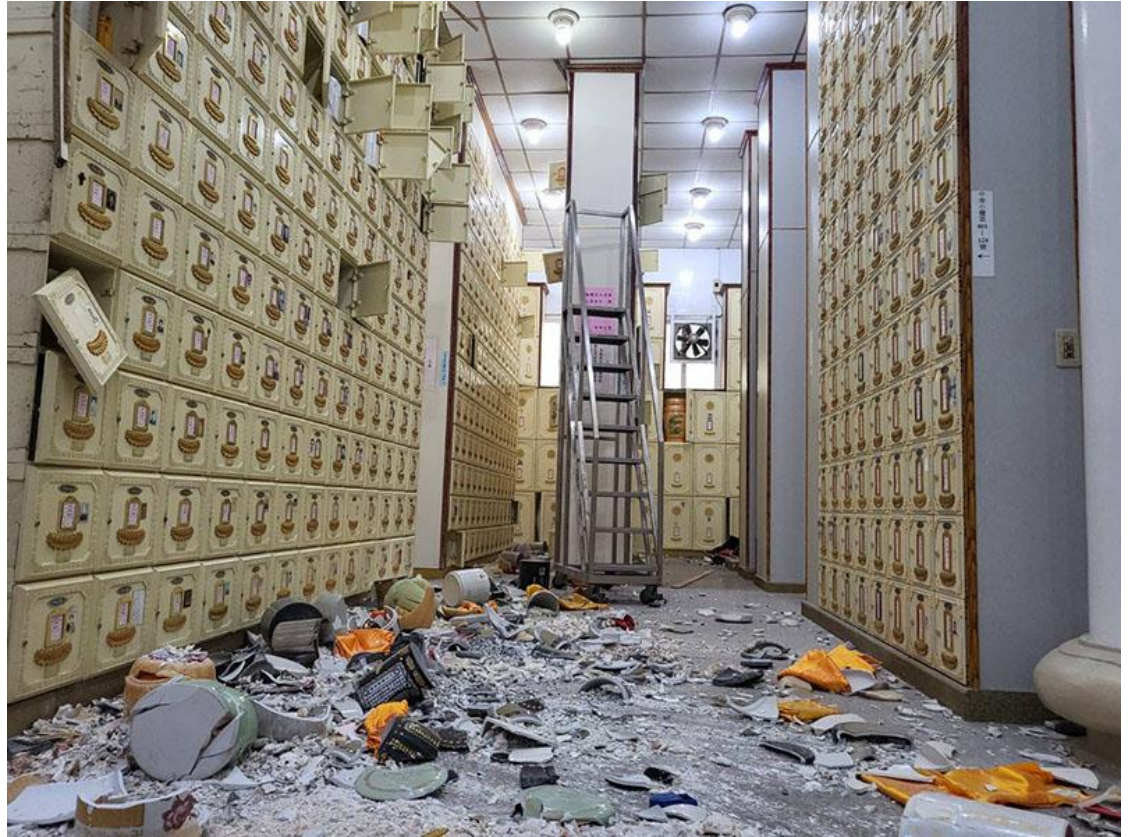
13. Ciyunshan Columbarium in Hualien

The urns dropped and ossuary cabinets were damaged in Ciyunshan Columbarium in Ji'an Township of Hualien County.

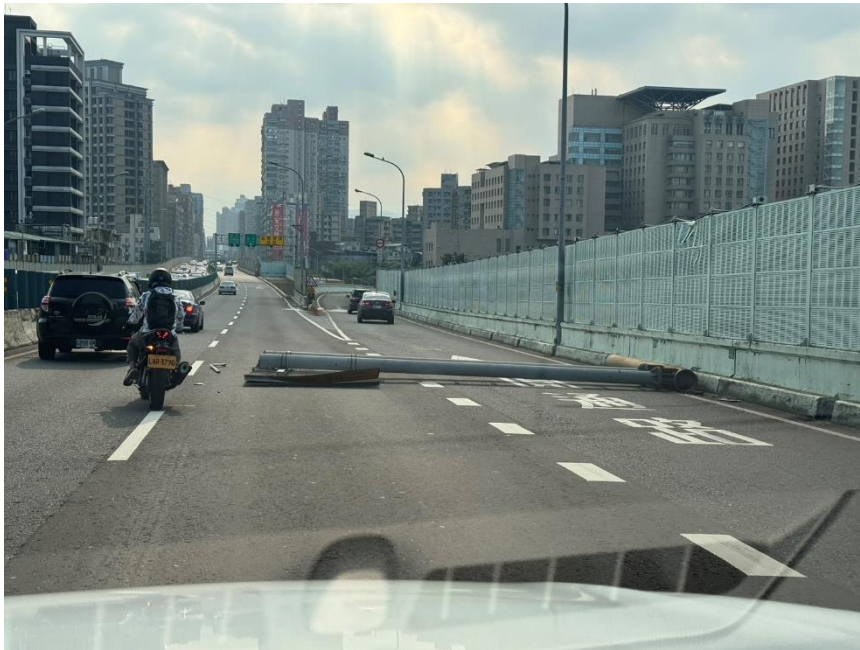
14. Elevated road

A street signpost collapsed on the No. 64 express way near Zhonghe District of New Taipei City.

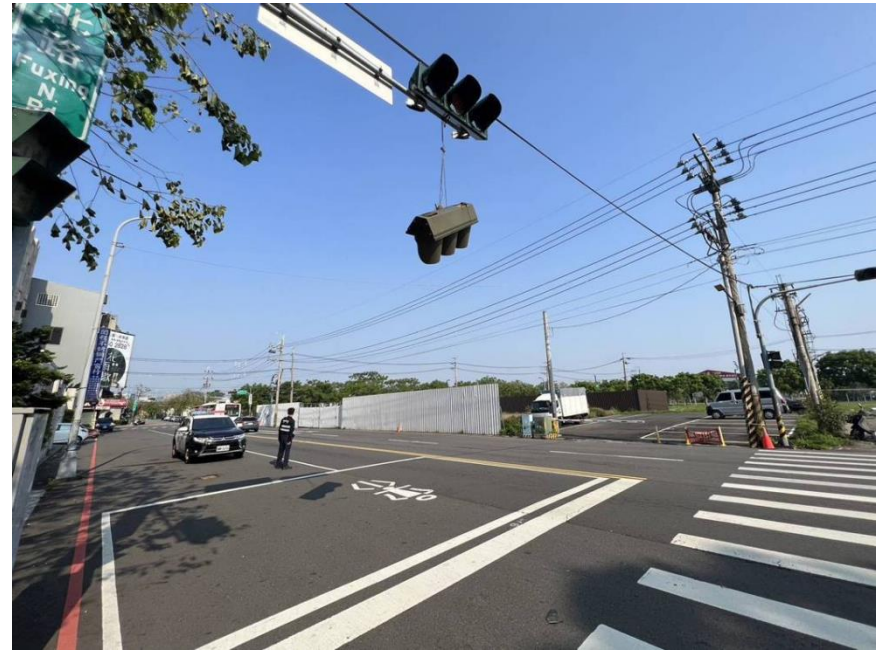
15. Public road

A traffic signal was damaged at the intersection between Fuxing North Road and Xiyuan Road in Xitun District of Taichung City.
