# Summary Report of Hualien Earthquake in Taiwan on April 3, 2024 (2<sup>nd</sup> edition, V2.0)

**Chung-Che Chou, Chiun-Lin Wu, Juin-Fu Chai, George C. Yao**

**NCREE, Taiwan**

**May 25, 2024**

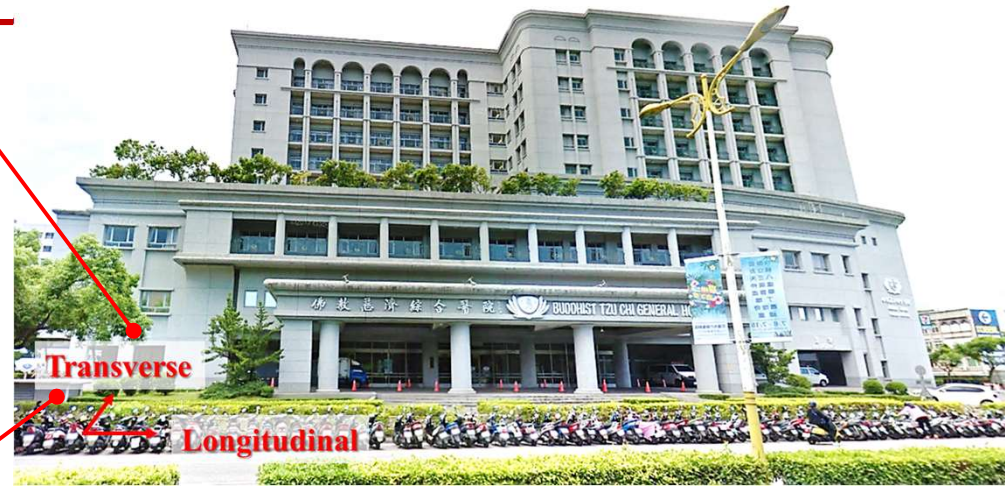
The maximum pushing displacement (isolation displacement) in longitudinal dir. could be roughly measured as 300mm

**Damages of stone slabs due to insufficient isolation moving space**

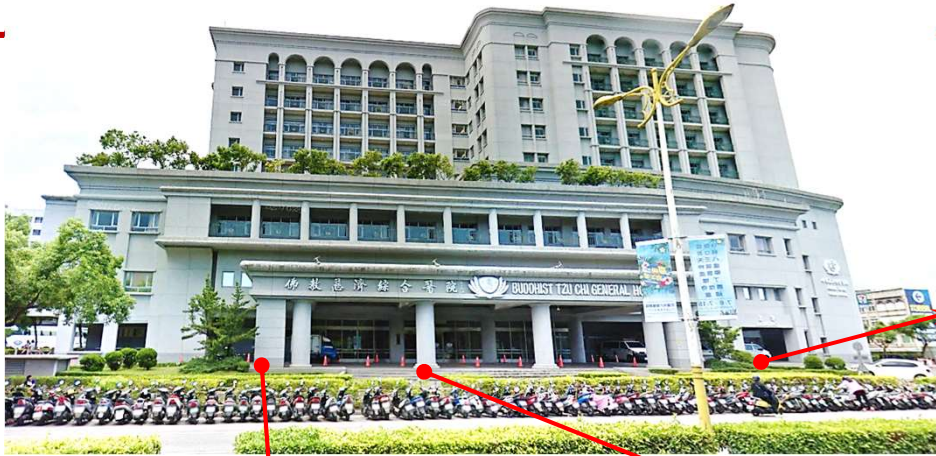
**400mm in  
transverse direction**

**Damages of garden  
stone pillars due to  
insufficient isolation  
moving space**

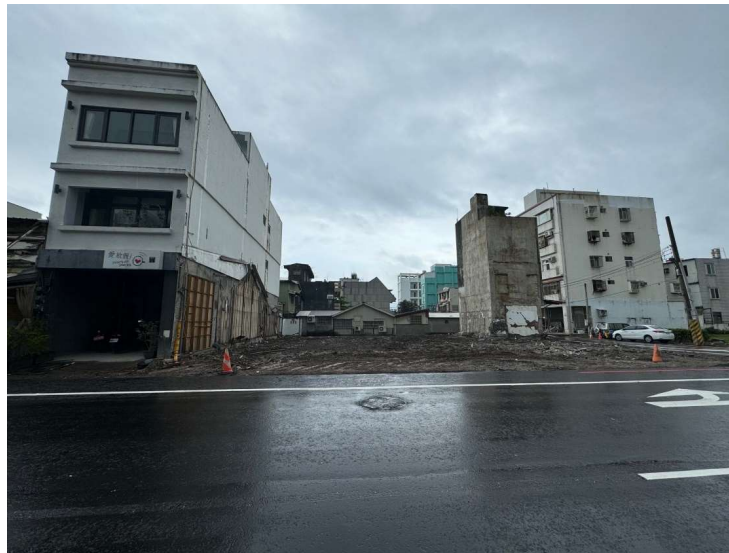
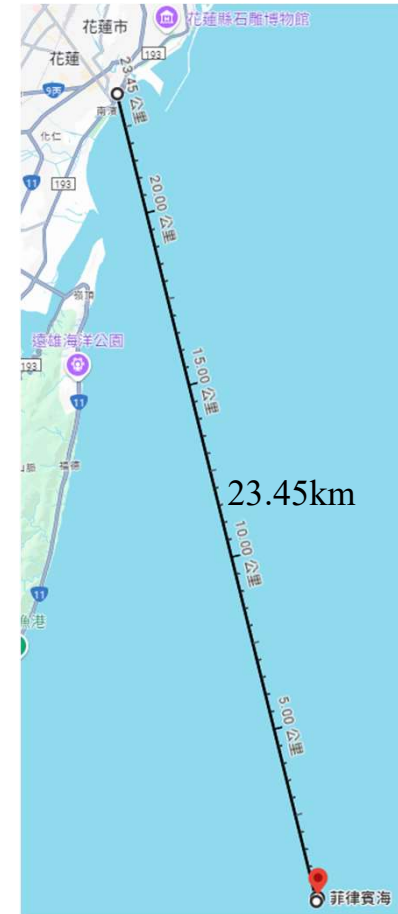
# 5-story Residential bldg. Hualien City

## Soft/weak story failure

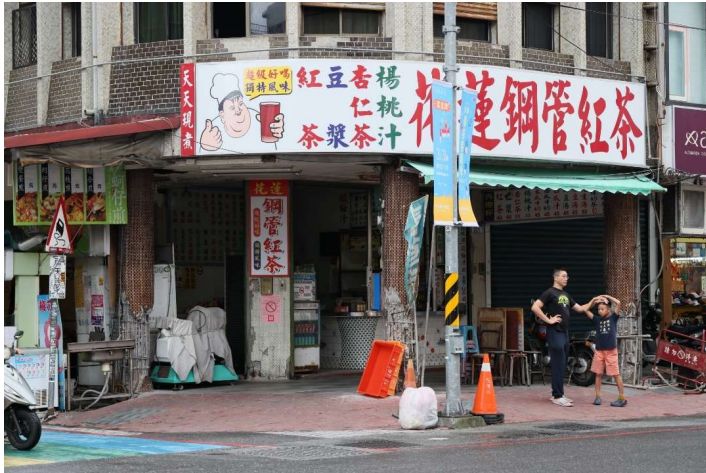
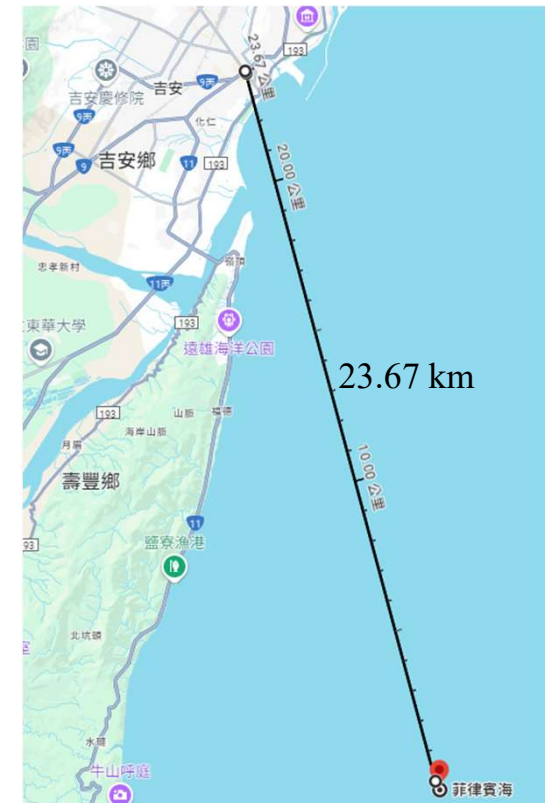
# 4-story Residential bldg. **NAR Labs**

## Column protective layer peeling off

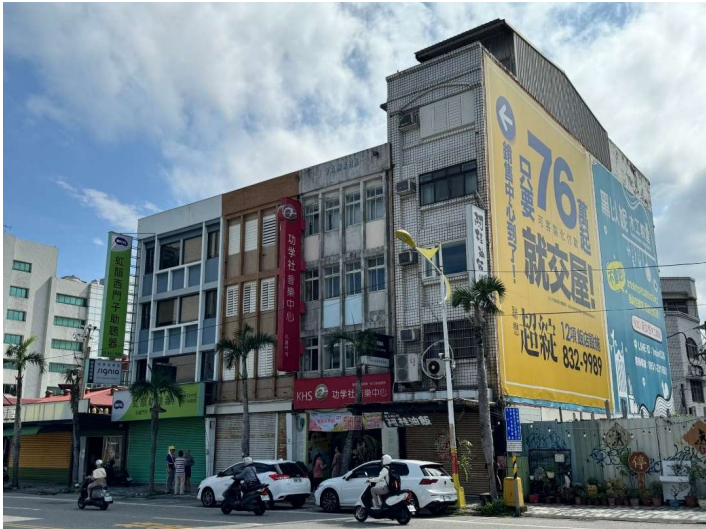
# 4-story Residential bldg. Hualien City

RC Beam-Column Connection Failure

Partition walls damaged

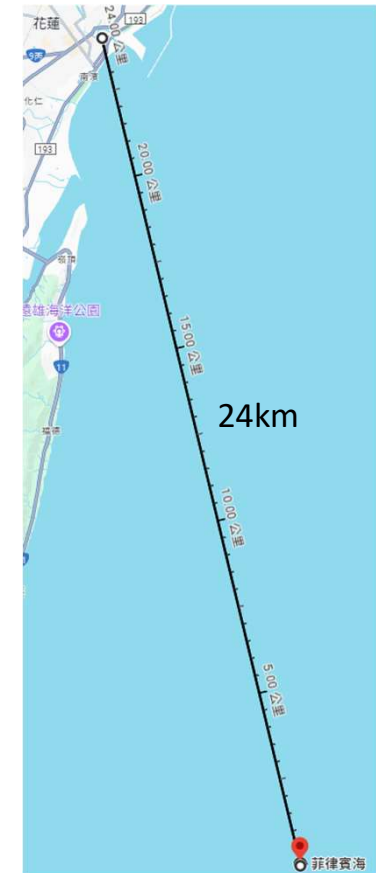
# School bldg. in Hualien City

windowsill shear failure

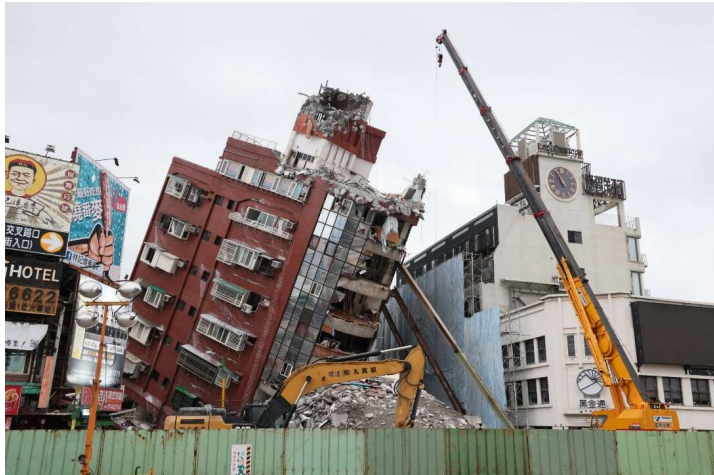
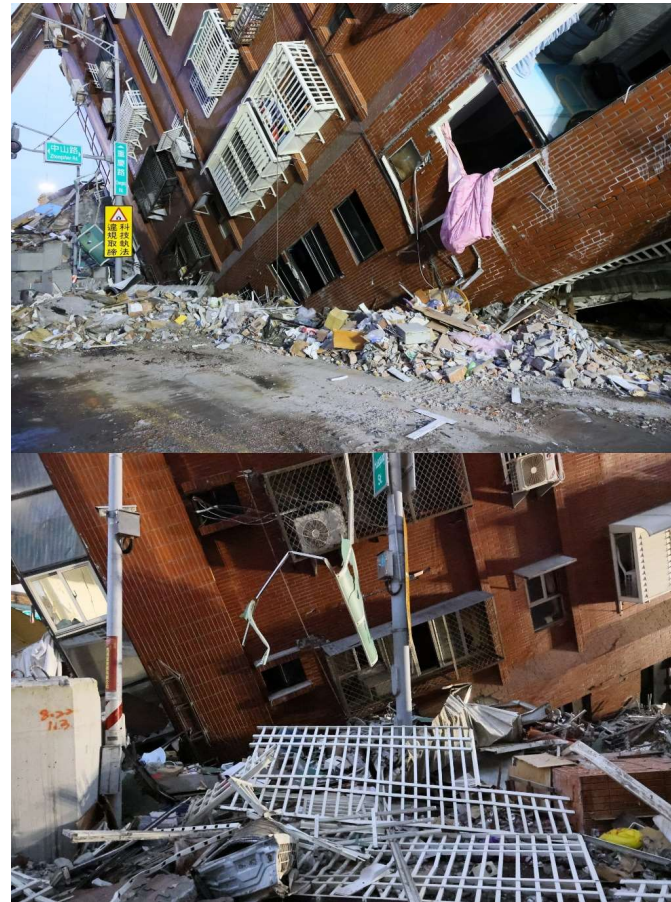
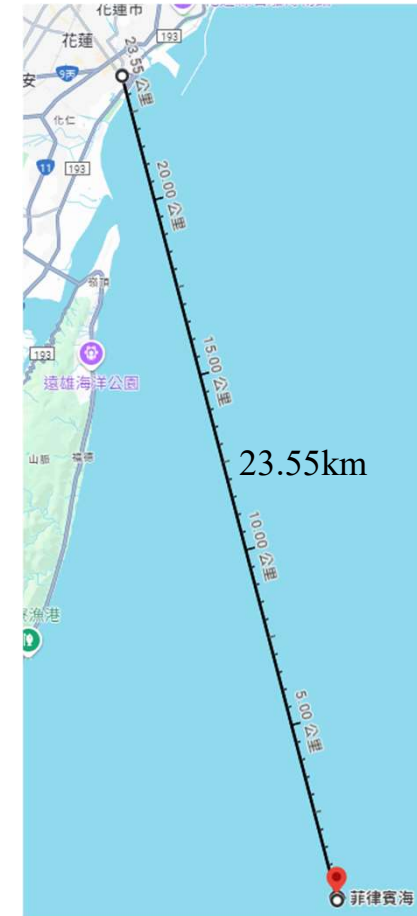
# 10-story Residential bldg.

- Soft/weak story failure

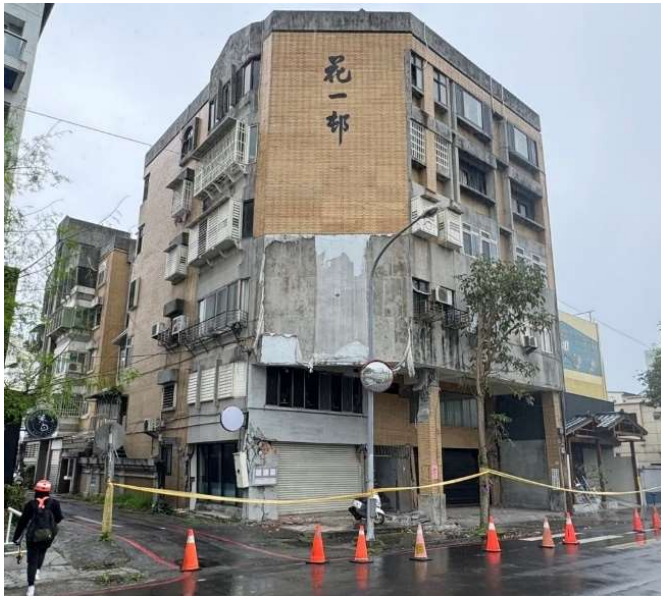
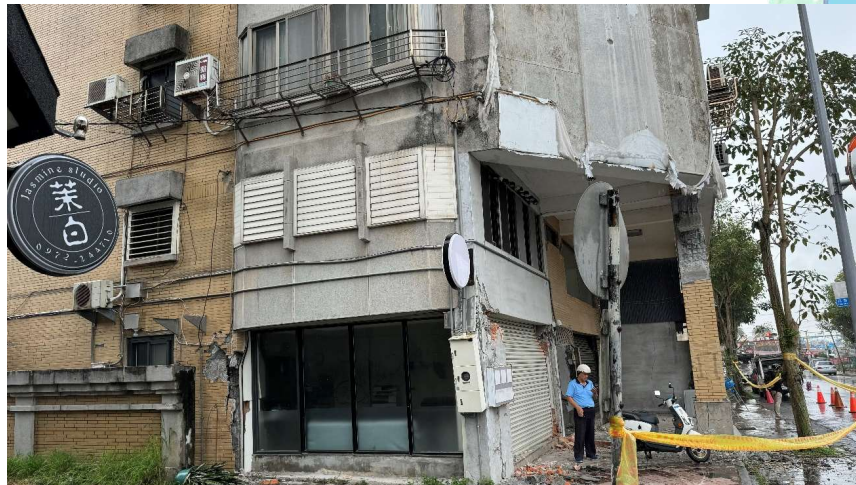
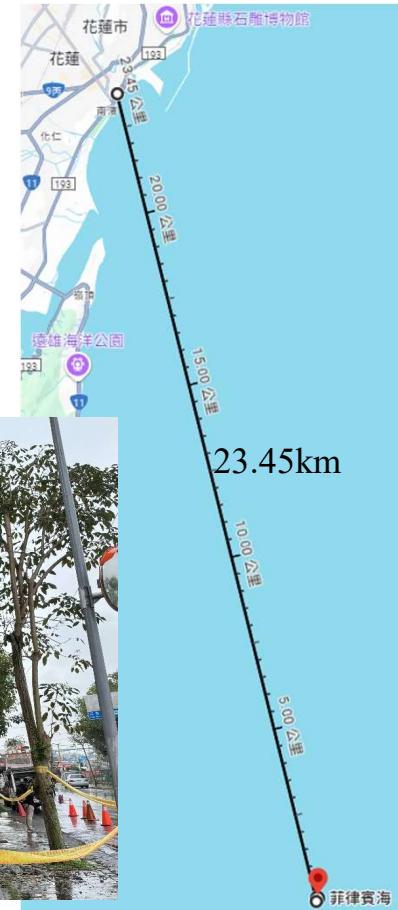
# 6-story Residential bldg. **NAR Labs** Hualien City

## Severe Damage to the Ground Floor

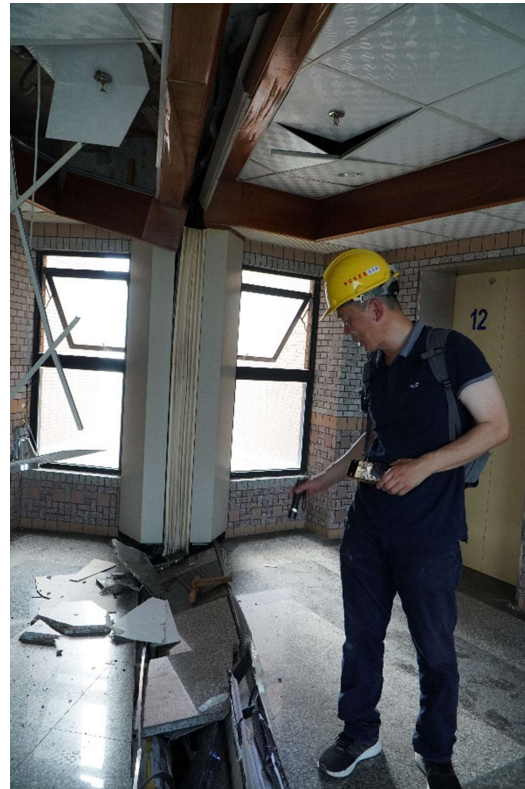
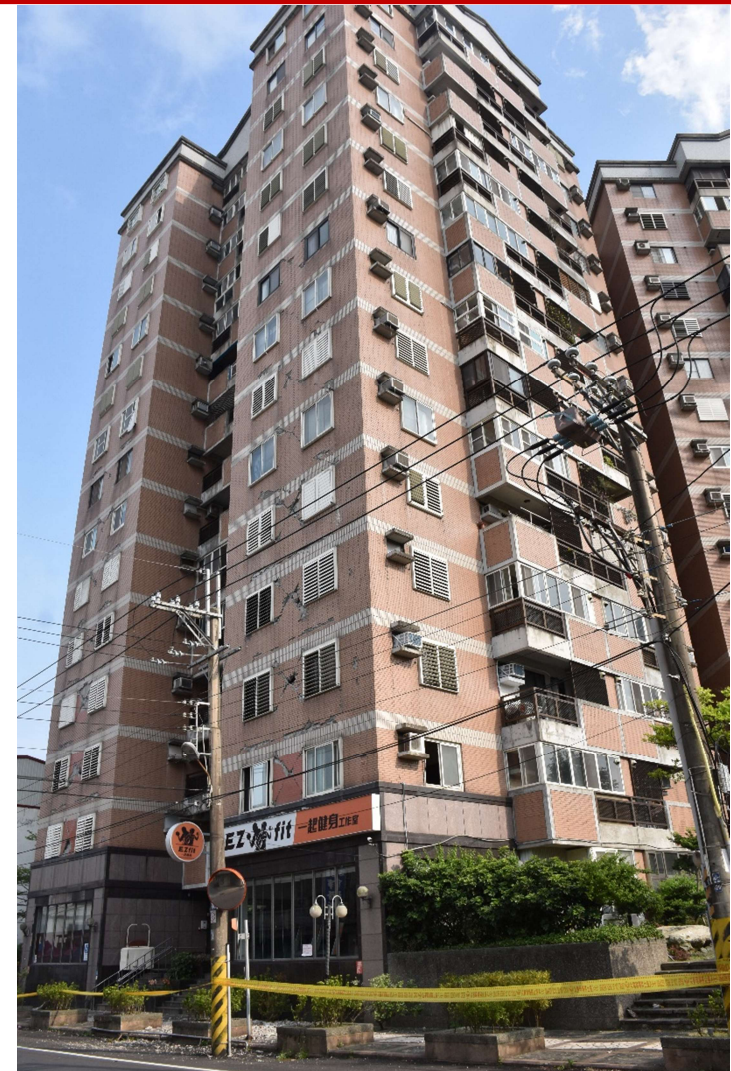
# Residential bldg.

## RC Wall failure

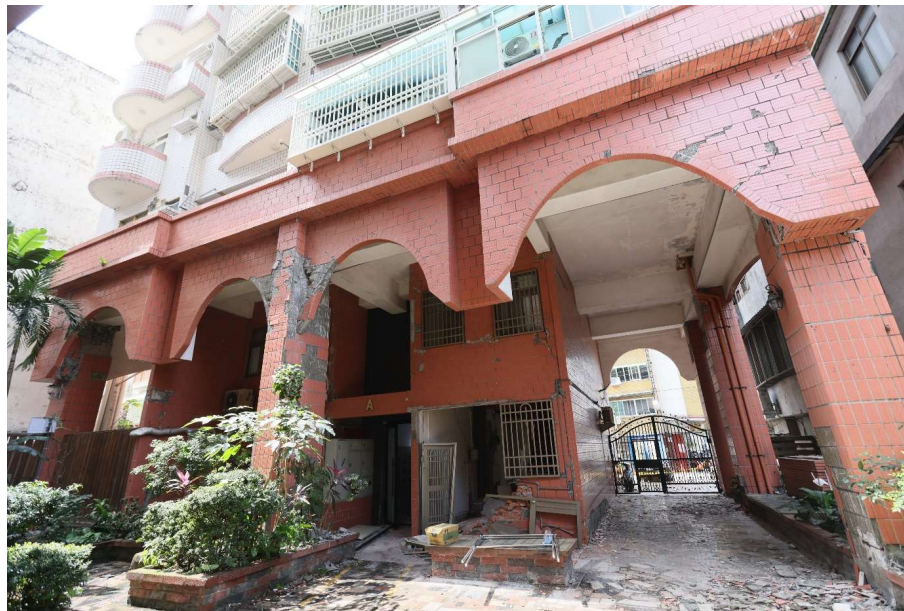
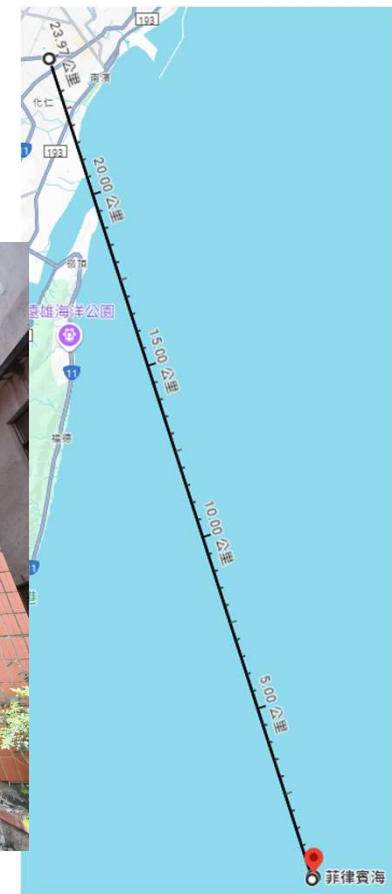
# Residential bldg. Hualien City

- **RC Columns flexural failure**
- **Walls damaged severely**

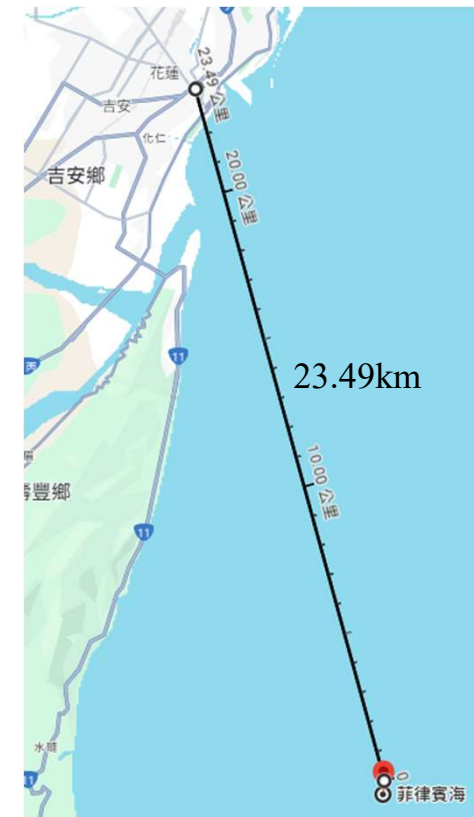
# 6-story Hotel bldg. Hualien City

- RC Columns and walls damaged severely

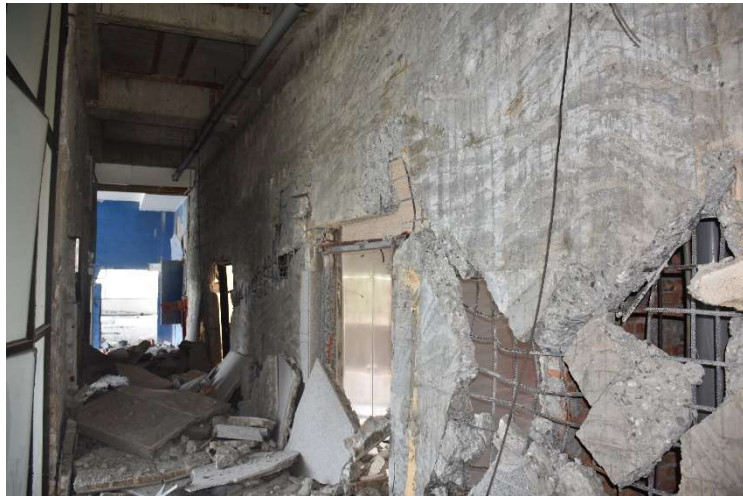
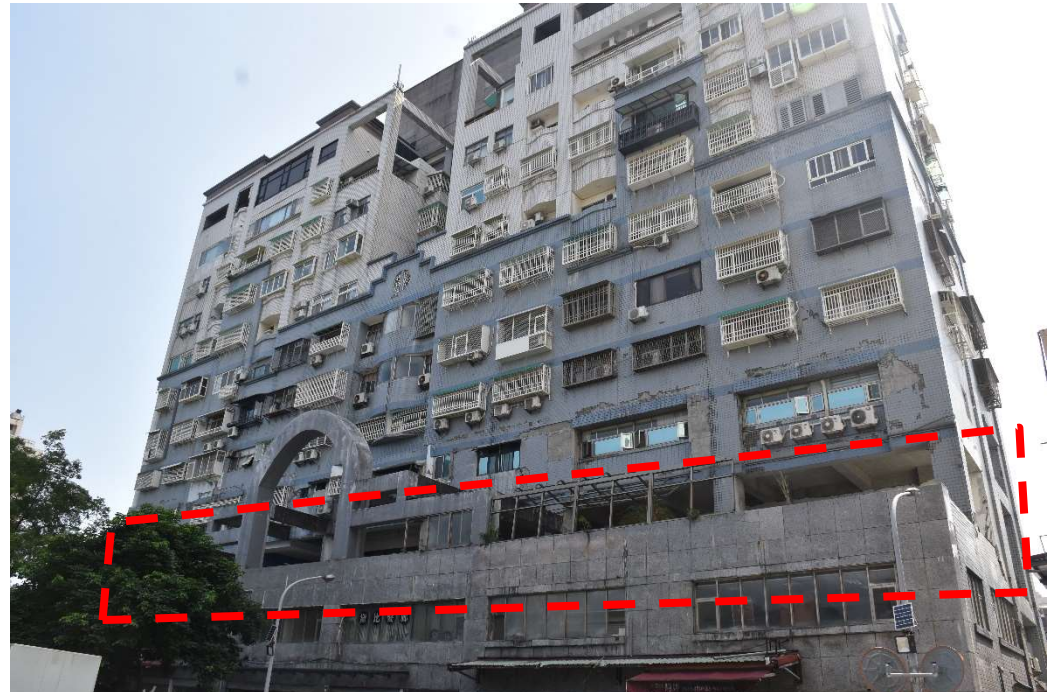
# 12-story Residential bldg. **NAR Labs**

- RC Walls and Partition walls shear failure
- RC Columns shear failure

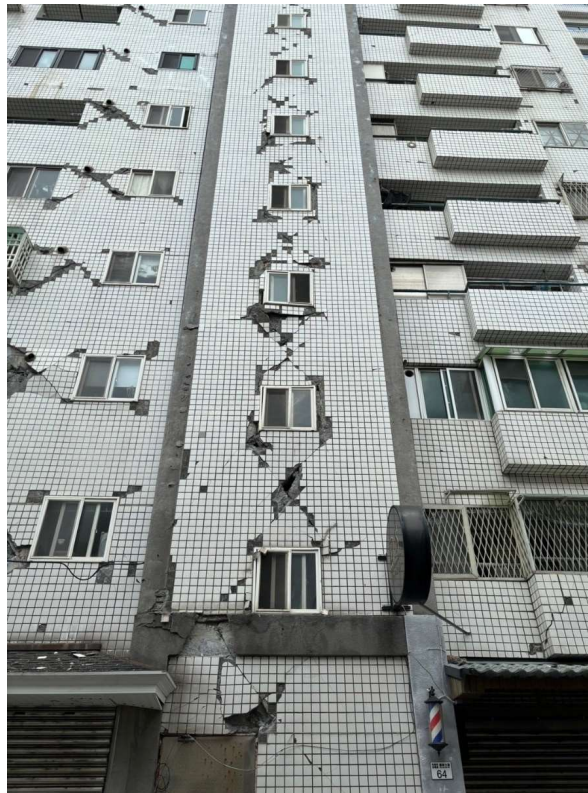
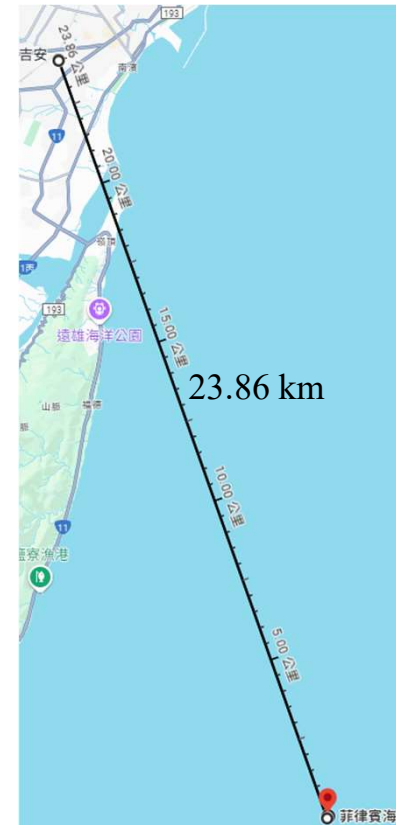
# Residential bldg.

## RC Walls Shear failure

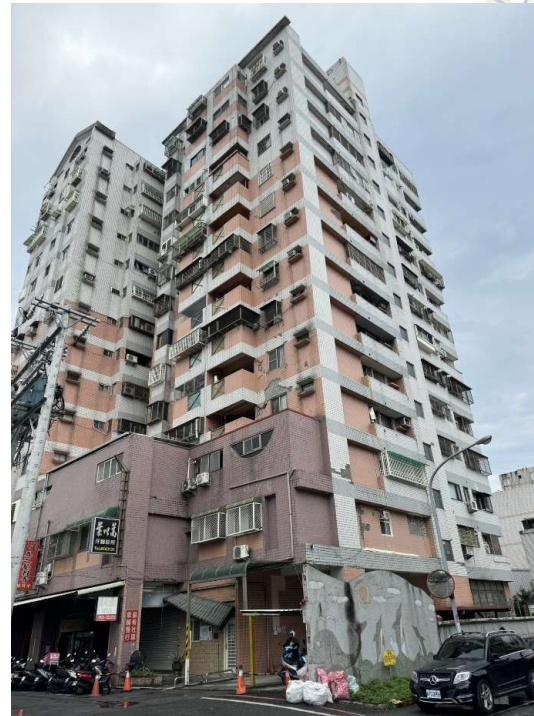
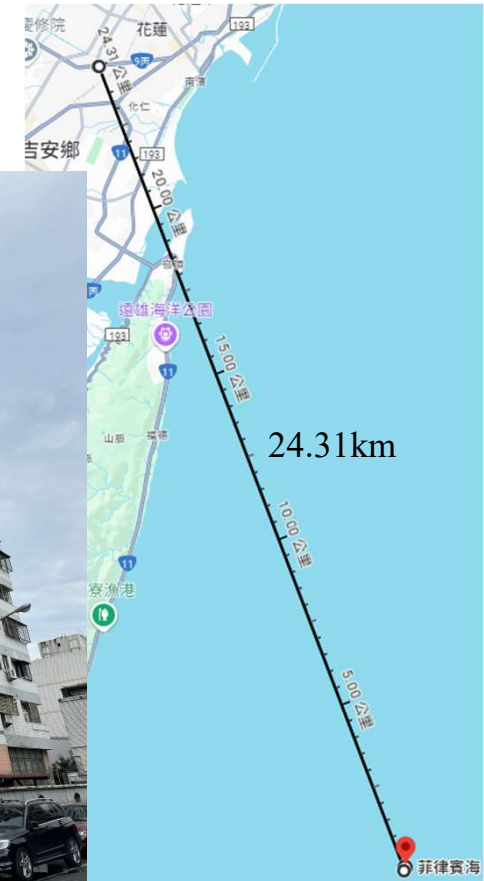
# 14-story Residential bldg. **NAR Labs**

RC Columns shear failure  
Tiles falling

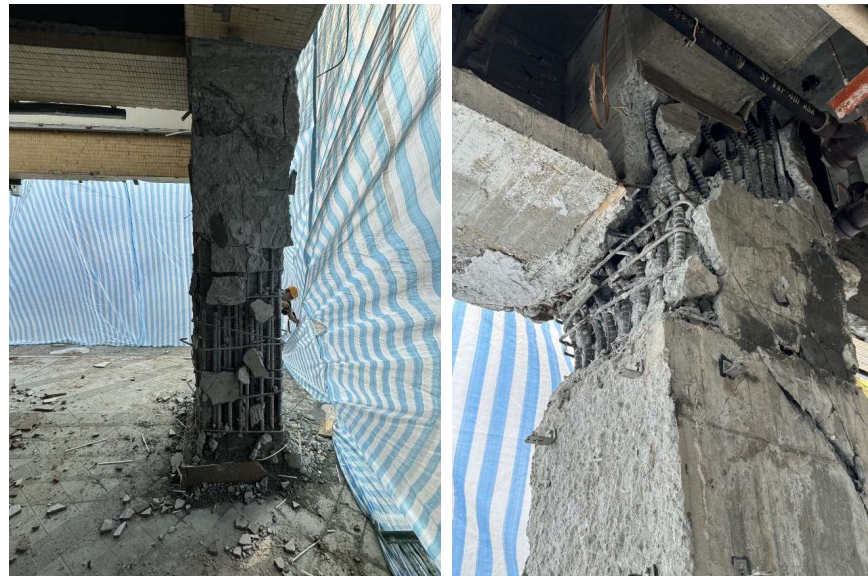
# Hotel bldg. Hualien City

## RC Column concrete bursts, steel bars buckle

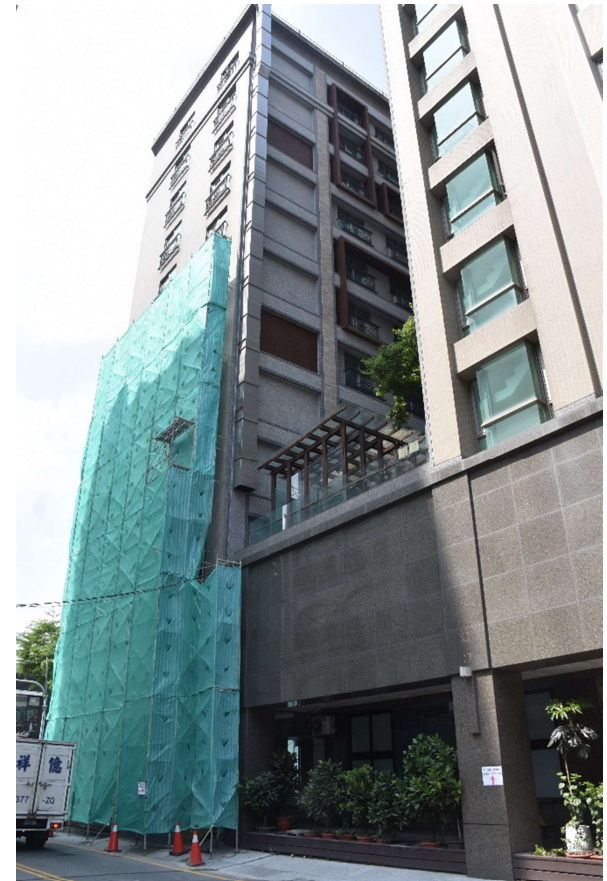
# Hotel bldg. Hualien City

## RC Columns damaged severely

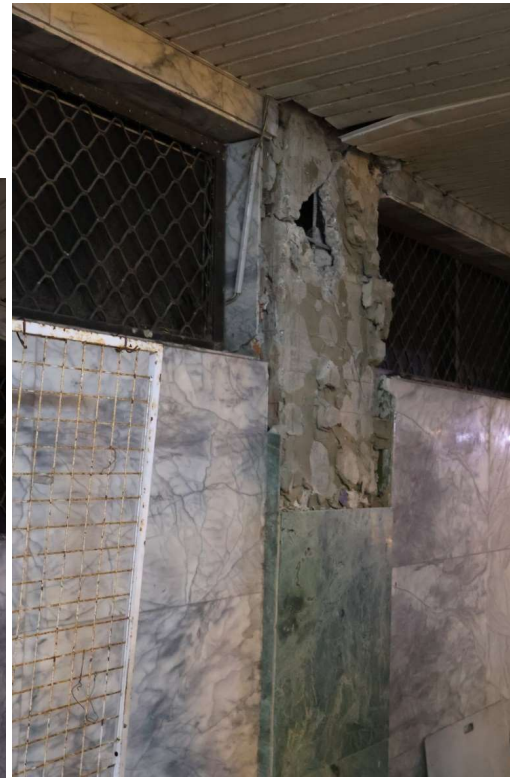
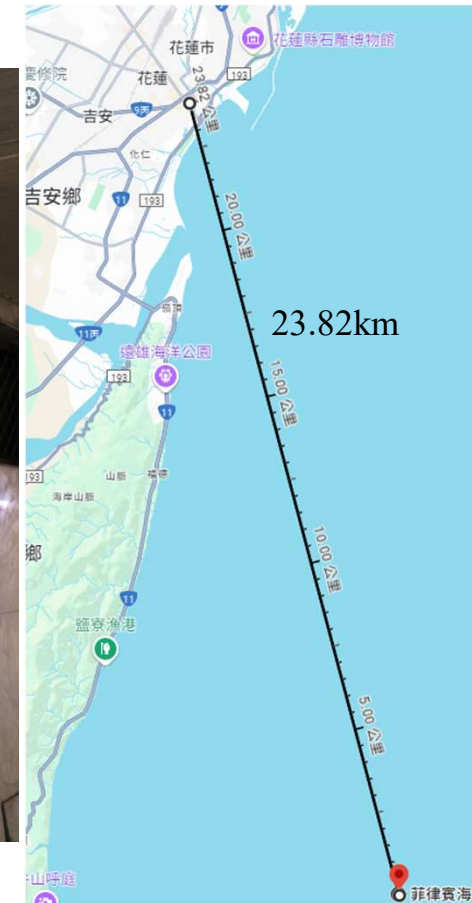
# Commercial bldg. Hualien City

## Non-structural walls damaged

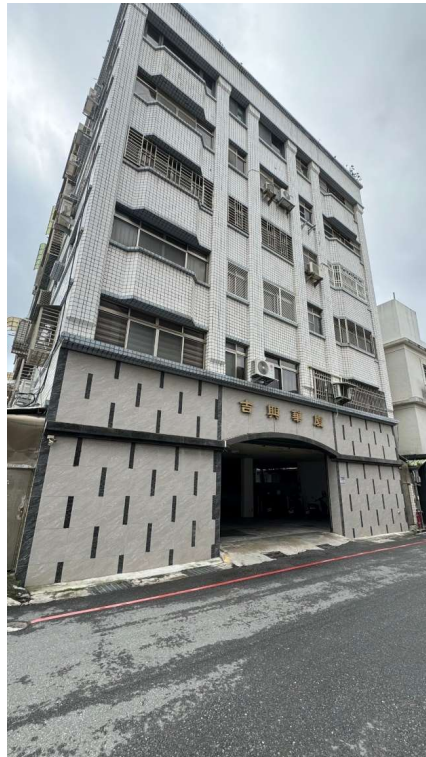
# 6-story Residential bldg. **NAR Labs**

- Retrofitted with RC shear walls
- Minor cracks in stucco

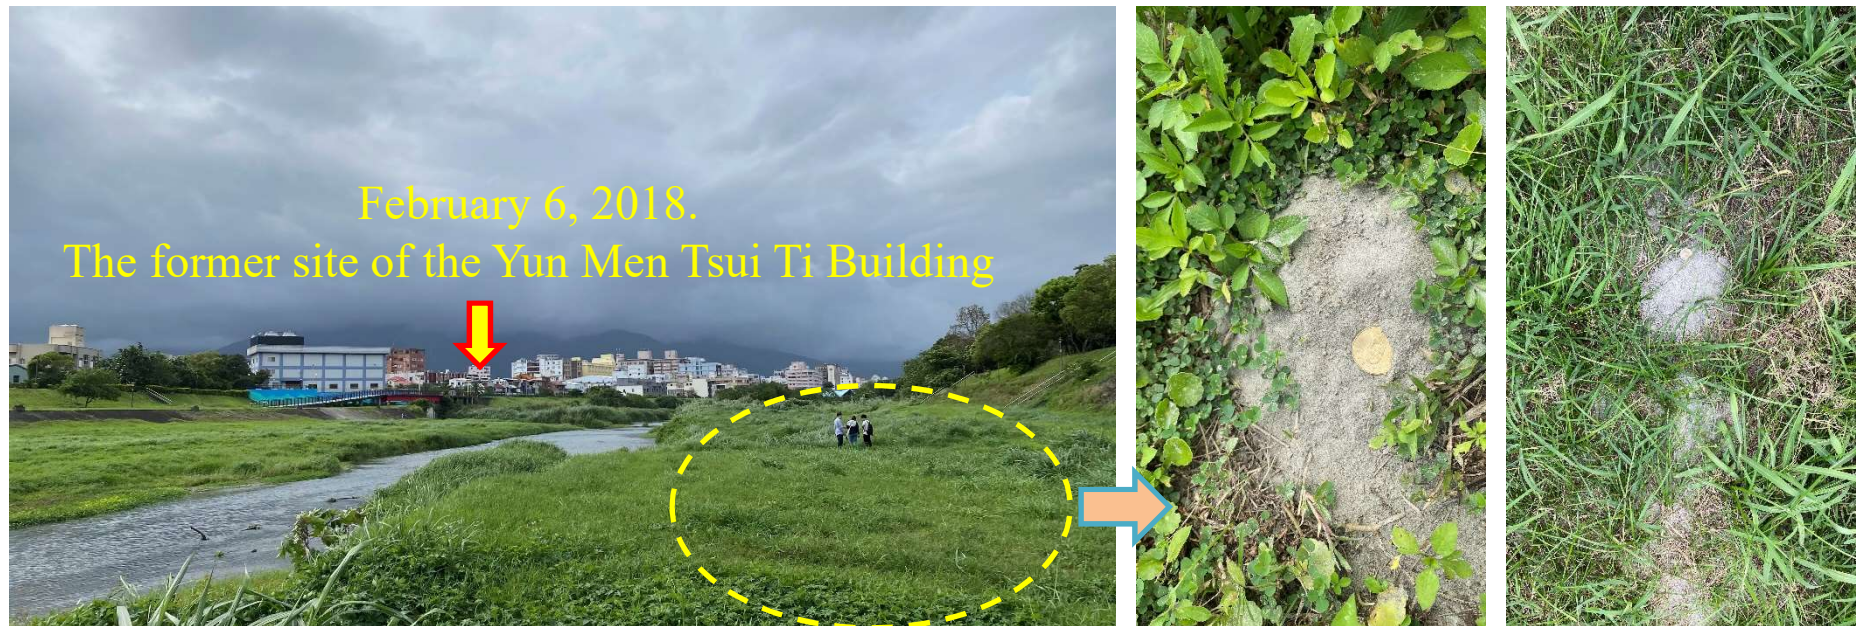
# Meilun River

- Signs of liquefaction were observed on the left bank sandbar of the Meilun River
- Similar liquefaction phenomena were observed at the same location during the previous earthquake.

Suspected sand boils possibly caused by soil liquefaction. 73

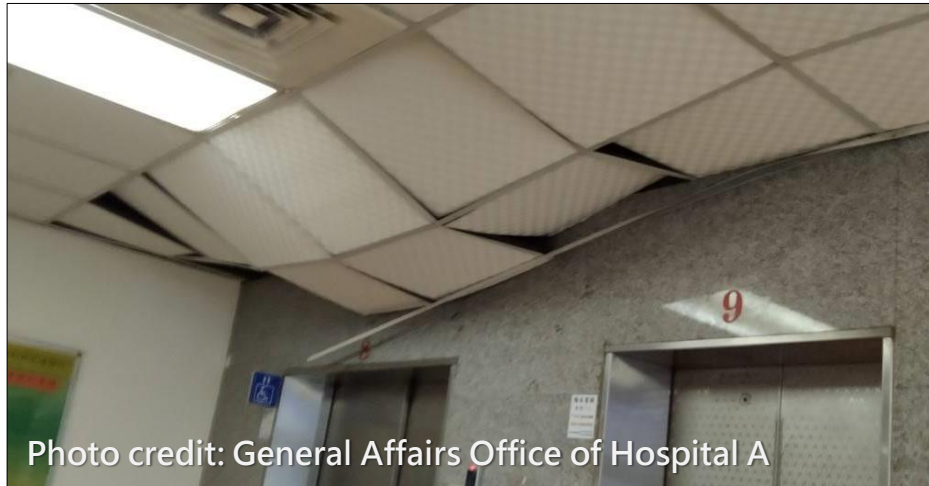
## Hospital building A2

Damaged ceiling at elevator hall on the first floor ↑

Deformed ceiling grid above the nursing station on the sixth floor ↑

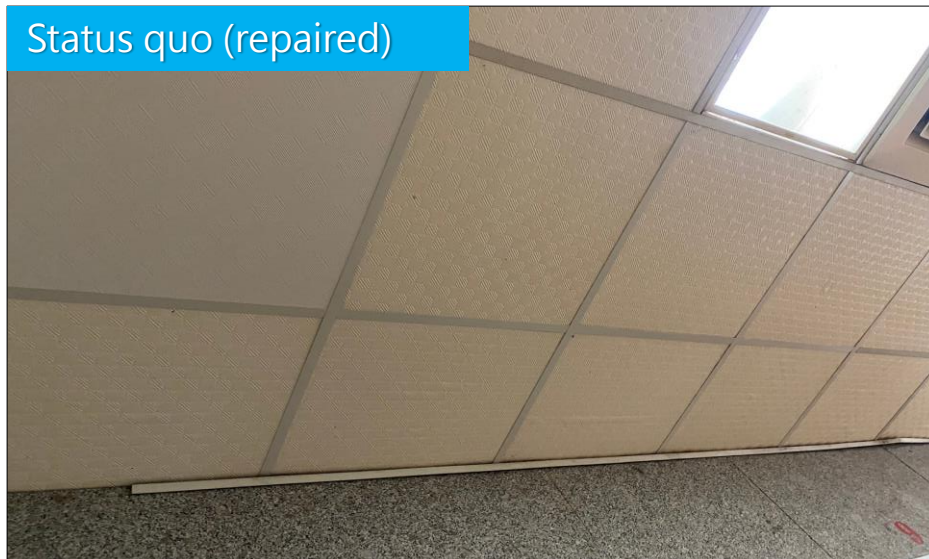
No suspension wires adjacent to the fire expansion cutout

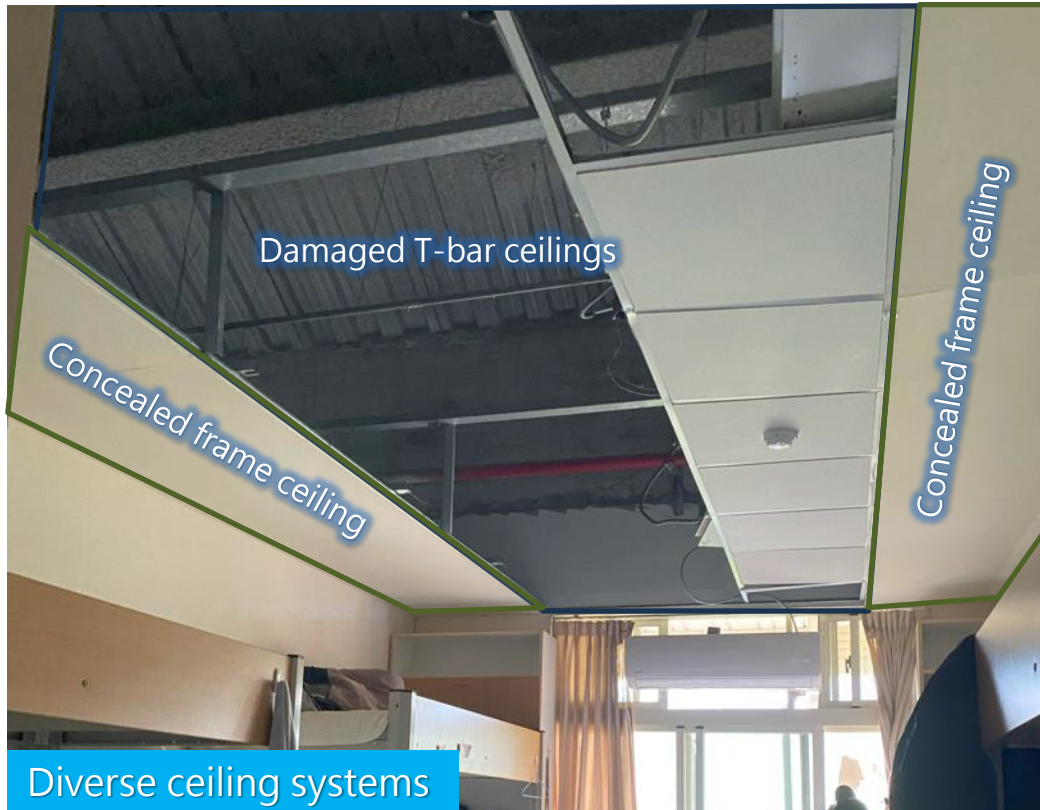
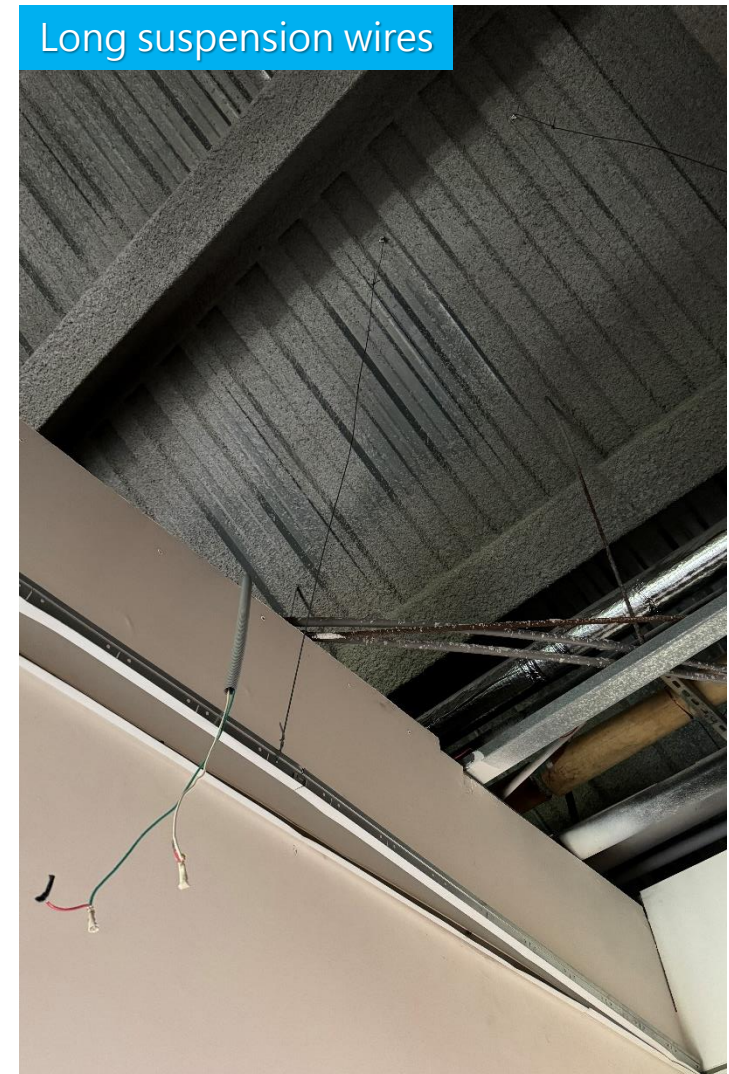
## University building D3

The pitched roof caused varying suspending lengths→

Damage concentrated on the T-bar ceilings ↓

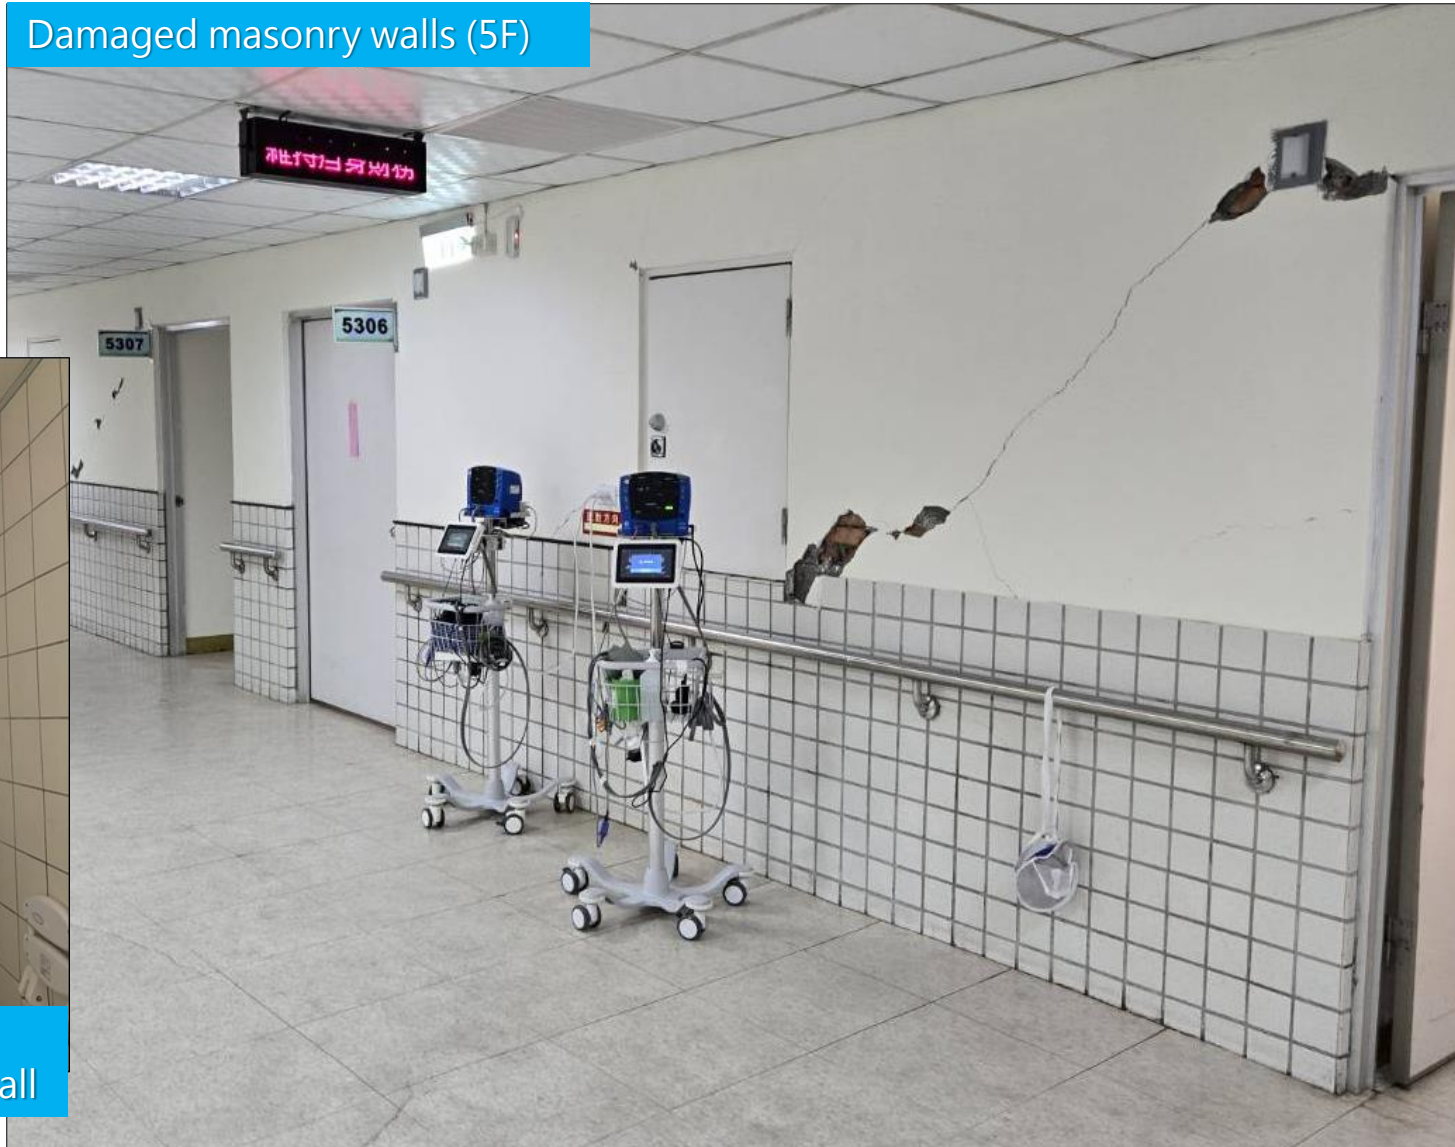
Shear cracks of the masonry walls of the wards on the fifth and sixth floors were observed.

Damaged masonry walls (5F)

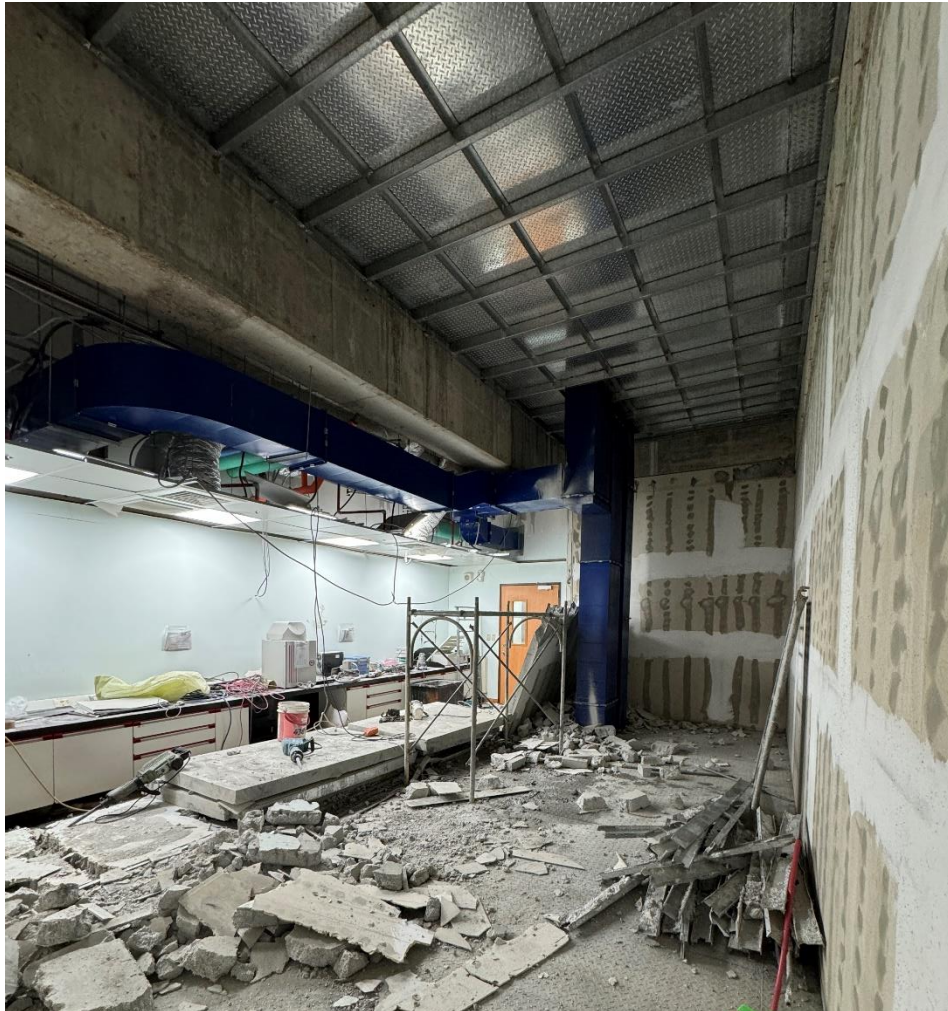
Tilted lightweight aggregate concrete (LWAC) walls  
(6F & 8F)

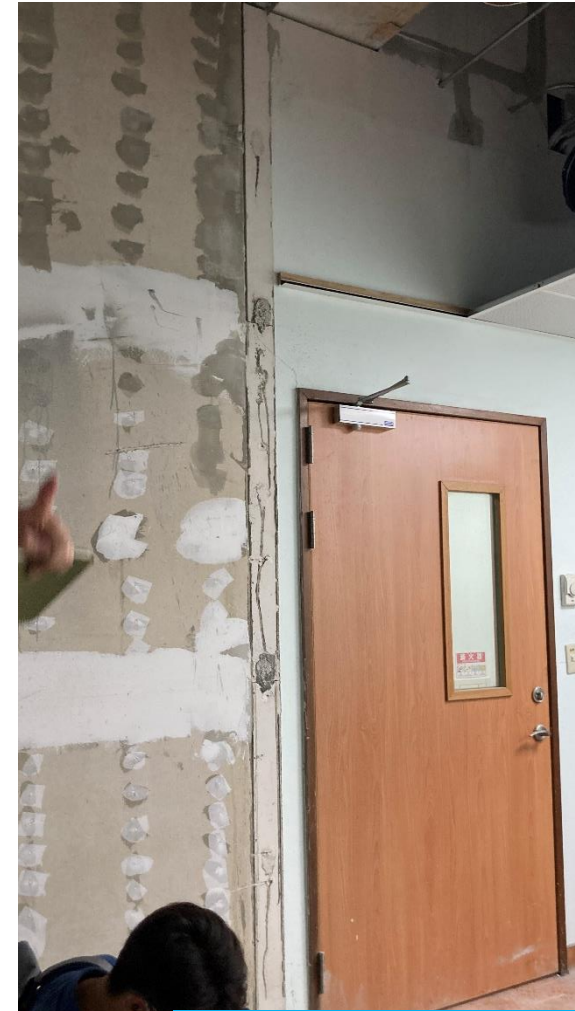
The boundary of the  
damaged wall (8F)

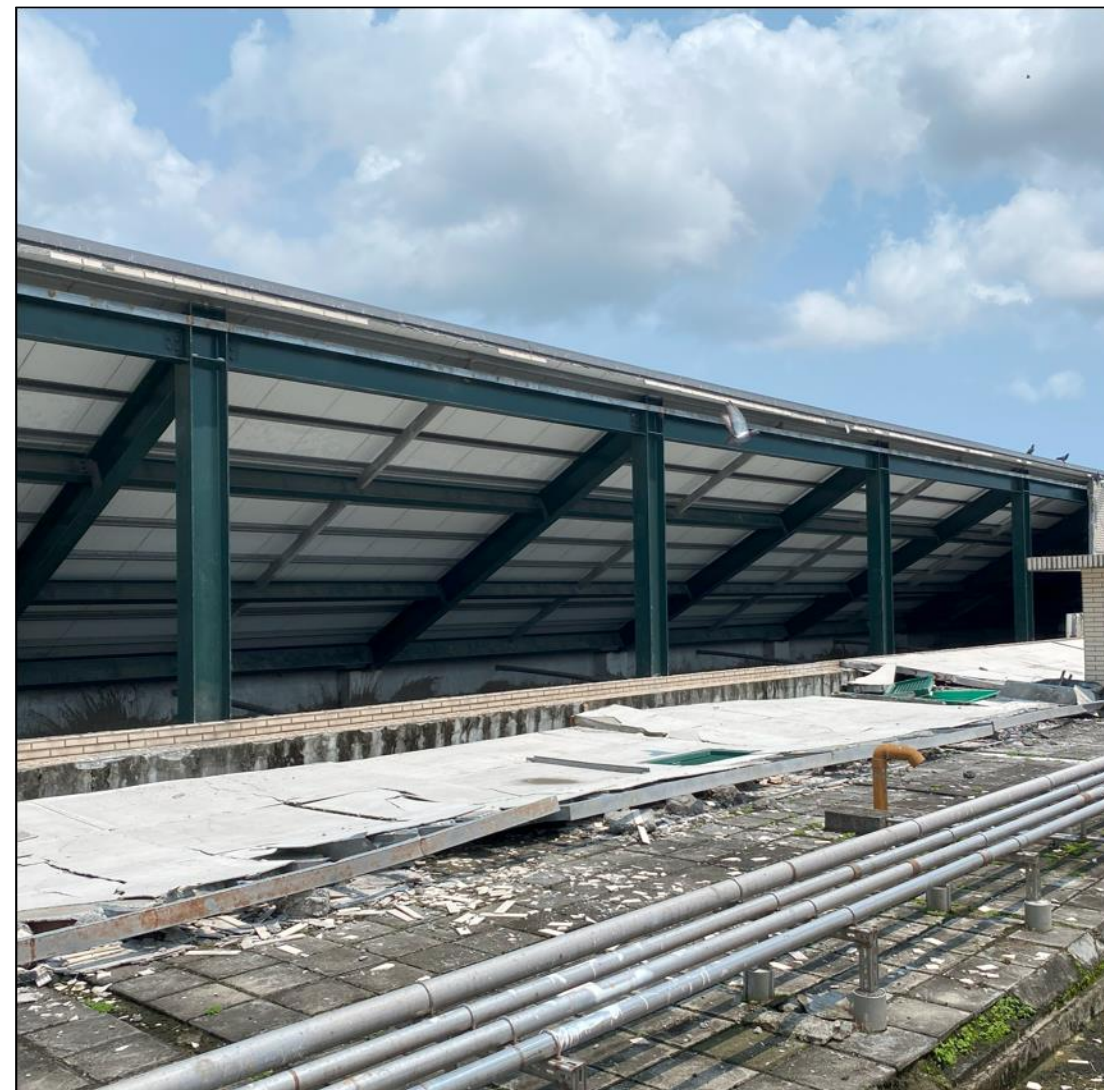
Collapsed windproof walls, composed of LWAC (rooftop)

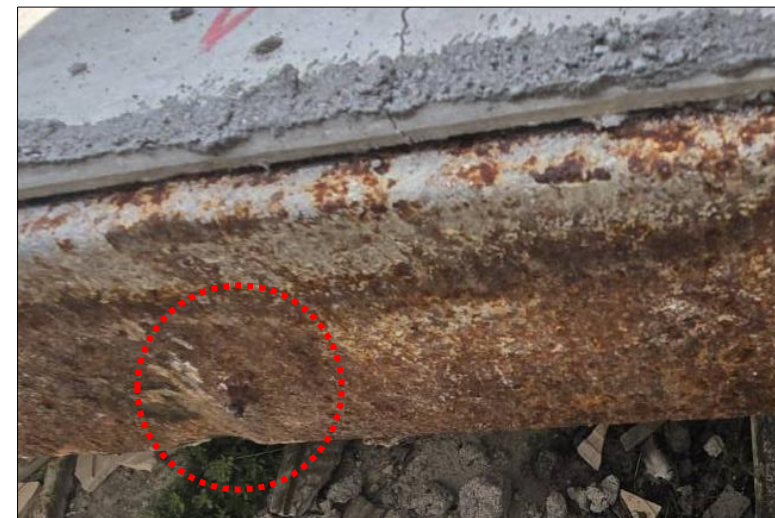
Failed anchorage of the collapsed wall

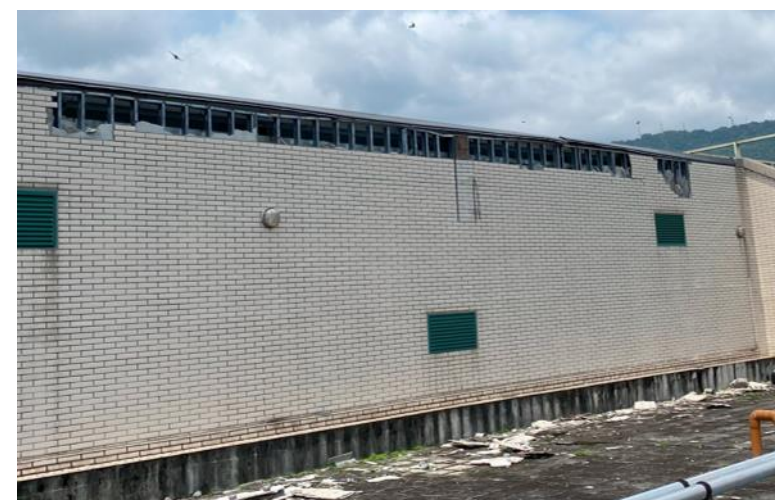
Partially-damaged windproof wall
