# Summary Report of Hualien Earthquake in Taiwan on April 3, 2024 (2<sup>nd</sup> edition, V2.0)

**Chung-Che Chou, Chiun-Lin Wu, Juin-Fu Chai, George C. Yao**

**NCREE, Taiwan**

**May 25, 2024**

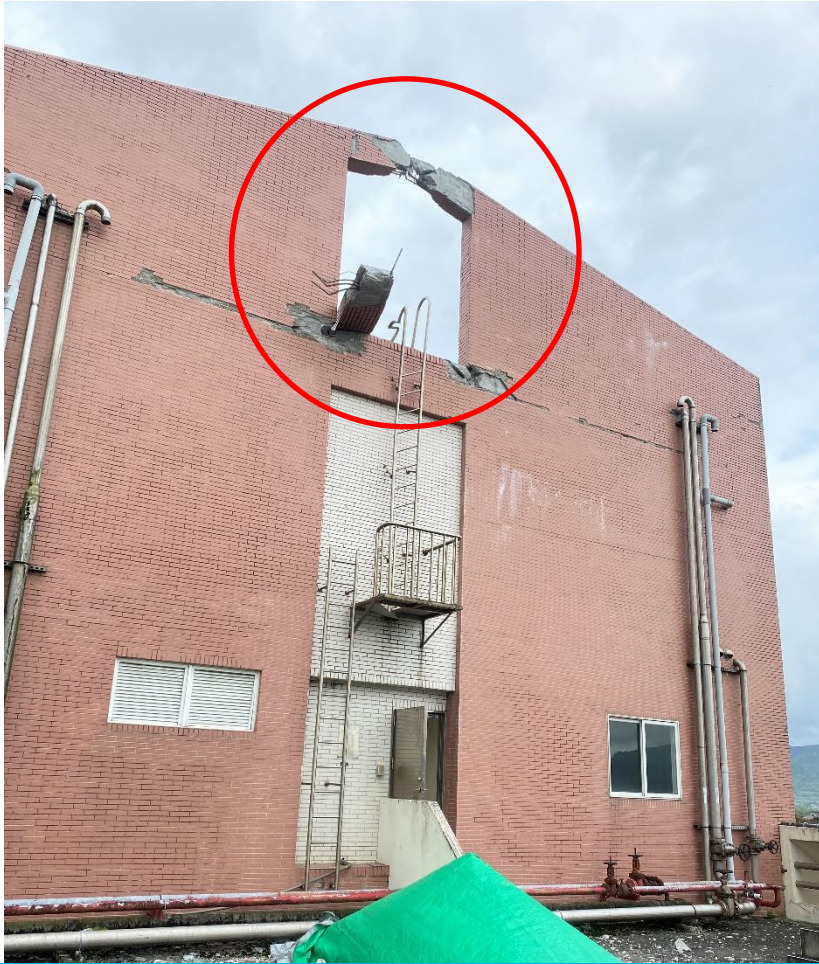
A beam connected to decorative gables collapsed on the penthouse

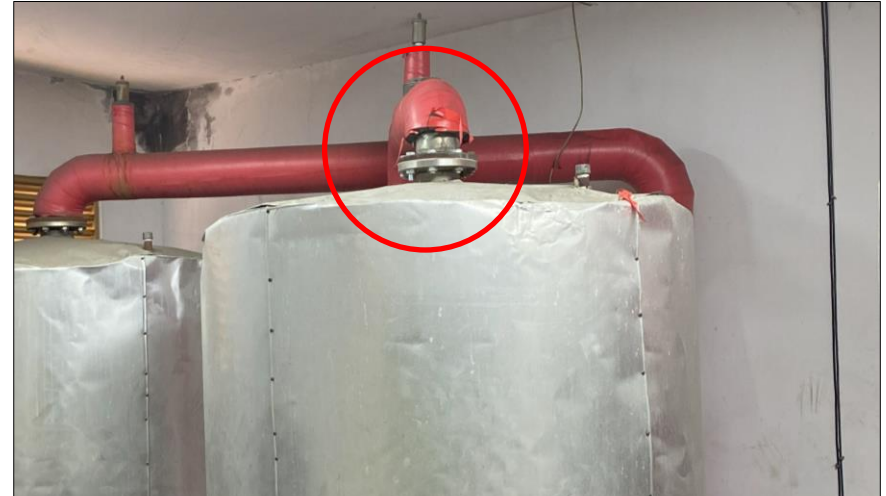
Collapsed tanks at rooftop of Bldg. A1

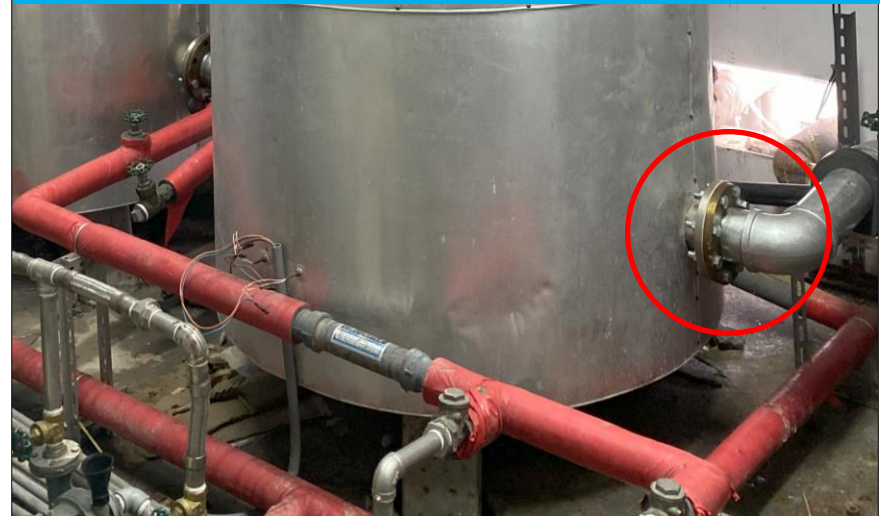
Damaged piping joints connected to the hot water tank in Bldg. A3 (repaired)

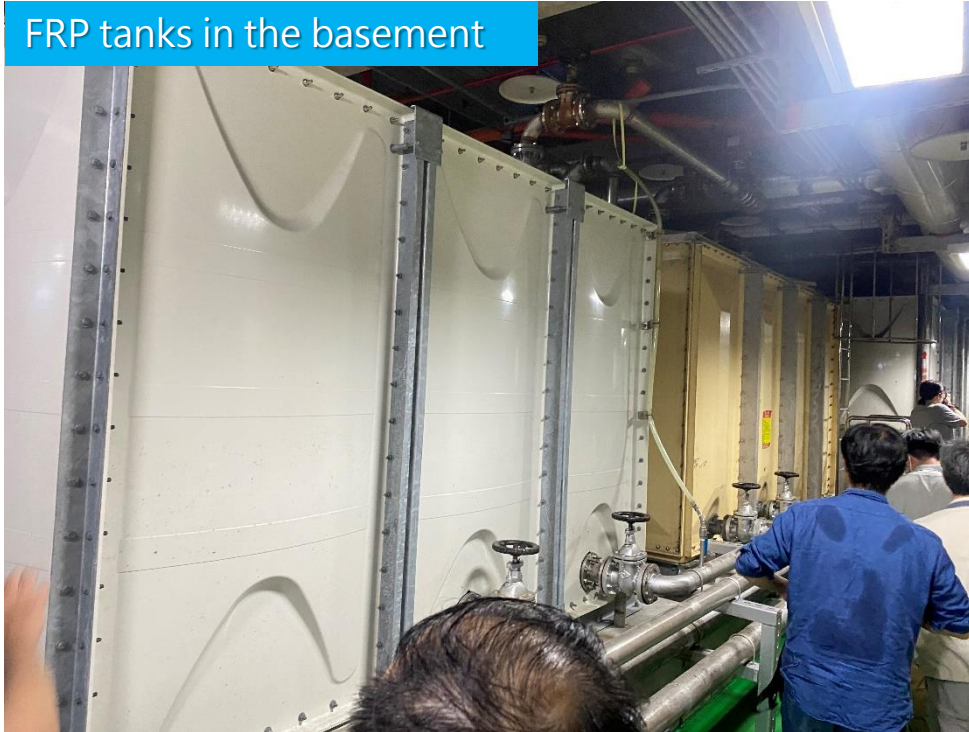
FRP tanks in the basement

- In the basement, there are four FRP tanks, each with slight variations in form. The FRP panels are joined with angle steel. The innermost tank suffered damage.
- Among the four tanks, only the angle steel of the damaged one was not well-connected. The connection joints were damaged during the earthquake, resulting in tearing and damage to the FRP tank wall. ↗

Tearing and damage to the FRP tank wall

Damage to the connection joints

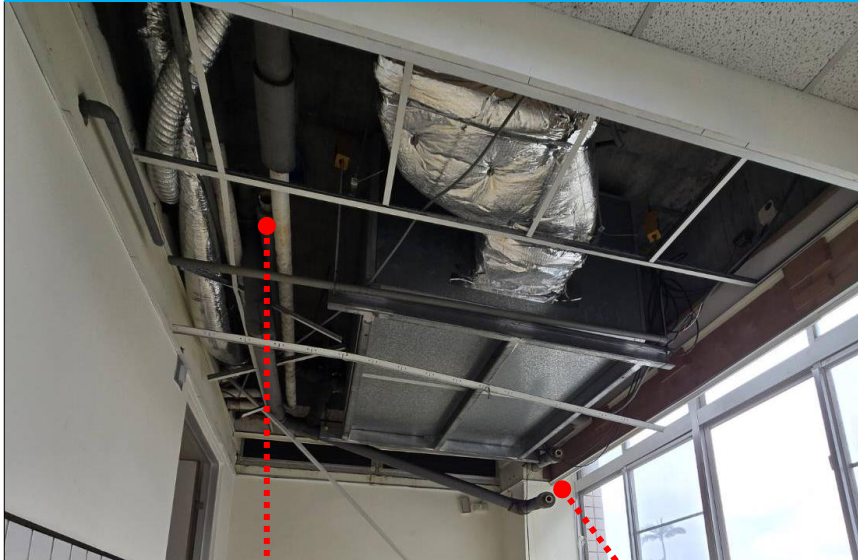
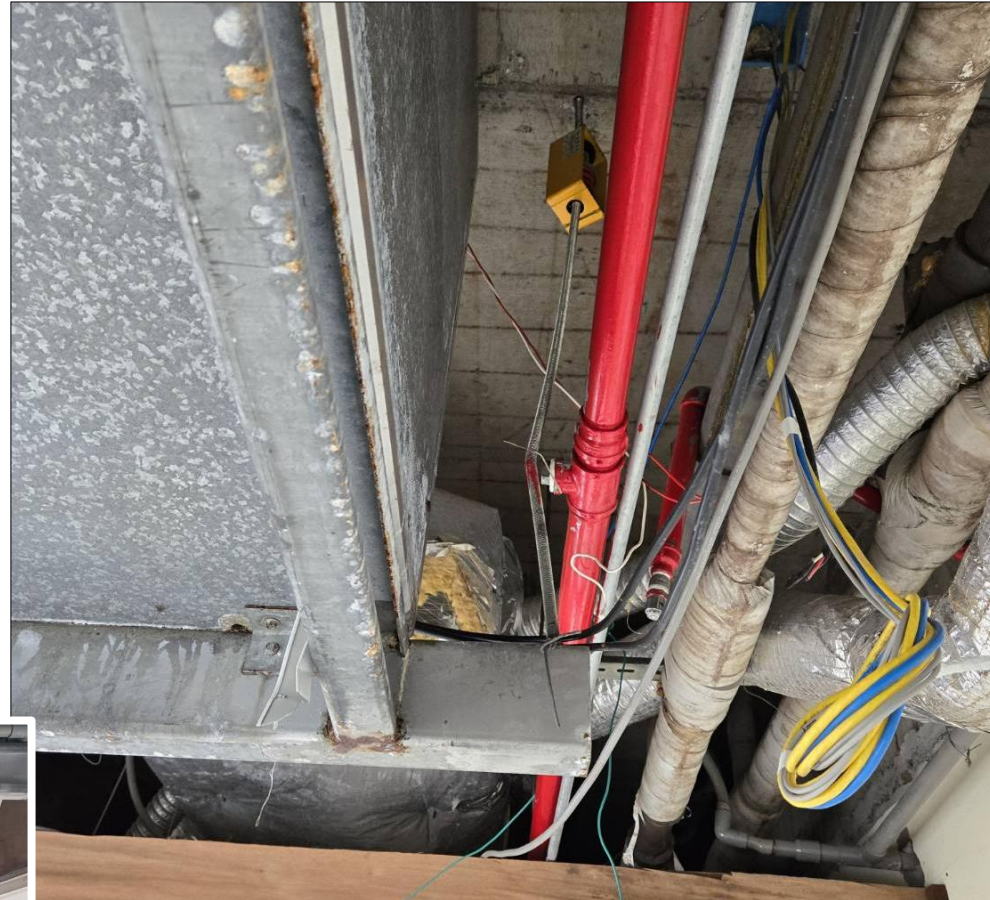
Excessive displacement of the pre-cooling air conditioning unit led to the rupture of the chilled water pipe connected to it (5F)

Excessive displacement of the air conditioning unit led to complete rupture of the adjacent fire sprinkler head due to impact (6F)

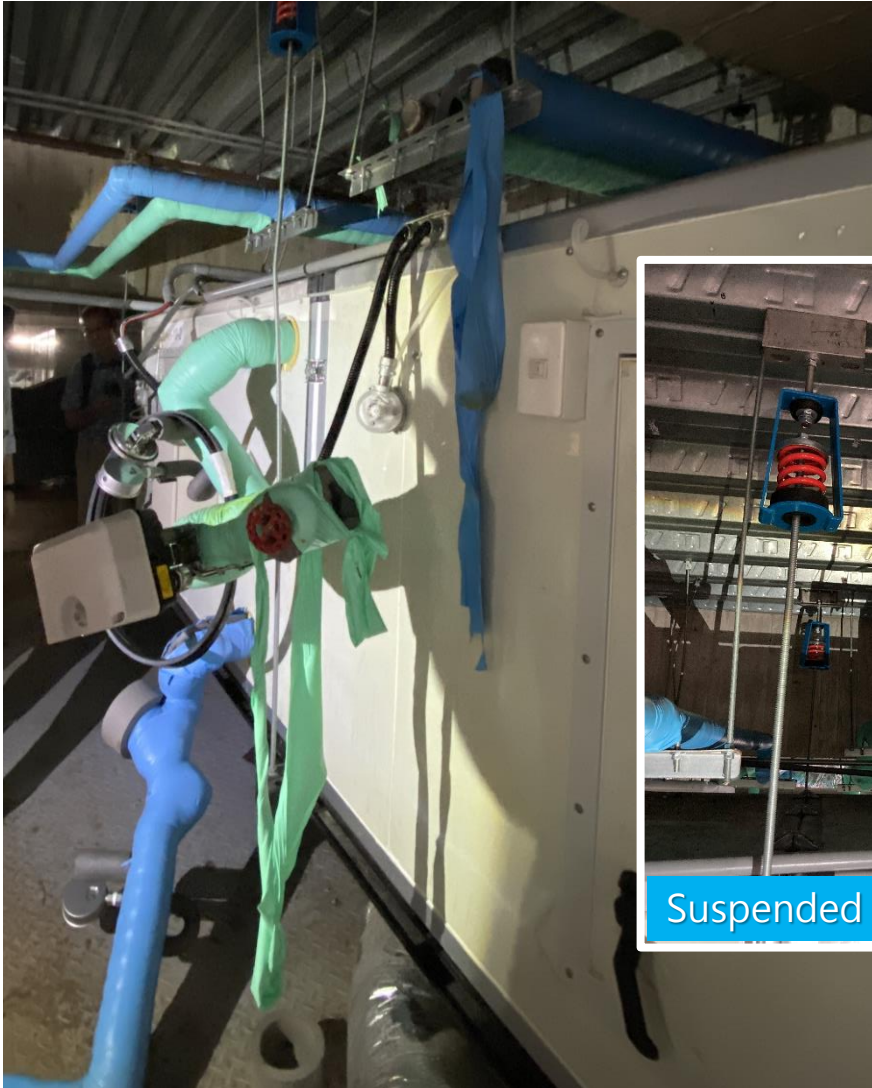
Broken pipeline connected to air-conditioning unit

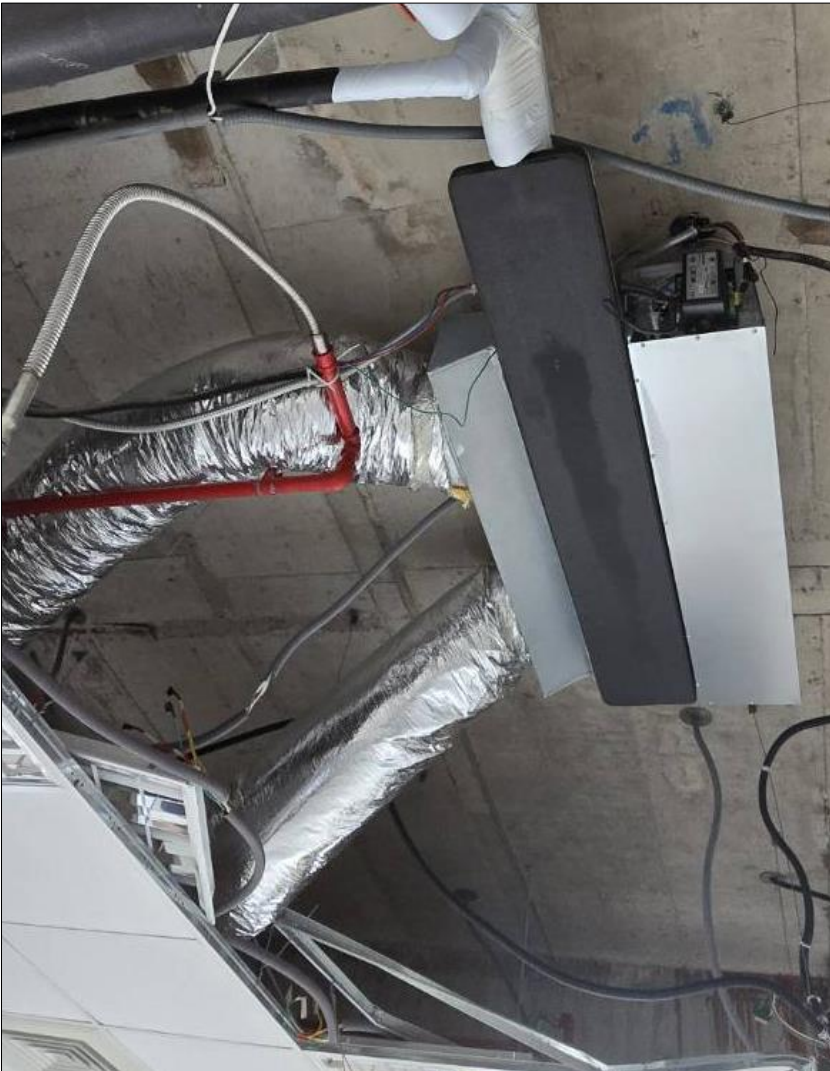
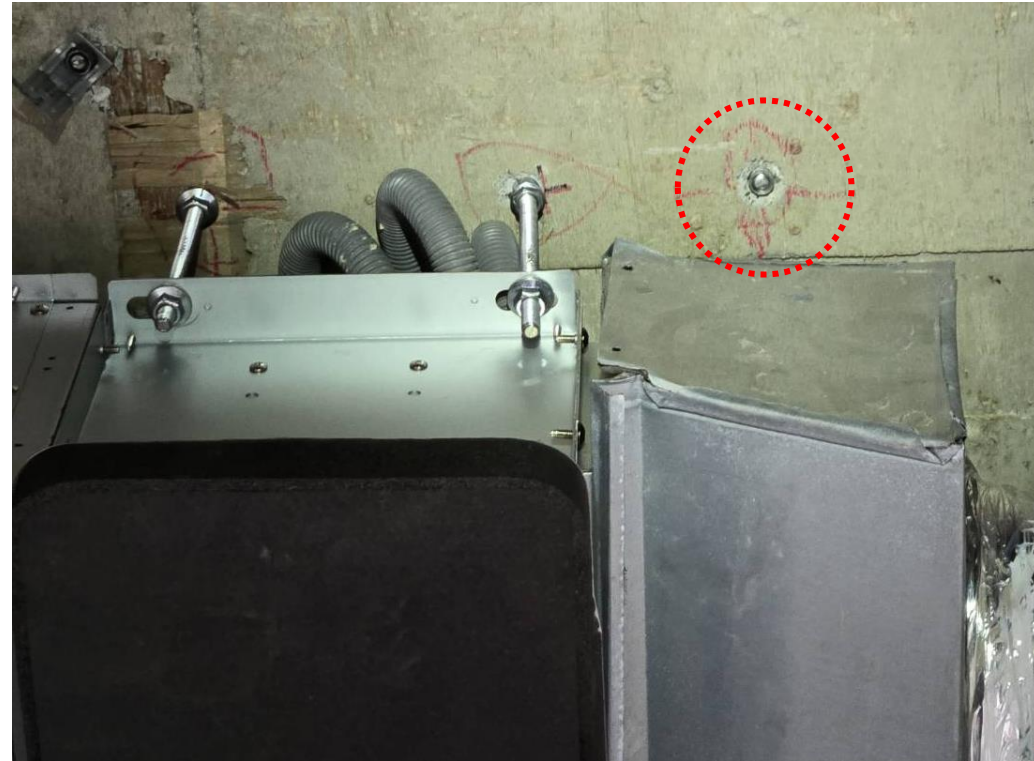
Excessive displacement of the small fan-coil unit resulted not only in the rupture of the connected water pipes but also in the shear failure of the suspension rods

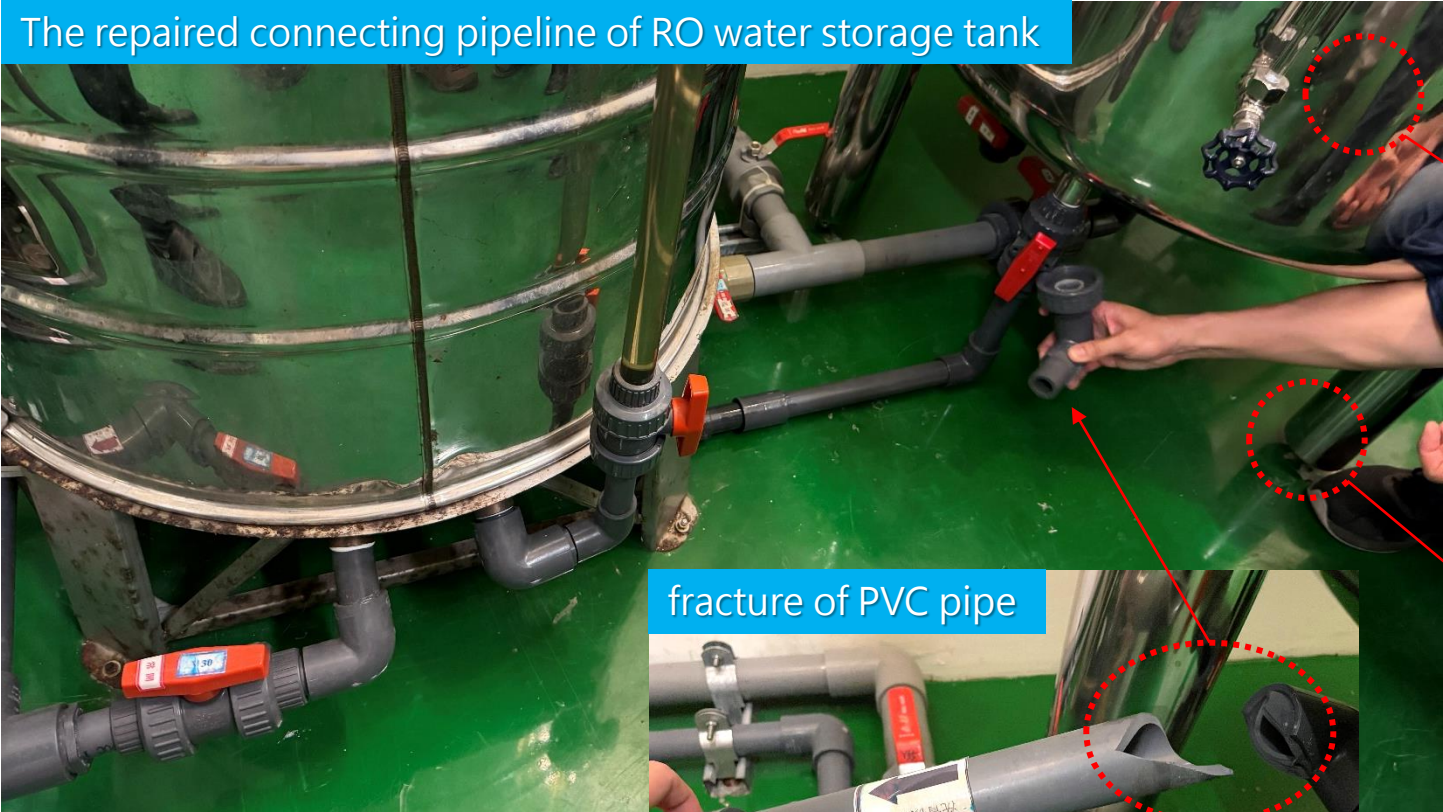
The repaired connecting pipeline of RO water storage tank

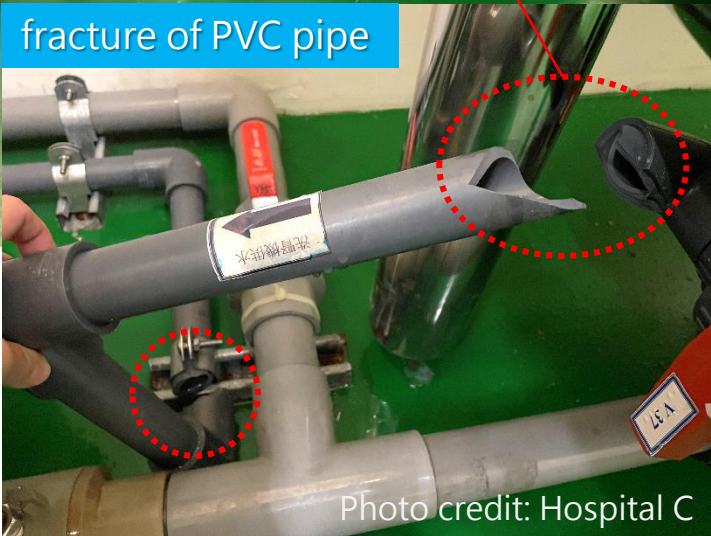
fracture of PVC pipe

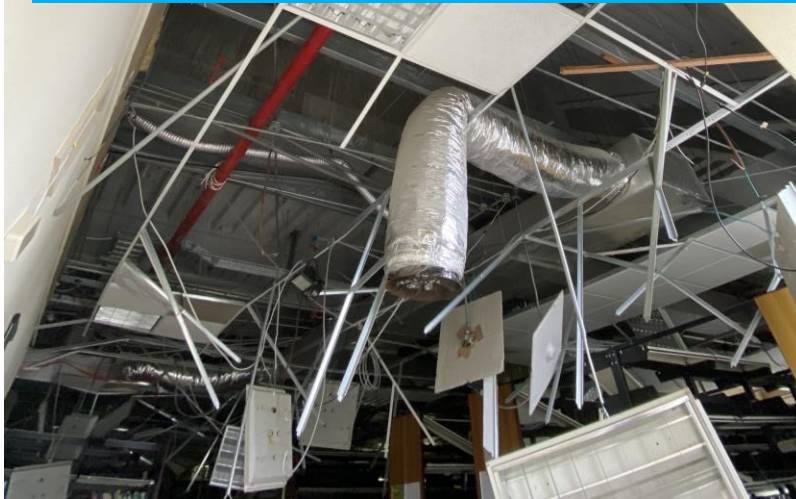
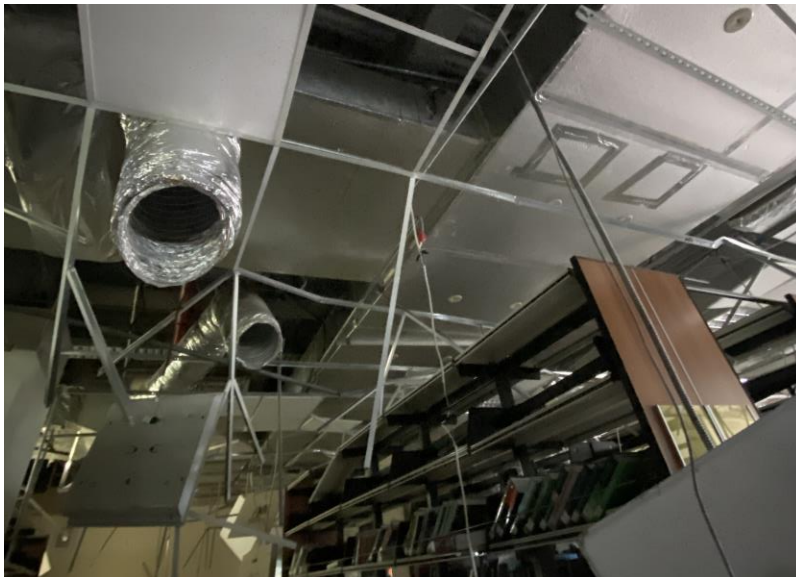
Damaged ductworks (6F of Bldg. DL)

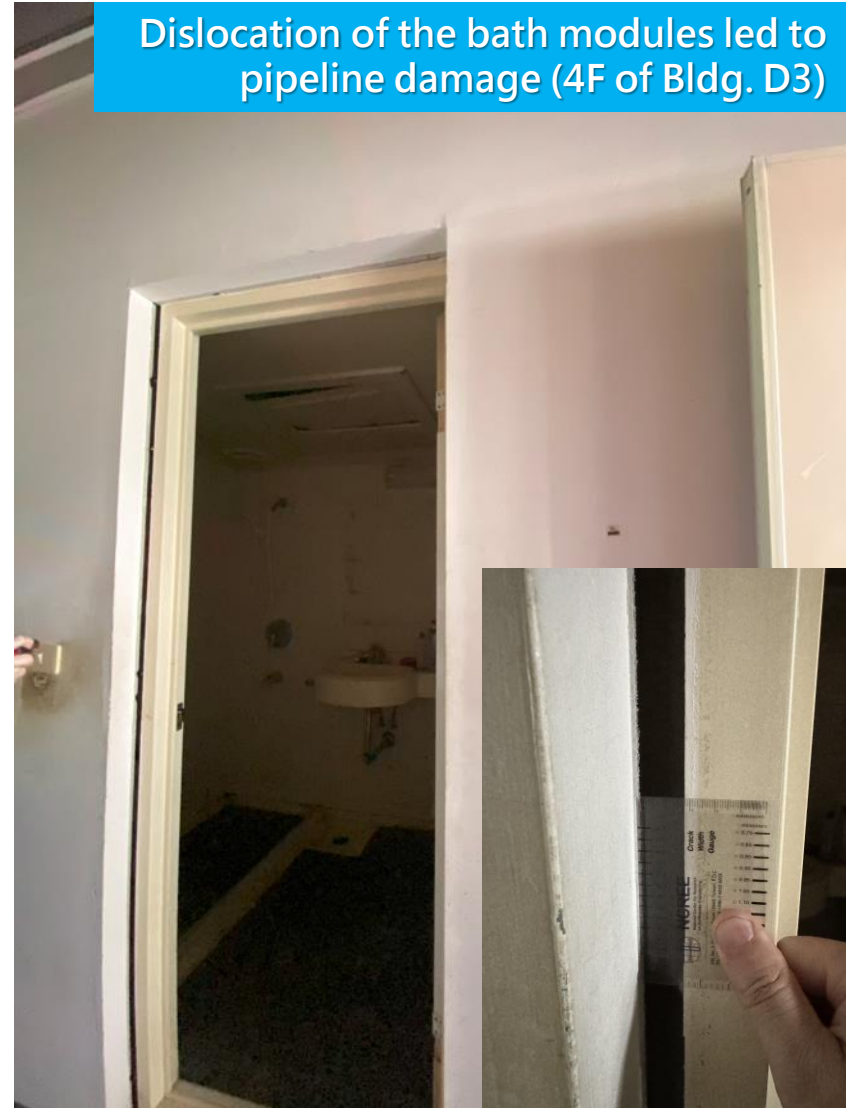
Dislocation of the bath modules led to pipeline damage (4F of Bldg. D3)
