# NCREE Special Newsletter

# Summary of the Hualien Earthquake Event on April 3, 2024

#### 1. Overview of Earthquake and Disaster Survey

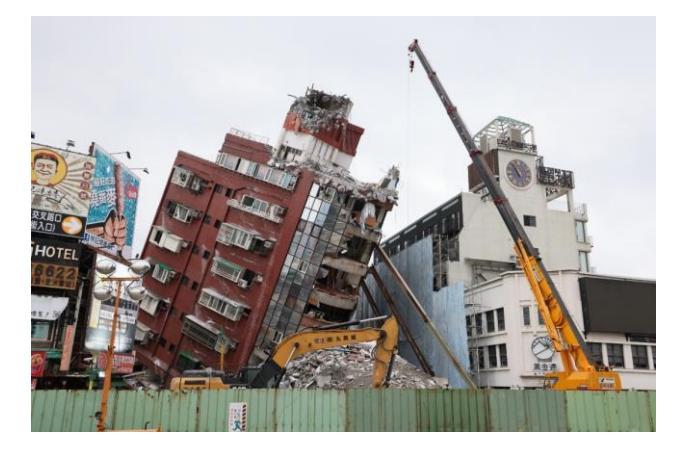
Figure 4-2 Collapse of Tianwangxing Building in Hualien

The damaged buildings depicted in Figures 4-2 and 4-3 are characterized by their triangular window arcade-style structures. These buildings exhibit irregularities in their structural plans and possess soft-story characteristics, making them susceptible to collapse or severe damage at lower levels during this earthquake.

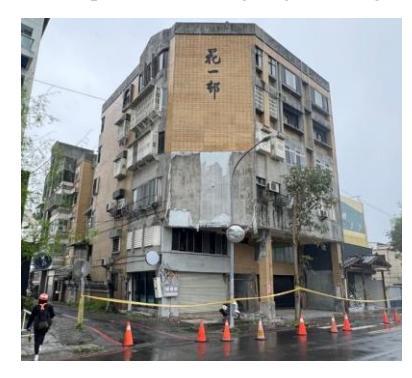
Figure 4-3 Severe Damage to the Ground Floor of a 6-Story Residential Building in Hualien

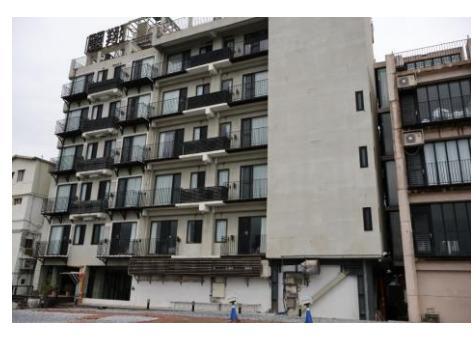
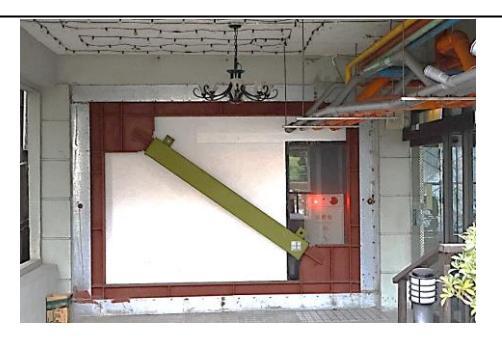
Figure 4-4 Hotel Structure Reinforced with BRB in Hualien City

Figure 4-5 Office Building Reinforced with SBRB in Hualien City As depicted in Figures 4-4 and 4-5, both structures implemented buckling-restrained braces (BRBs) for strengthening at their lower levels. During this earthquake, these two buildings showed no significant damage, indicating the effectiveness of the strengthening measures implemented.

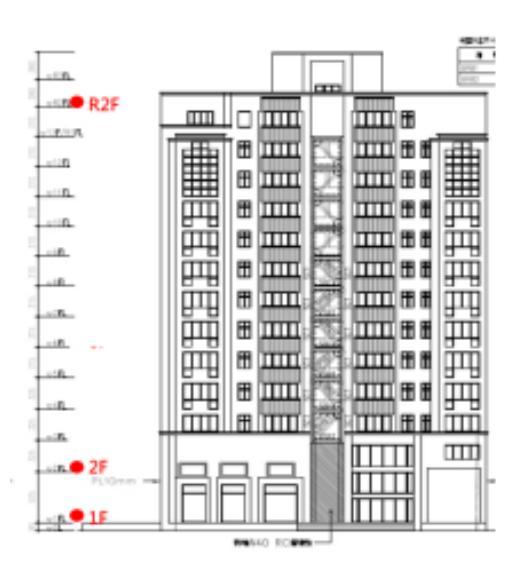
Figure 4-6 Elevation Plan of Reinforced Building A00600 in Taipei City

In addition, in a case study of a building in Taipei City that has undergone seismic strengthening measures (as shown in Figure 4-6), the building's ground floor was reinforced with reinforced concrete walls, while steel frame diagonal braces were used for reinforcement on other floors. Accelerometers were installed on the ground-floor base, the second-floor slab, and the roof slab for structural monitoring. The monitoring results from this earthquake are as follows:

- Seismic Intensity: 5-Weak
- Structural Damage Severity: Light
- Maximum Acceleration on 1st-floor slab: 86.2 gal
- Maximum Acceleration on 2nd-floor slab: 90.0 gal
- Maximum Acceleration on roof slab: 266 gal
- Displacement Ratio (1st floor): 0.295% (Safety threshold: 0.250%)
- Displacement Ratio (2nd floor and above): 0.146% (Safety threshold: 0.250%)

The building exhibited only minor structural damage during this earthquake, indicating the effectiveness of its seismic strengthening measures, demonstrating good seismic performance.

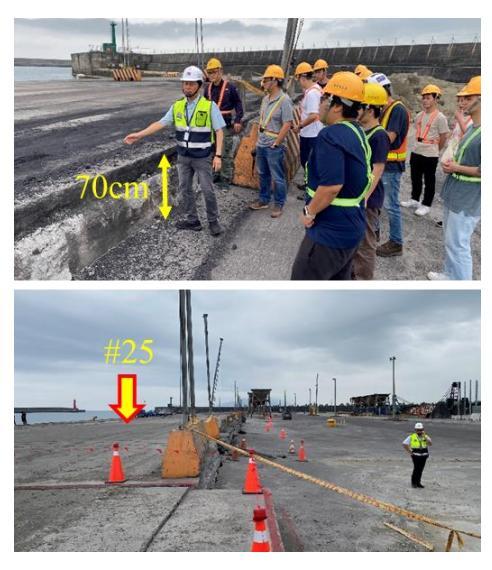
Figure 5-3 Damage to Pier 25 and Wharf Apron at Hualien Port Table 5-1 Maximum Settlement of Hualien Port Piers

Pier Number	Maximum
	Settlement
#25	70 cm
#23~#24	50 cm
#19~#22*	50 cm
#17~#18*	12 cm

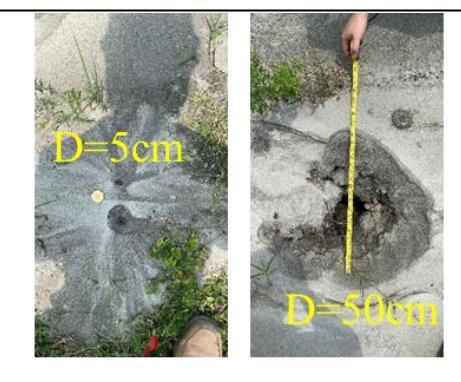
# Figure 5-4 Sand vents in the Gravel Backfill Area of Pier 25 at Hualien Port

In addition, evident sand vents and cracks were found in the gravel backfill area behind the pier line. Observation indicated that the material ejected from the sand vents and surrounding cracks appeared as milky white sand with varying sizes of gravel, distinct from the surrounding soil, as shown in Figure 5-4. This phenomenon is attributed to the excessive pore water pressure generated by soil liquefaction. Apart from fine sand, larger gravel particles were also brought to the surface by the water pressure. Notably, there is significant variation in the diameter of the sand vents generated in the gravel backfill area. Among them, sand vents with diameters of up to 50 cm were measured to have depths exceeding 100 cm. This is a rare occurrence of sand vents resulting from soil liquefaction and can serve as a valuable reference for subsequent studies on soil liquefaction in gravel layers.

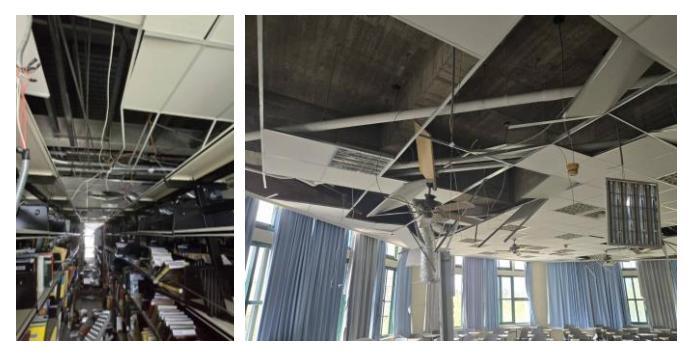
1. T-bar ceilings: T-bar ceilings suffered widespread and significant damage during this seismic event, which is attributable to inadequate grid strength and improper seismic installation. Fig. 6-1 depicts the ceiling damage inside a university library in Hualien County (left figure), and in multiple classrooms across the university campus, with instances of light fixtures and ceiling fans falling (right figure).

Fig. 6-1 Extensive ceiling collapse occurred inside the library (left) and light fixtures and ceiling fans fell in the classrooms (right) (PGA: 321 Gal).

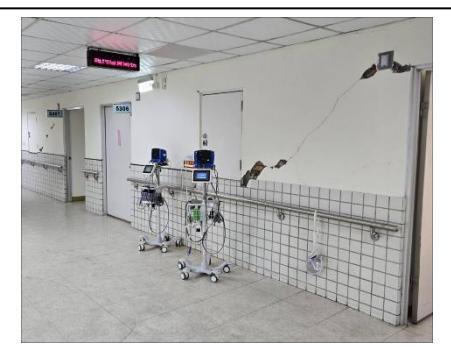
2. Non-structural walls: after the earthquake, damages to nonstructural walls, including masonry walls and lightweight aggregate concrete (LWAC) walls, were investigated. In the fifth- and sixth-floor wards of a hospital in Hualien City, multiple instances of shear damage were observed on the masonry walls, which are oriented along the northwest to southeast direction (Fig. 6-2).

Fig. 6-2 Both sides of the masonry walls were cracked (PGA: 418 Gal).

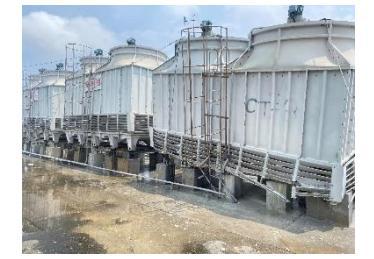
3. Cooling towers and water tanks: Damage to cooling towers made of fiber-reinforced plastic (FRP) was observed on the rooftops of buildings in two hospitals in Hualien City. In the case of one of the hospitals, the base of the cooling tower on the rooftop of a building was damaged and tilted, as shown in Fig. 6-3. During the earthquake, the metal water tower on the rooftop of a hospital building in Hualien City was damaged. In addition to the damage to the water tower itself, its supporting base was also distorted and deformed under the overall inertial force and hydrodynamic pressure exerted by the water tower, as shown in Fig. 6-4 (left). In addition, another hospital building in Hualien City suffered damage to a FRP water tank located on the basement floor. This water tank is composed of FRP panels in vertical and horizontal steel frames. Because of the lack of connection at the joints of the vertical steel frames, the inertia force resulting in tearing of the FRP panels and water leakage, as shown in Fig. 6-4 (right).

Fig. 6-3 The base of the FRP cooling tower was damaged and tilted (PGA: 395 Gal).

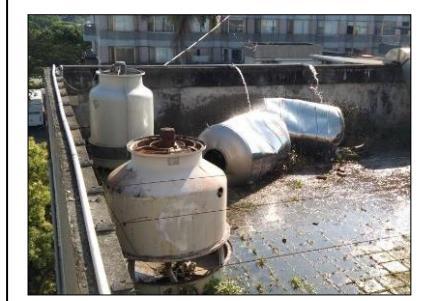
Fig. 6-4 The water tower and supporting base were deformed (left figure, PGA: 418 Gal), and the panels of the FRP water tank ruptured, resulting in water loss (right figure, PGA: 395 Gal).

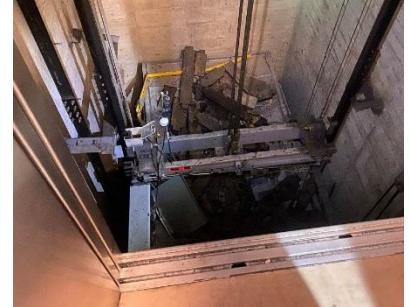
4. Elevators: Three of the four elevators in a medium-sized hospital in Shoufeng Township could not be used immediately after the earthquake. One elevator was rendered unusable because of the significant displacement of the overhead hoist machine located in the elevator machine room on the roof floor, causing the associated cable to detach (Fig. 6-5, left). The other two elevators were rendered inoperable because parts of the mass blocks fell out of their counterweights. The blocks then damaged the elevator cars below (Fig. 6-5, right).

Fig. 6-5 The hoist machine of one elevator was displaced (left) and mass blocks fell out of the counterweight of the other elevator (right) (PGA: 366 Gal).

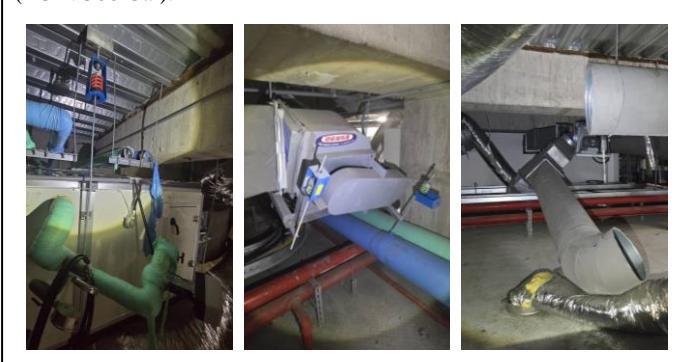
5. Air-conditioning equipment: Damage caused by airconditioning equipment was observed in three hospitals across Hualien County and City. In a hospital in Hualien City, damage to the airconditioning equipment on the catwalk level included ruptured and detached chilled-water pipes from the air-conditioning unit, broken suspension rods of the ventilation fan, and damage to the ductwork around the ventilation fan, as shown in Fig. 6-6.

Fig. 6-6 The chilled-water pipe rupture and detachment from the air

conditioning unit (left), broken suspension rod of the ventilation fan (middle), and damage to the ductwork around the ventilation fan (right) (PGA: 395 Gal).

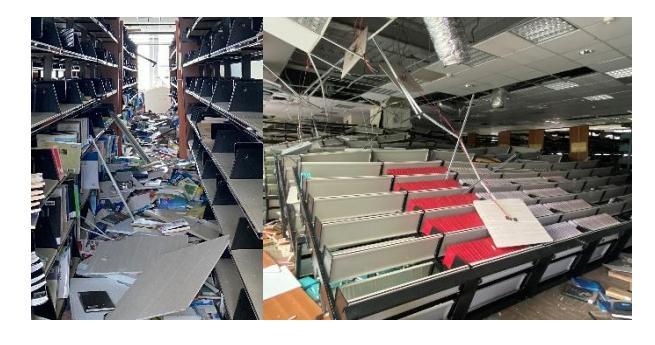
8. Library shelves: A six-floor SRC (Steel-reinforced concrete) library was part of a university in Hualien City. Without anchorages, these free-standing bookshelves underwent sliding, rocking, and overturning during the earthquake, leading to books falling off and shelves being deformed, as shown in Fig. 6-7. Approximately 90% of the books fell from the bookshelves. The majority of earthquake damage occurred on the second to the sixth floors.

Fig. 6-7 Books falling and bookshelves overturing (PGA: 321 Gal).
