# 近斷層地震作用下 具有軟弱底層之建物的受震反應

林瑞良 陳雯惠

May 29, 2018

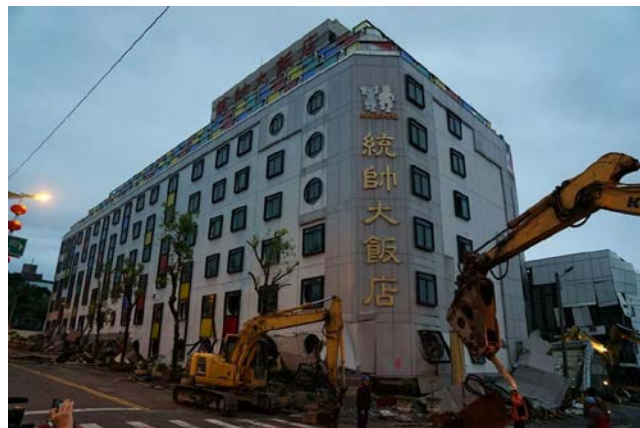
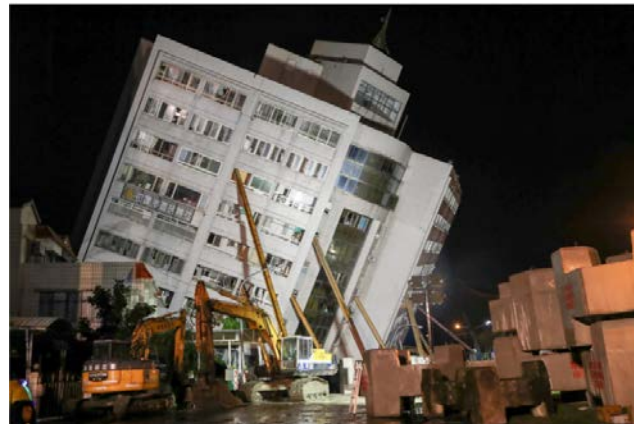
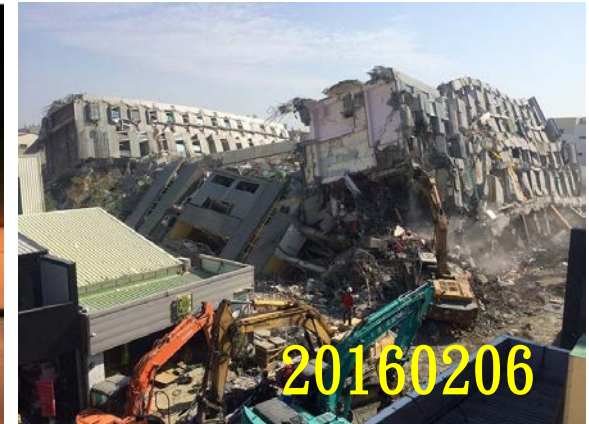
**sit down (統帥飯店)**

partition  
walls

elevated  
open space

**Collapse mechanism**

**kneel down (雲門翠堤)**

plastic  
hinges TYP.

**lie down (維冠大樓)**

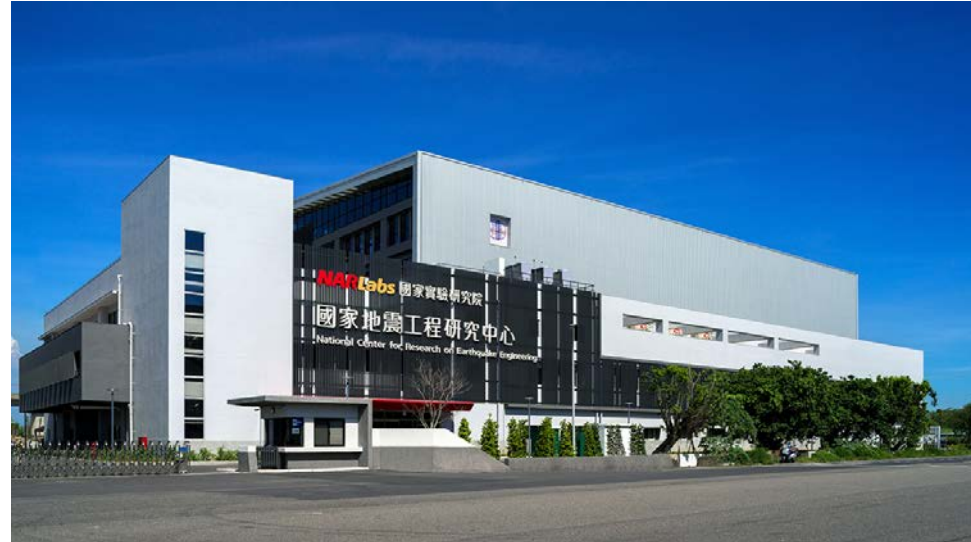
At the NCREE Tainan lab, an **8 m × 8 m** 6-degree-of-freedom tri-axial shaking table with a **250-ton payload** was established to simulate near-fault ground motions.
