February 6, 2016 (local time)
M_L-6.4 Meinong Earthquake
Kaohsiung City, Taiwan

2016/02/06 – Ver5.0

2016.02.06 Meinong Earthquake

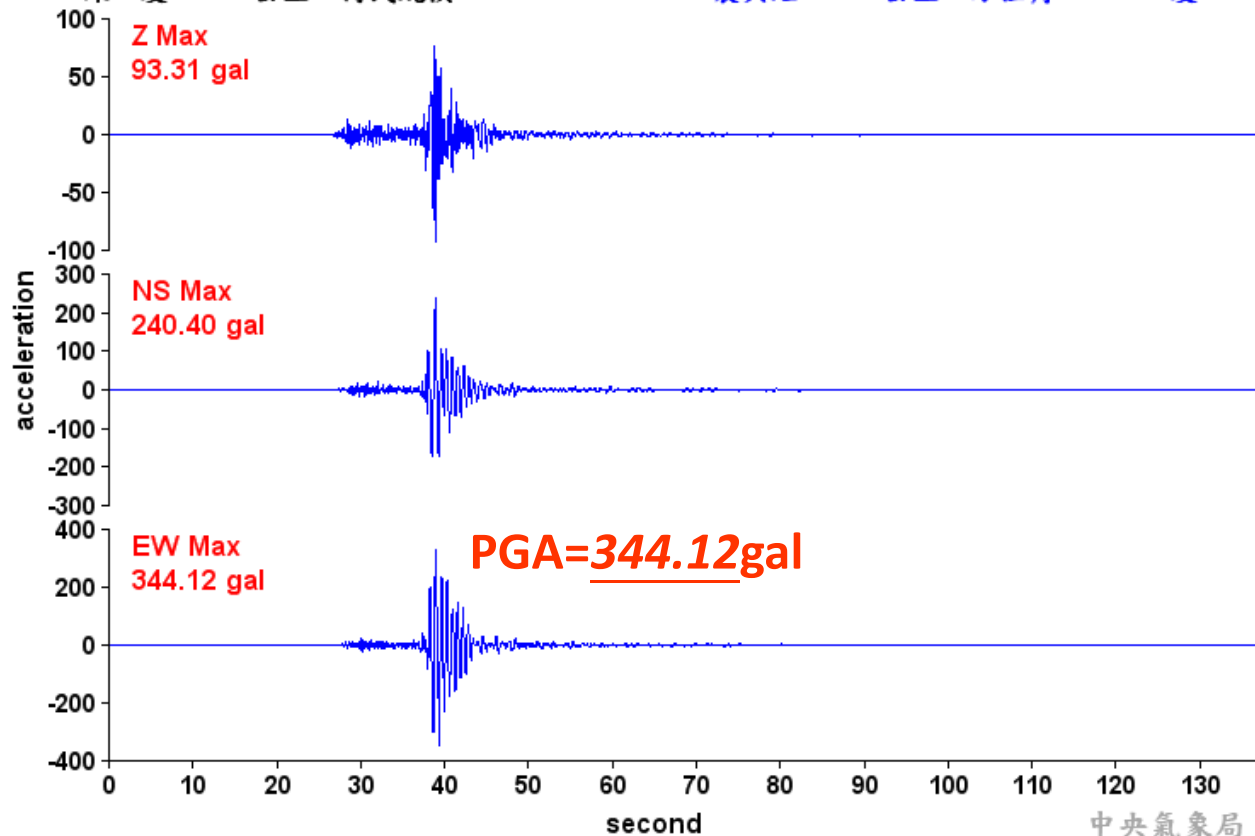
Waveforms recorded at Near-Fault Station

Caoling (CHN5) Intensity Level 6

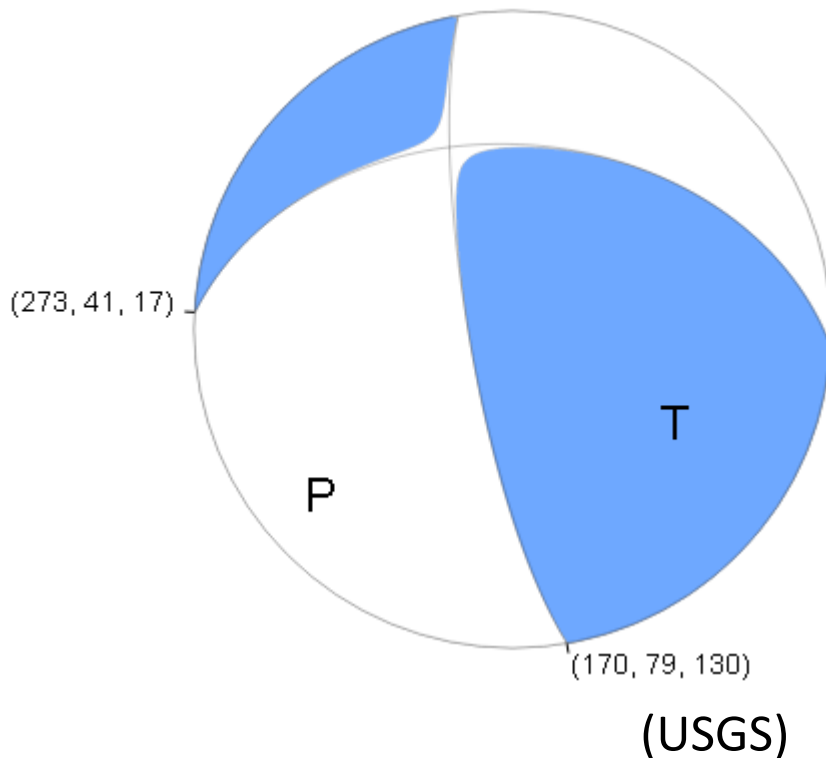
Focal Mechanism Solution

- The focal mechanism solutions reported by CWB-Taiwan and USGS are similar
- Mixture of reverse and strike slip rupture

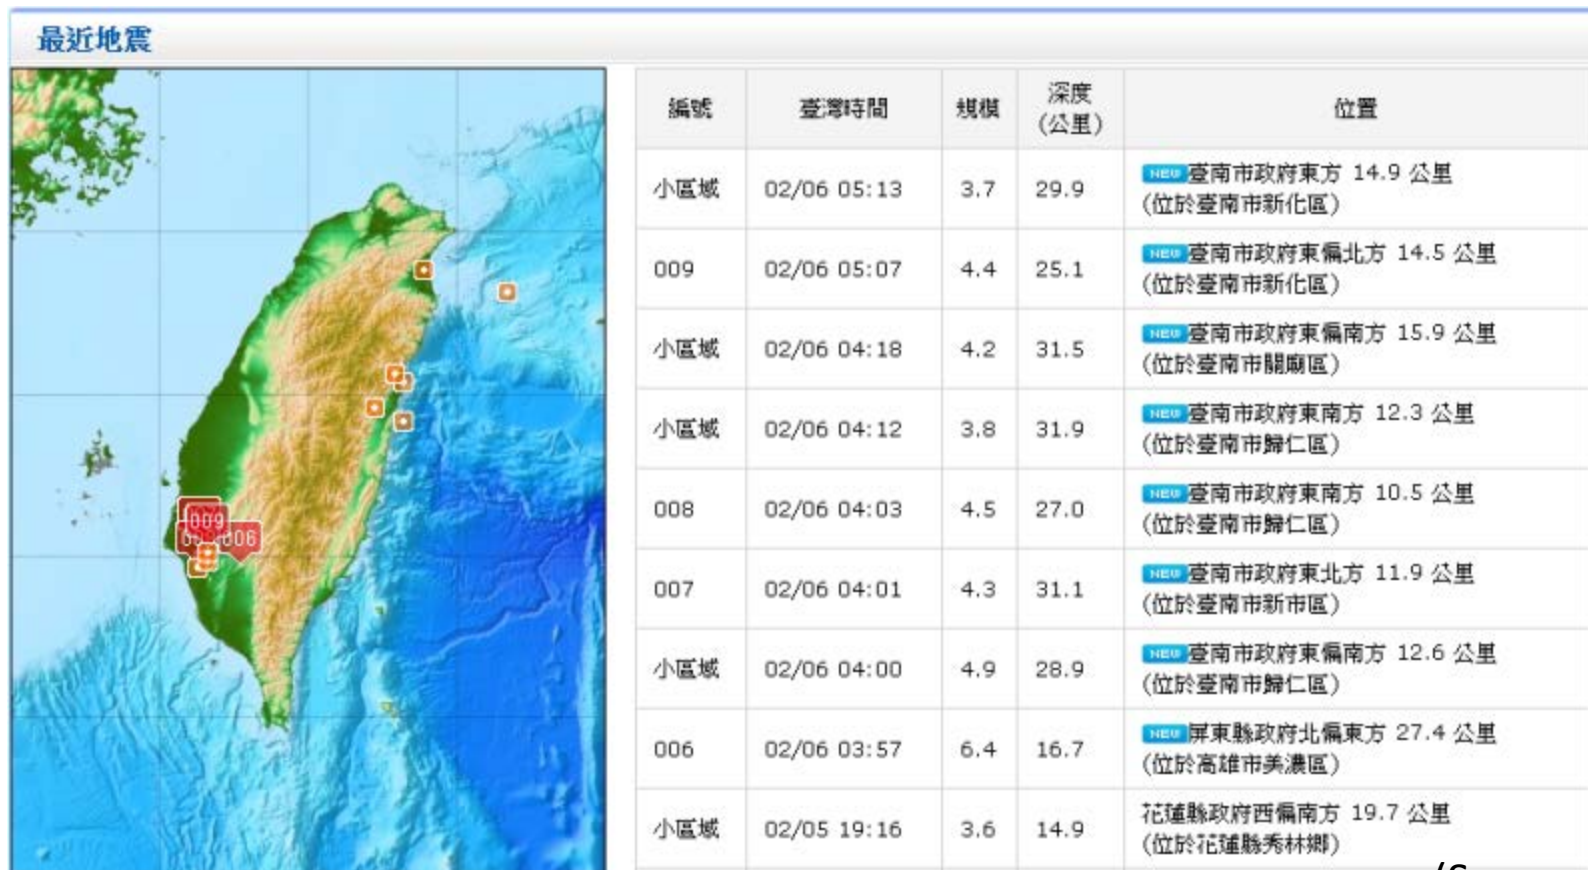
Activities of Aftershocks

- 7 aftershocks observed as of 6:00am, Feb 6 (local time) according to CWB
- Max. magnitude of aftershocks measures $M_L 4.9$; all 7 aftershocks were located west of the main shock and had deeper focal depths

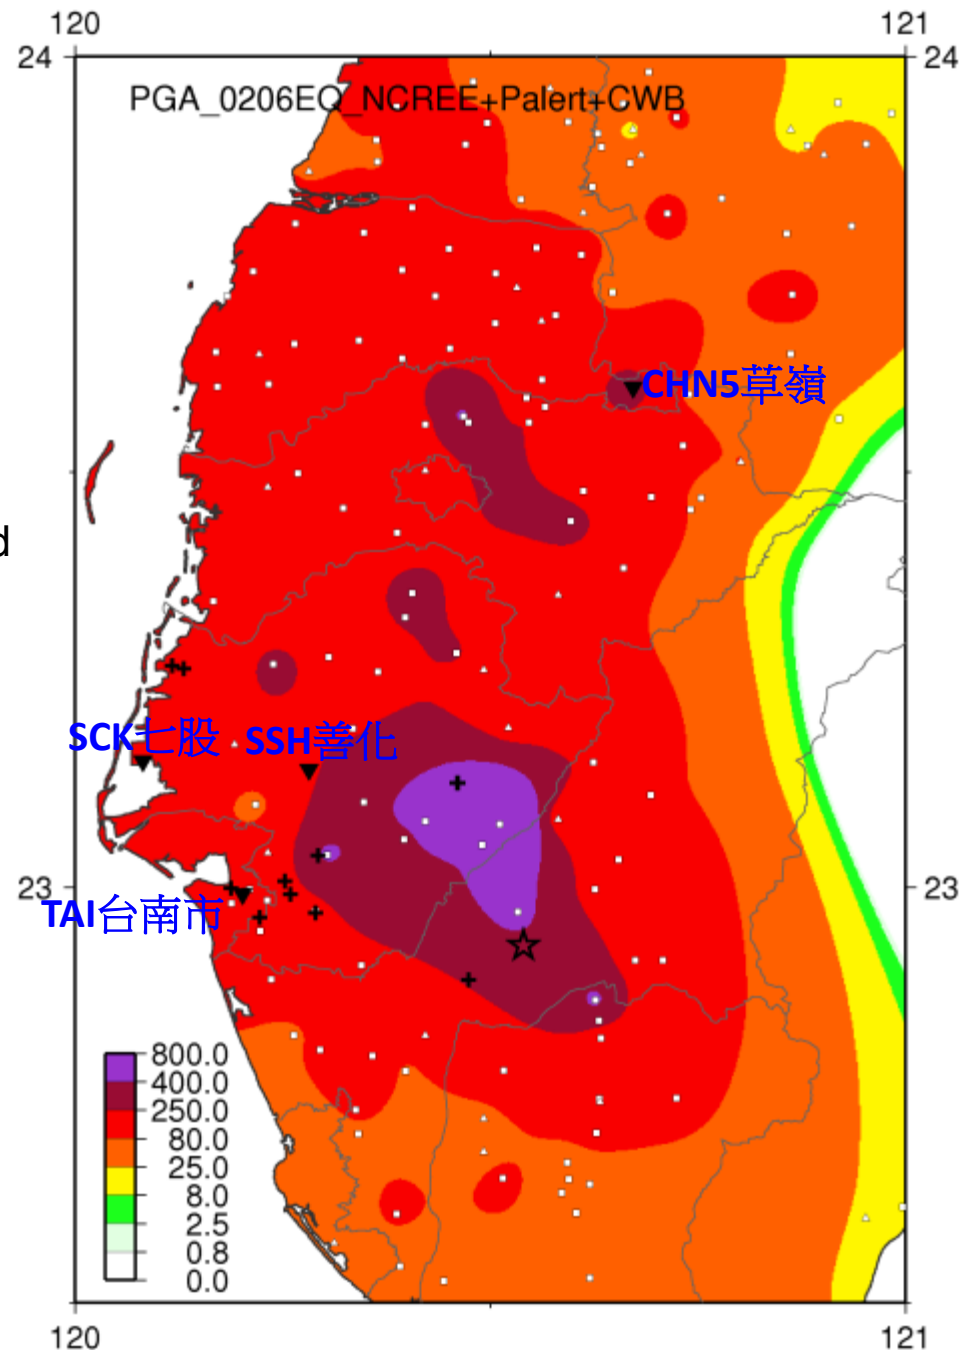
Stations w/ Velocity Pulses

PGA Distribution calculated using
NCREE + P-alert + CWB stations

Black triangle: station observing velocity
pulses

Black cross: building damage sites reported

Correlation seemingly exists between
velocity pulses observations and
building damage sites.

Station Code	PGV (cm/s)	Tp (pulse period)
CHN5	46	0.84
TAI	35	2.38
SSH	62	2.07
SCK	41	1.15

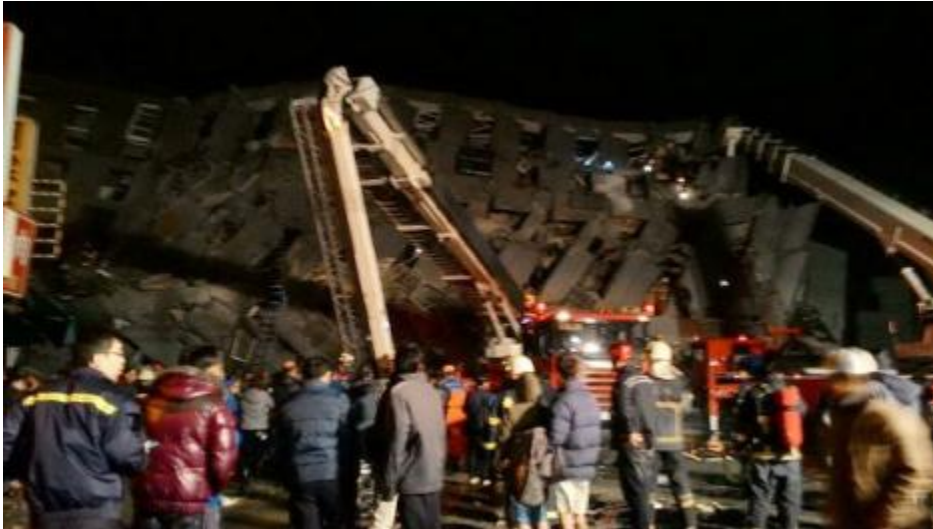
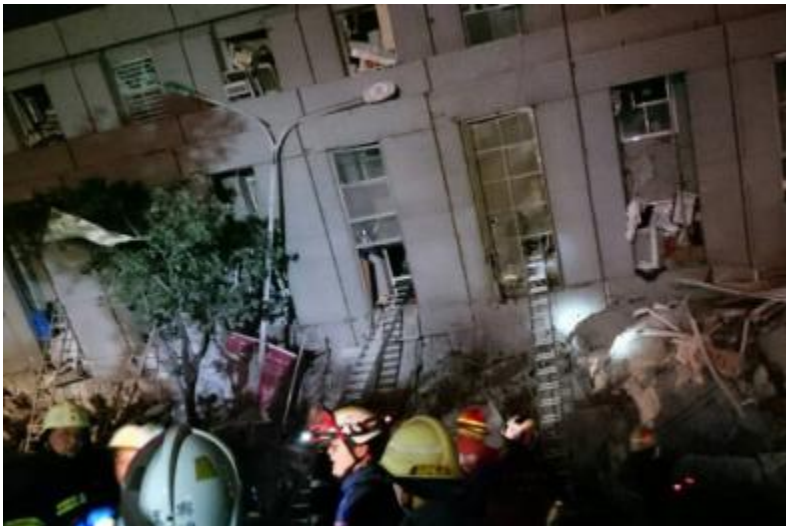
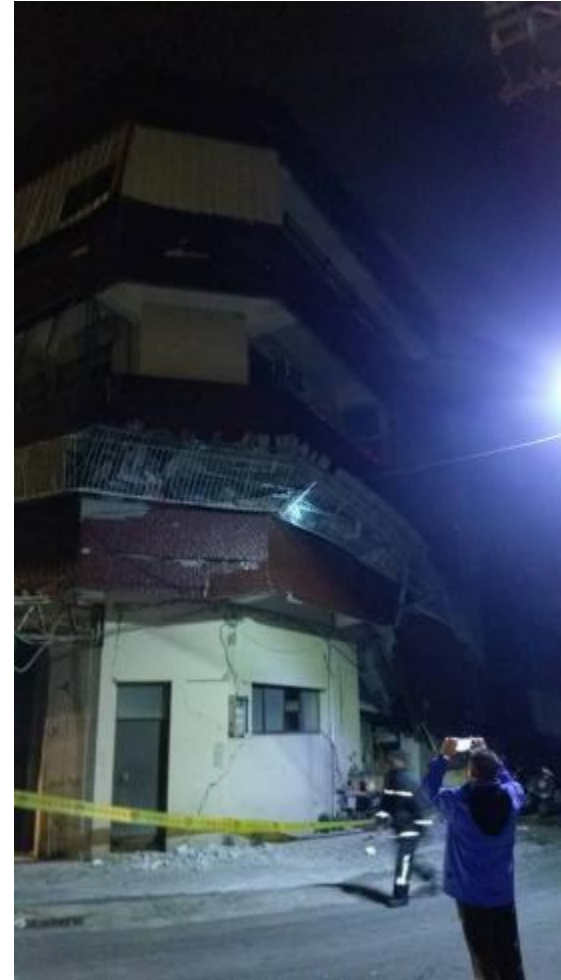
Building collapses in Yongkang District , Tainan

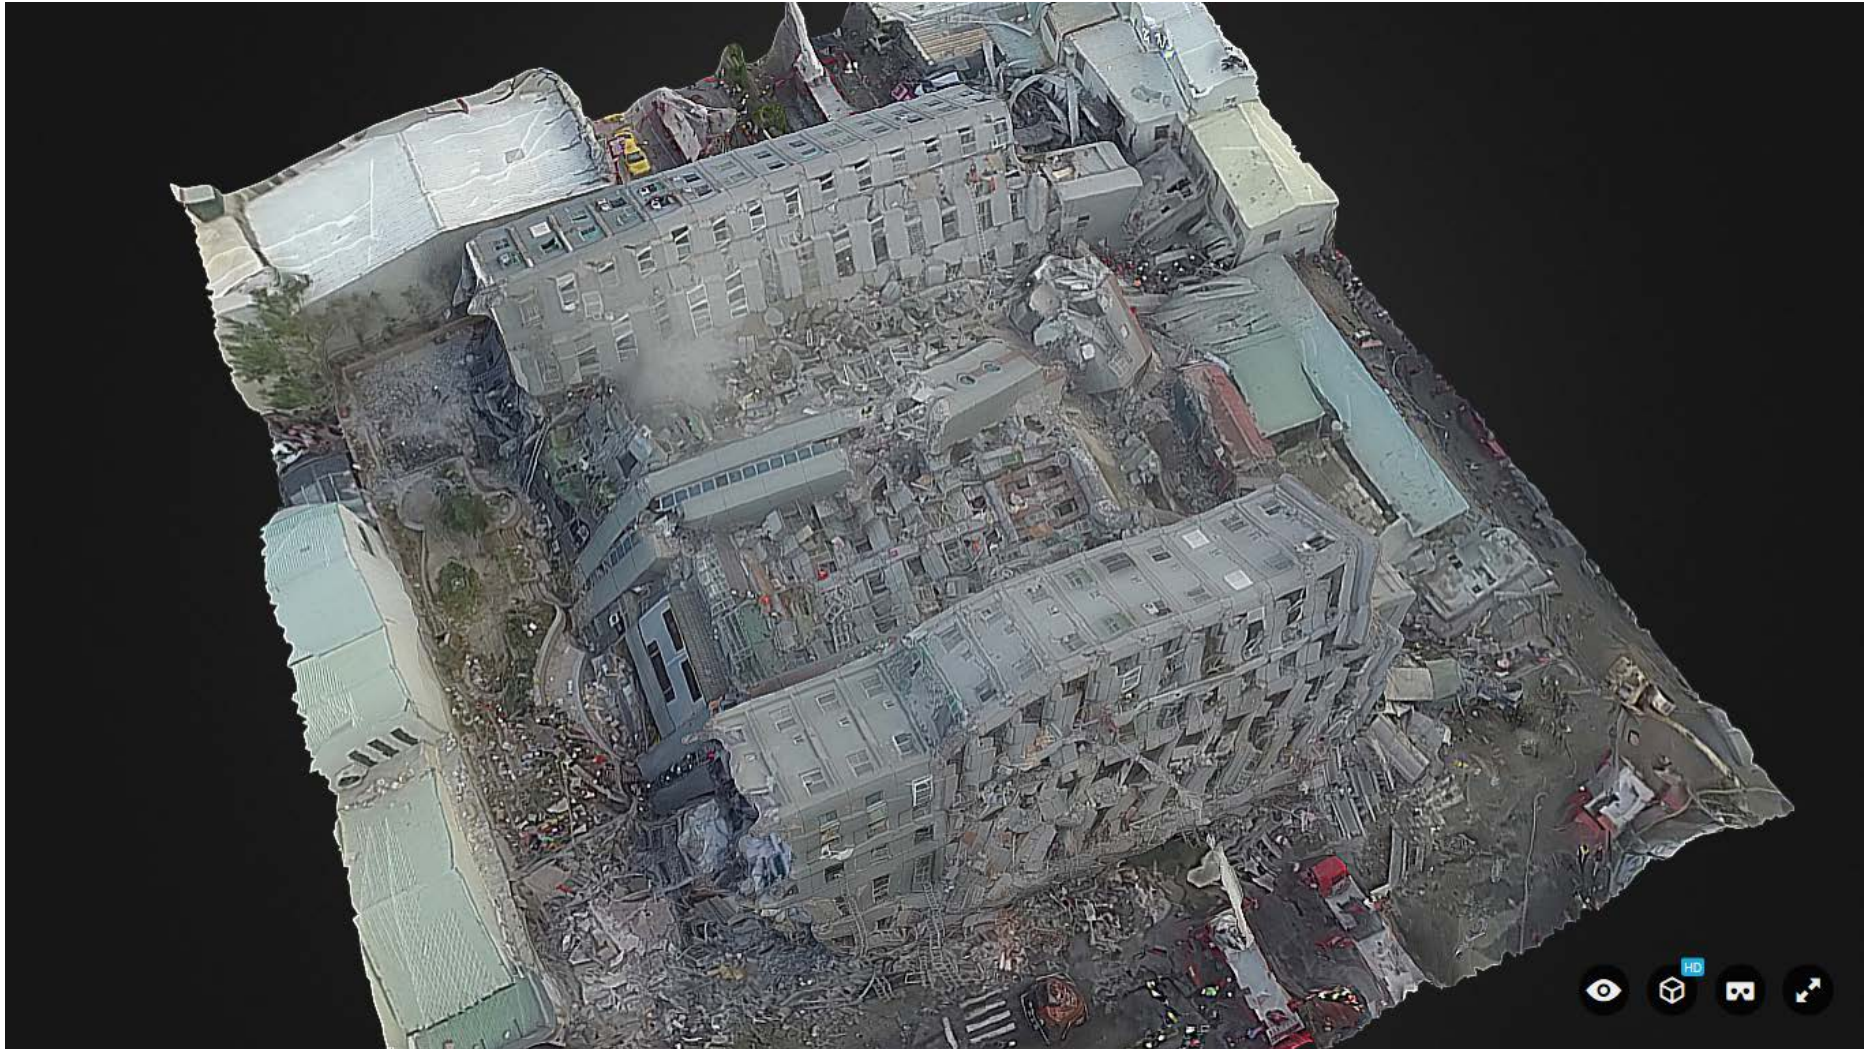
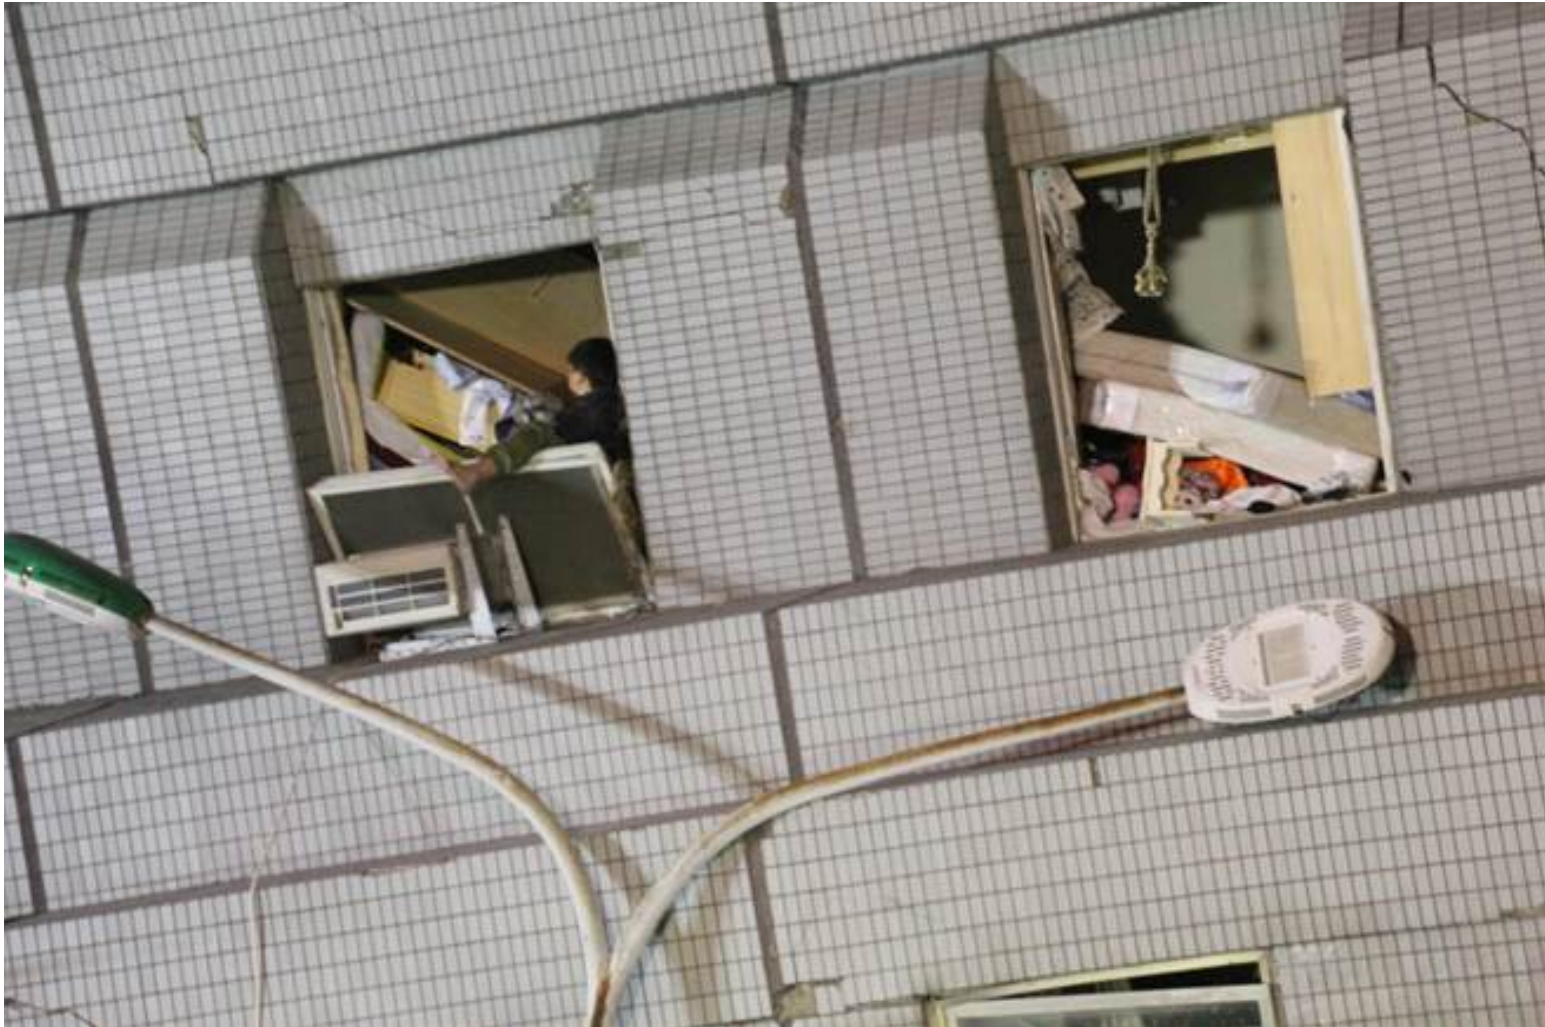
(1) Weikuan Jinlong (維冠金龍/燦坤) Complex

- On Section 2, Yongda Rd. and Guoguang 5th St., Yongkang District, Tainan City
- 16-story RC building collapse

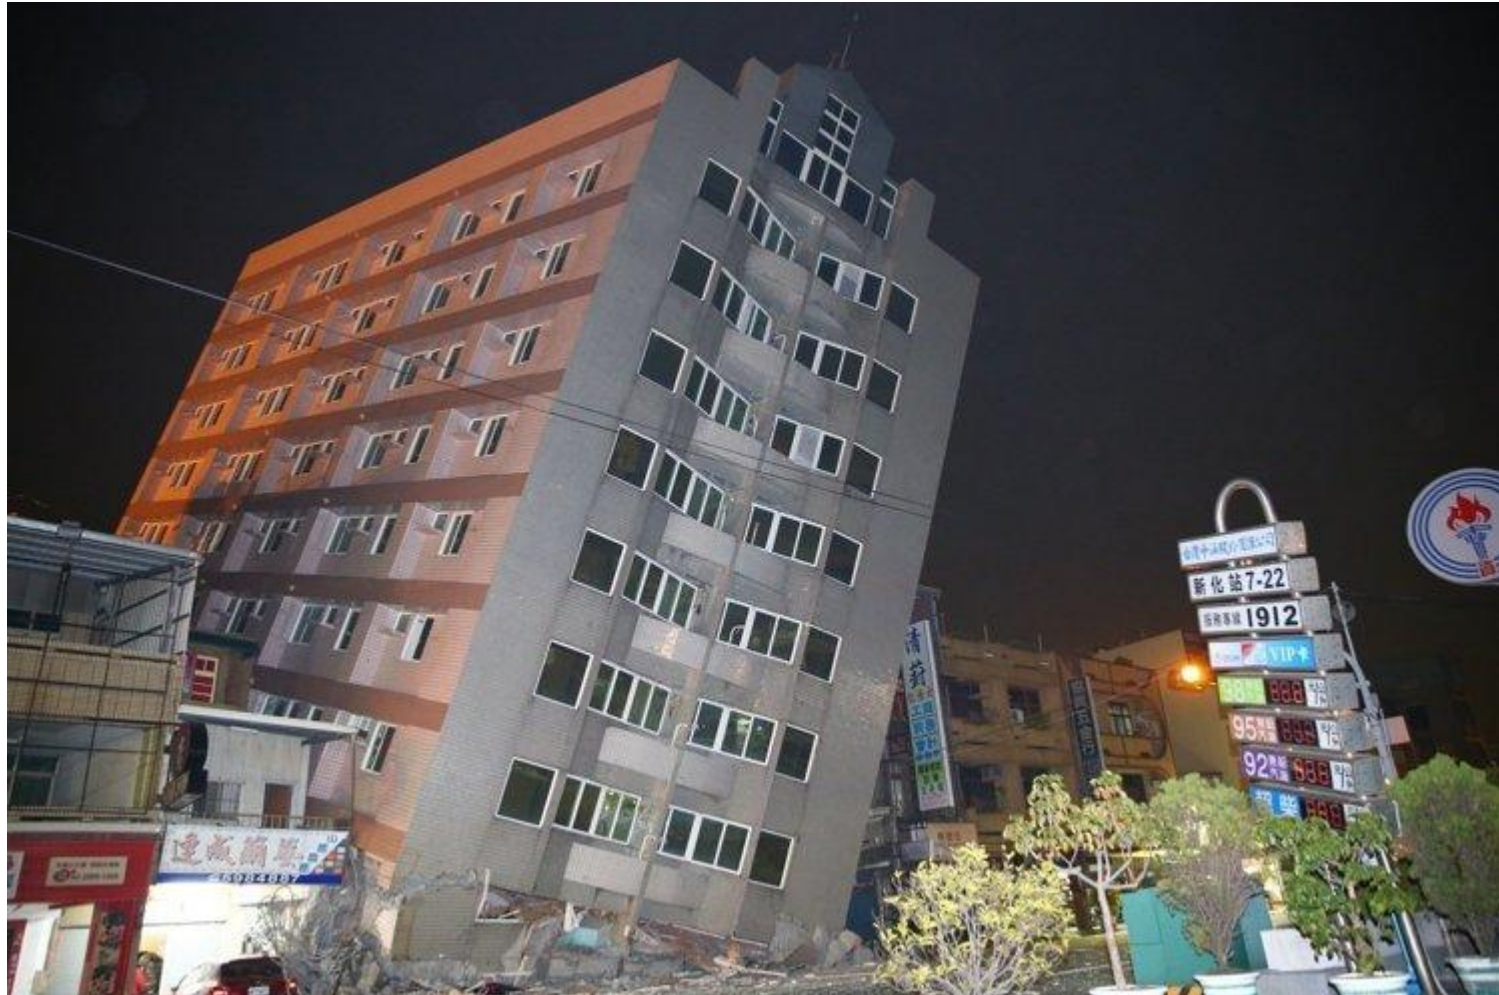
Photographical View of King's Town Bank (京城銀行) after Earthquake

- 586 Zhongshan Rd., Sinhua District, Tainan City
- 10-story

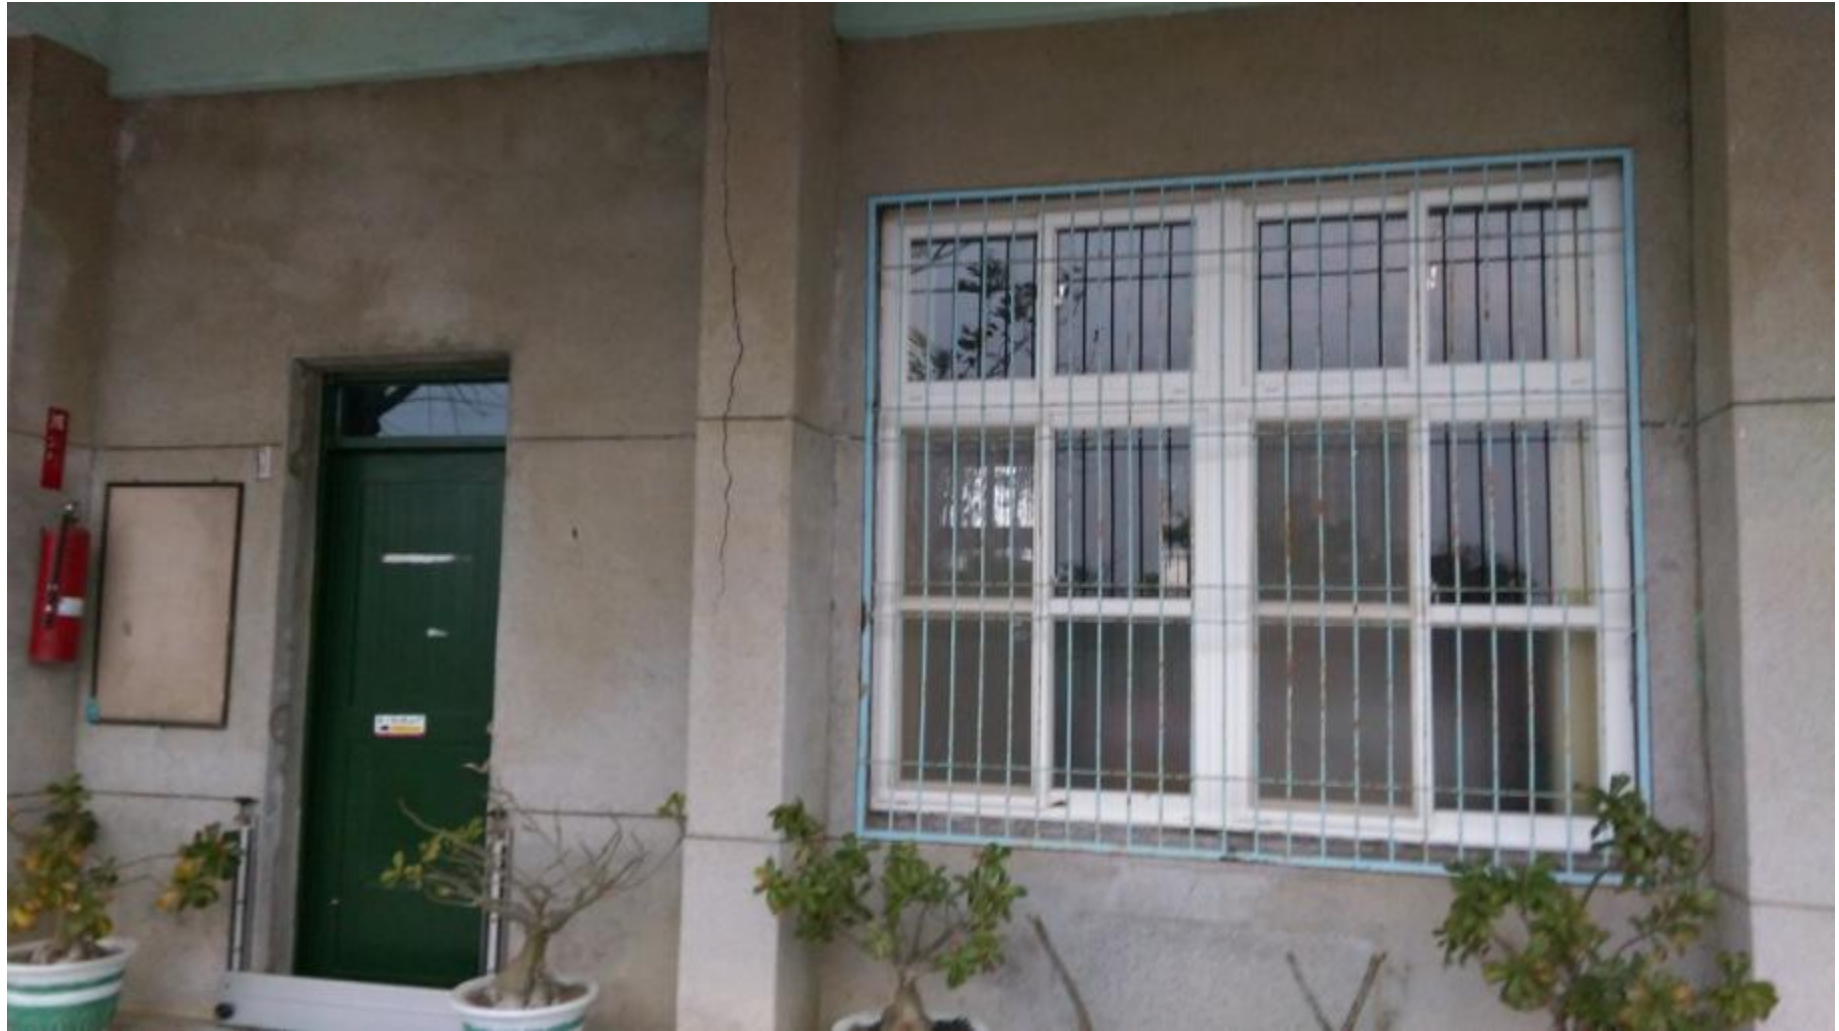
Damage of West Building, Beimen Elementary School at Yuhu Branch (北門國小玉湖分校)

◎ B4. B5. B6 補強過 (鋼板補強)

◎ B2 重直裂縫

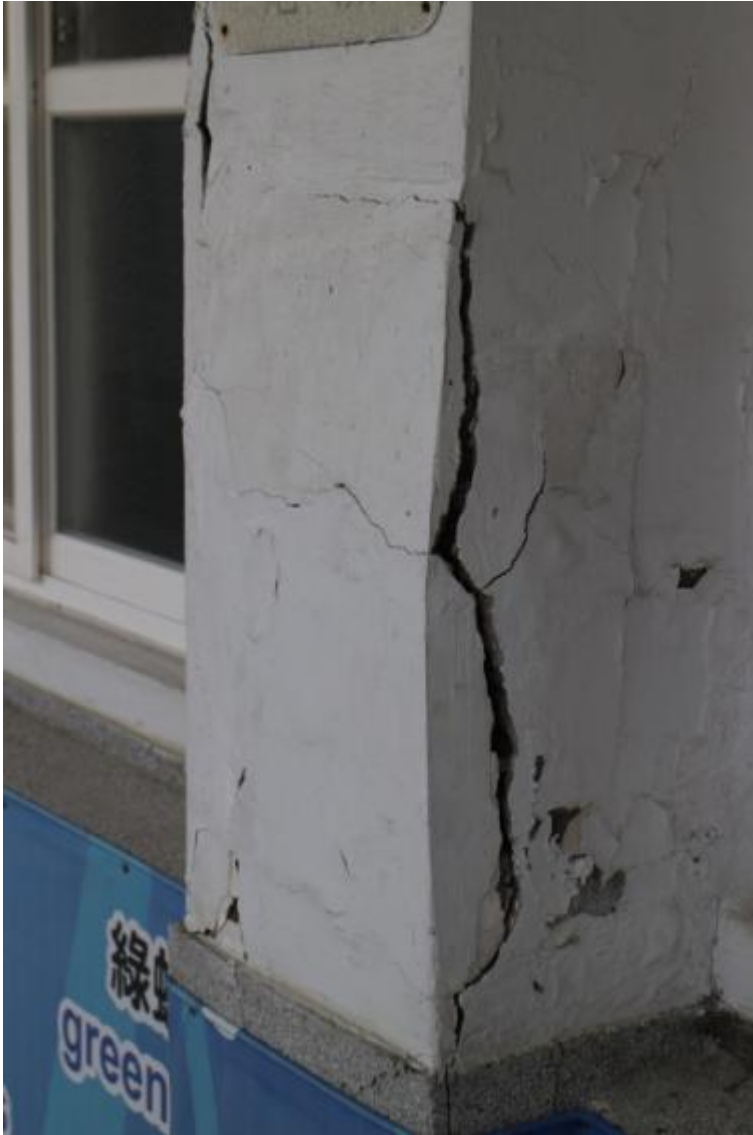
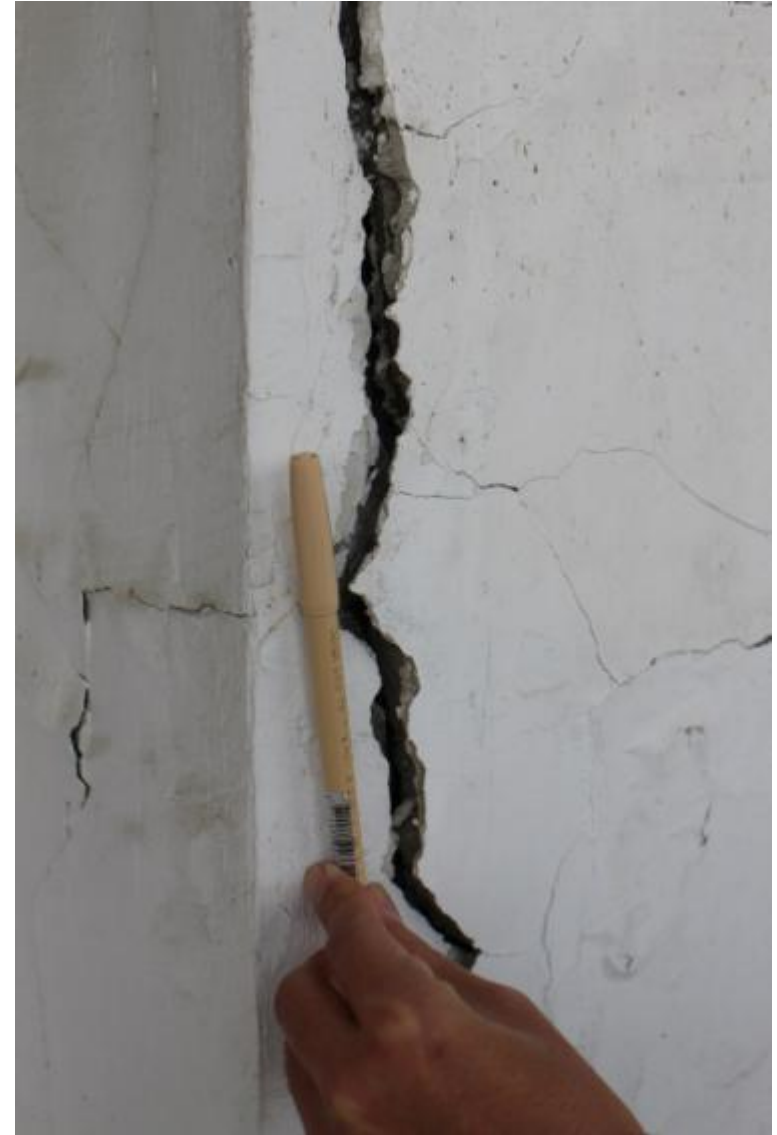
Damage of West Building, Beimen Elementary School (北門國小)

◎ B2、B6 垂直向裂縫

◎ A23梁有見主筋 (推測非此起震造成)
