# NCREE Special Newsletter

# Summary of the Hualien Earthquake Event on April 3, 2024

#### 1. Overview of Earthquake and Disaster Survey

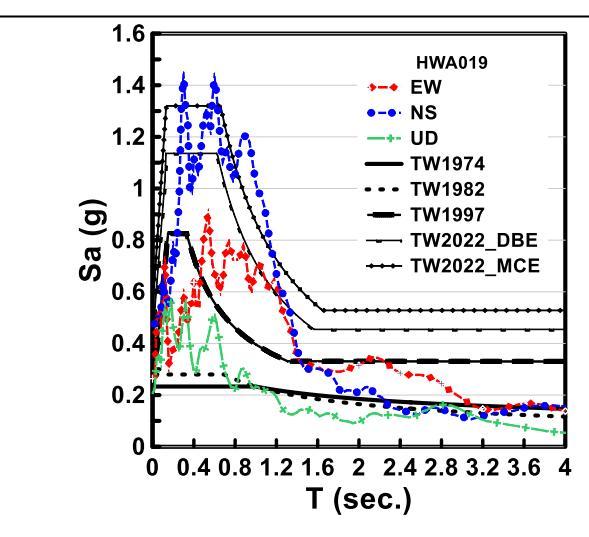
Figure 4-1 Acceleration Response Spectrum of Station HWA019

The acceleration response spectra obtained from the HWA019 station in Hualien City, as depicted in Figure 4-1, were compared with the design response spectra prescribed by the current seismic design regulations in Taiwan. It was found that both the short-period (0.3-sec) and long-period (1.0-sec) spectral accelerations from the station exceeded the maximum considered earthquake spectral acceleration values specified in the existing seismic design regulations.

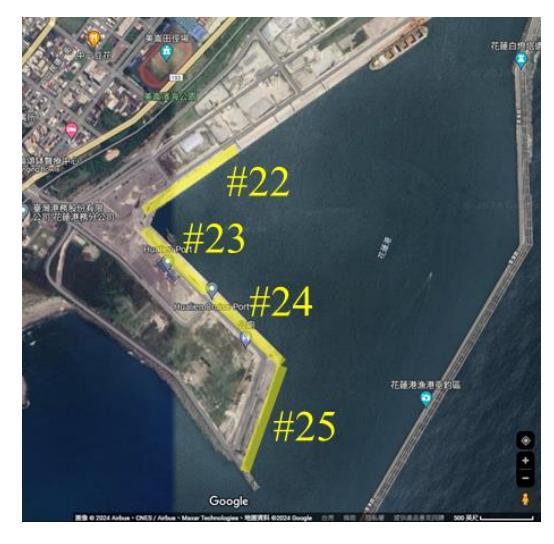
Figure 5-1 Schematic Diagram of Hualien Port Pier Area

The seismic impacts in the Hualien region mainly resulted in landslides, rockfalls, and slope failures in mountainous areas. Significant damage to geotechnical structures occurred primarily in the Hualien Port area. Considering the urgent need for emergency response due to road collapses and the mountainous terrain, our center focused solely on conducting damage assessments in the Hualien Port area. We collaborated with National Taiwan University, National Yang Ming Chiao Tung University, National Chung Hsing University, National Cheng Kung University, National Sun Yat-sen University, and others to plan field visits. Hualien Port is situated northeast of Hualien City, bordering the Pacific Ocean to the east and backed by the Meilun Mountain to the west. Since its establishment as an international port in 1963, expansion projects were completed in 1973, 1977, and 1990. The port currently comprises a total of 25 piers, including 16 in the inner port area with water depths ranging 6.5-10.5 m, capable of accommodating vessels of 4,000-12,000 metric tons. The outer port area consists of 9 piers with water depths ranging 12-16.5 m, capable of accommodating vessels of 30,000 to 60,000 metric tons. This area was severely affected by the earthquake, making it the most heavily impacted region. The main focus of our assessment was on the areas around piers 25, 24, and 23, as illustrated in Figure 5-1.

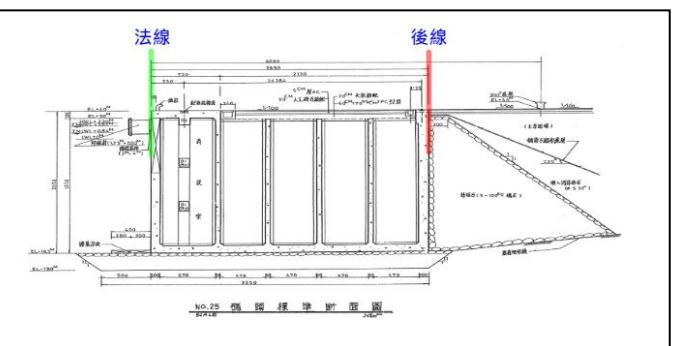
Figure 5-2 Cross-sectional Design of Pier 25 at Hualien Port (Source: Hualien Port Authority)

Hualien Port's pier 25 is a gravity caisson wharf with a structure width of 28.5 m. It features a wave-dissipating chamber structure at the front edge and is designed with a water depth of 16.5 m and a length of 332 m, primarily for general cargo handling. The standard cross-section design of pier 25 is illustrated in Figure 5-2. During this earthquake, pier 25 experienced more severe damage compared to neighboring piers 23 and 24. Significant differential settlement occurred at the joint between pier 25 and its wharf apron, with surface settlement reaching 70 cm at the wharf apron, as shown in Figure 5-3. Similar phenomena were observed at piers 23 and 24. The differential settlement of piers and wharf apron in the Hualien Port area due to the earthquake is summarized in Table 5-1.

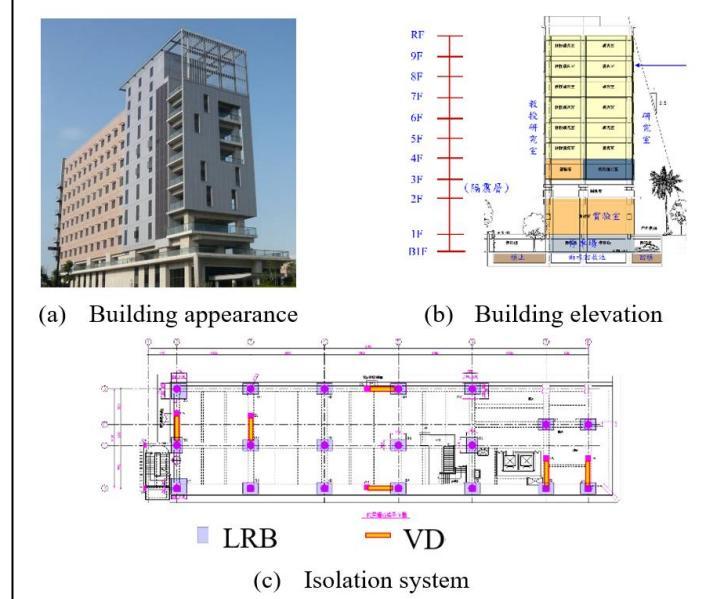
Fig. 7-1 The NTU Civil Engineering Research Building.

The NTU Civil Engineering Research Building (Figure 7-1(a)) is a precast reinforced-concrete mid-story seismically isolated structure, comprising one basement, nine above-ground levels, and two penthouse levels. The isolation layer is situated on the second floor (Figure 7-1(b)). The building includes laboratories, professors' research offices, administrative offices, student research rooms, and multipurpose classrooms. The base-isolation system (Figure 7-1(c)) consists of nineteen lead rubber bearings (LRB) with a diameter of 900 mm, along with two liquid viscous dampers (VD) in the longitudinal direction and four in the transverse direction. The dampers have a stroke of  $\pm$ 500 mm, a maximum force of 100 tons, and a non-linear index of 0.6.

After the April 3 earthquake event, an immediate inspection was conducted, confirming that the earthquake caused no damage to the structure or the isolation system. However, some minor non-structural damages occurred because of the movement of the isolation system, which can be easily restored and repaired. As shown in Figure 7-2(a), the movable cover plate for the suspended elevator below the isolation layer exhibited slight misalignment and compression deformation. The waterproof sealing strip between the superstructure and substructure was flipped, and its fasteners loosened (Figure 7-2(b)). The flexible fire-resistant material between the fireproof covers of the isolation units was damaged, deformed, or extruded as a result of deformation of the isolation units (Figure 7-2(c)).

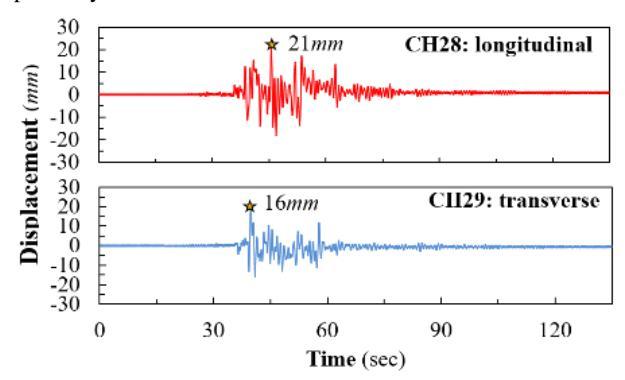
Fig. 7-3 Non-structural damages to the NTU Civil Engineering Research Building.

displacement transducers are installed in the isolation layer. The maximum displacements in the longitudinal and transverse directions were 21 mm and 16 mm, respectively (Figure 7-3). Summarizing the peak accelerations in the longitudinal and transverse directions for each floor (Table 7-1) reveals no significant dynamic amplification effect in the superstructure. The reduction efficiency in the long and short directions was 21% (= 100% - 79%) and 37% (= 100% - 63%), respectively.

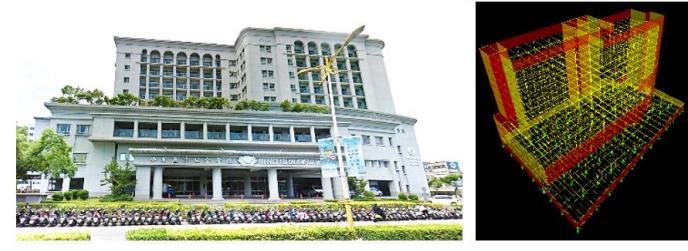
(a) Building appearance(b) Numerical modelFig. 7-4 The HeXin Building of the Hualien TzuChi Medical Center.An inspection conducted on April 13 revealed no structural

damage to the Hexin Building, thanks to the function of the isolation system. However, some non-structural components suffered damage due to inadequate allowance for isolation movement (Figures 7-5(a)– (c)). In contrast, the Xieli Building, a traditional aseismic structure, experienced various structural and non-structural damages. This demonstrates that base-isolation design not only effectively reduces structural seismic response but also significantly lowers the risk of non-structural component and equipment damage.

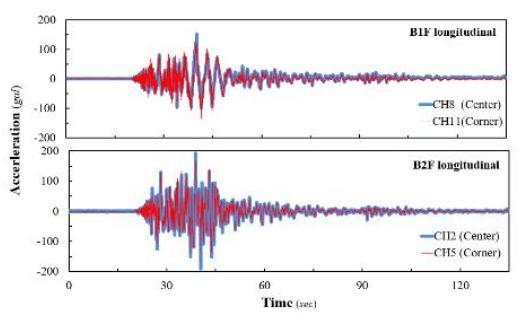
Fig. 7-6 Acceleration histories of the HeXin Building.

The structure is equipped with 26 accelerometers and four displacement transducers, all of which were damaged in previous earthquakes. The accelerometers are installed at the foundation (below the isolation layer), the first basement floor (above the isolation layer), and the fourth, fifth, and roof floors. Each floor has longitudinal and transverse accelerometers installed at both the center and corners of each floor. As shown in Figure 7-6, the overlap between longitudinal and transverse records indicates that no torsion occurred in the structure. Moreover, after transmission through the isolation system, seismic excitation led to reduced acceleration and an increased oscillation period. According to the peak acceleration from each floor in Table 7-2, the reduction efficiency in the longitudinal direction was between 20% and 30%, while the transverse reduction was less pronounced but exhibited no signs of dynamic amplification.

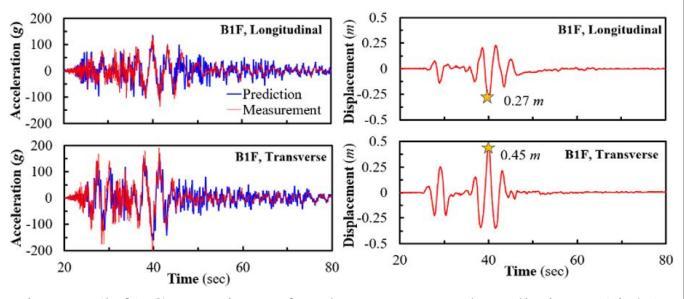
The acceleration history recorded at the foundation was used as input for numerical analysis (Figure 7-4(b)). Once the results aligned with the real responses (Figure 7-7(left)), the base-isolation displacement was estimated (Figure 7-7(right)), revealing maximum displacements of 27 cm and 45 cm in the longitudinal and transverse directions, respectively.

Fig. 7-7 (left) Comparison of real responses and predictions. (right) Predicted isolation displacement.
