Summary Report of Hualien Earthquake in Taiwan on April 3, 2024 (first edition, v1.0)

Chung-Che Chou, Chiun-Lin Wu, Juin-Fu Chai, George C. Yao

NCREE, Taiwan

April 05, 2024

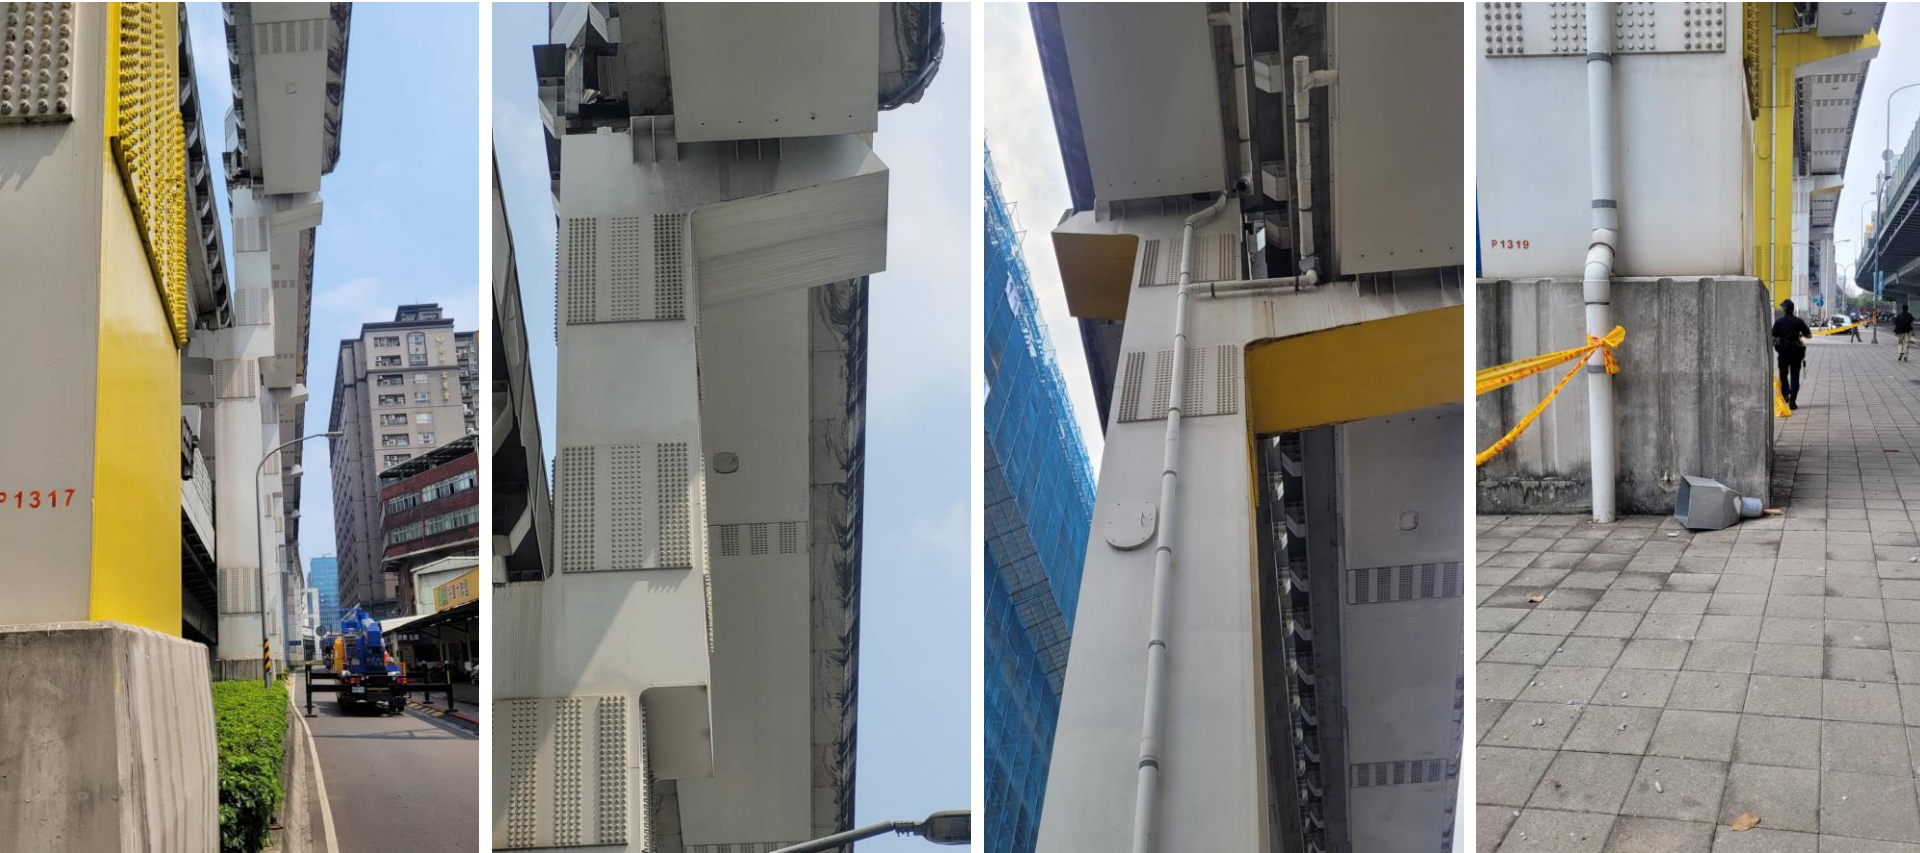
Xiaqingshui Bridge

- The damaged part of the circular line was near the intersection between Banxin Road and Section 2, Sanmin Road, Banqiao District, New Taipei City. P1319~P1316.
- The pier columns' bases were still intact, but the main beam shifted horizontally, and the drainage pipe joints were damaged and have fallen onto the ground.

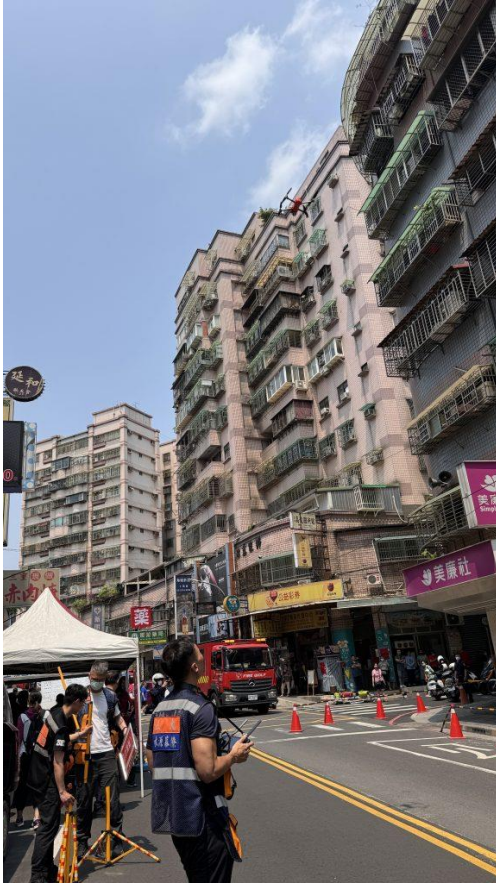
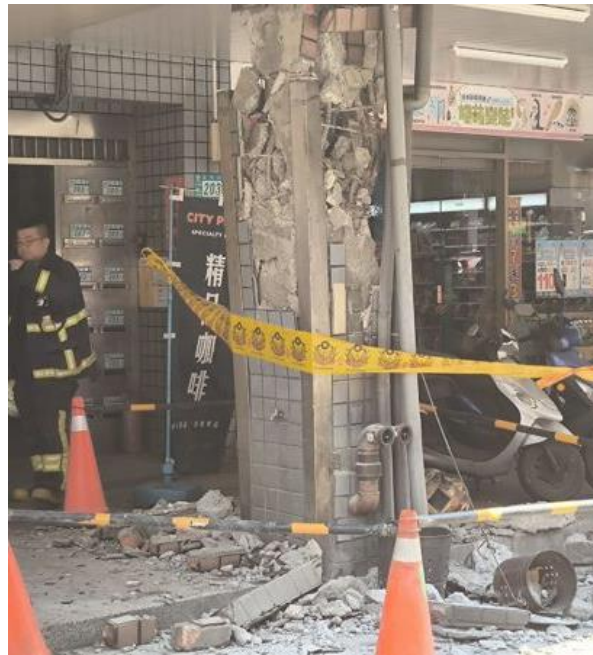
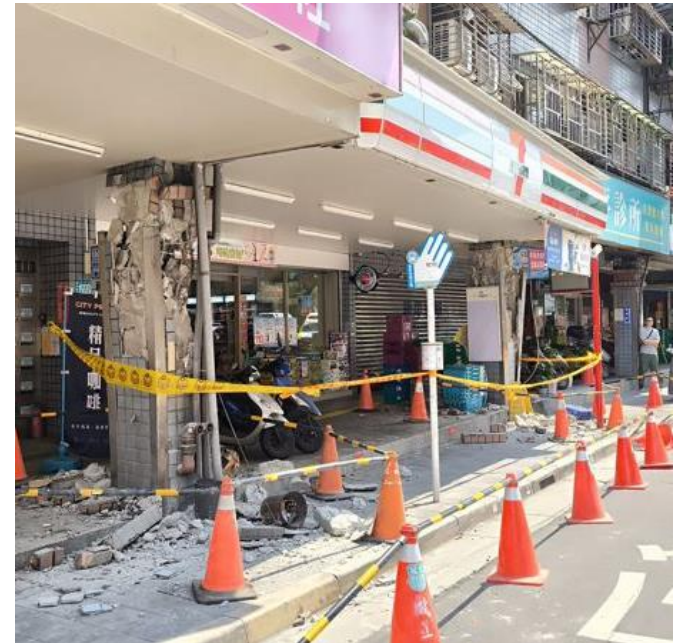
8-story Residential bldg. .

**1st floor column core concrete was crushed.
The spacing of the reinforcement bars was
too large.**

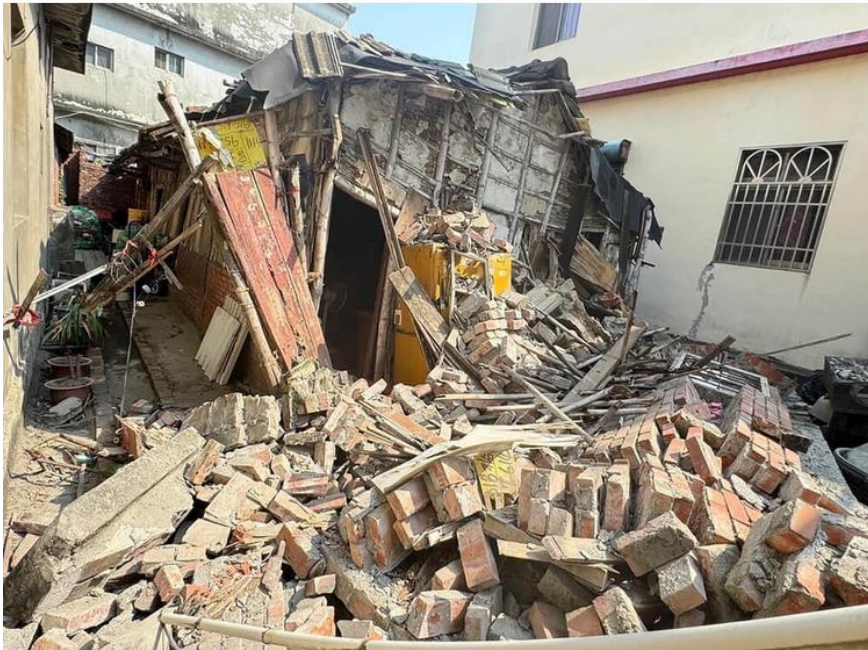
Residential bldg.

花蓮近海3日上午發生強震，造成彰化縣埔鹽鄉埔港路一處平房倒塌，一對母子及時逃出未受傷，因房子已不能居住，鄉公所協助安置2人。(民眾提供) 中央社記者鄭維真傳真 113年4月3日

Brick house collapsed

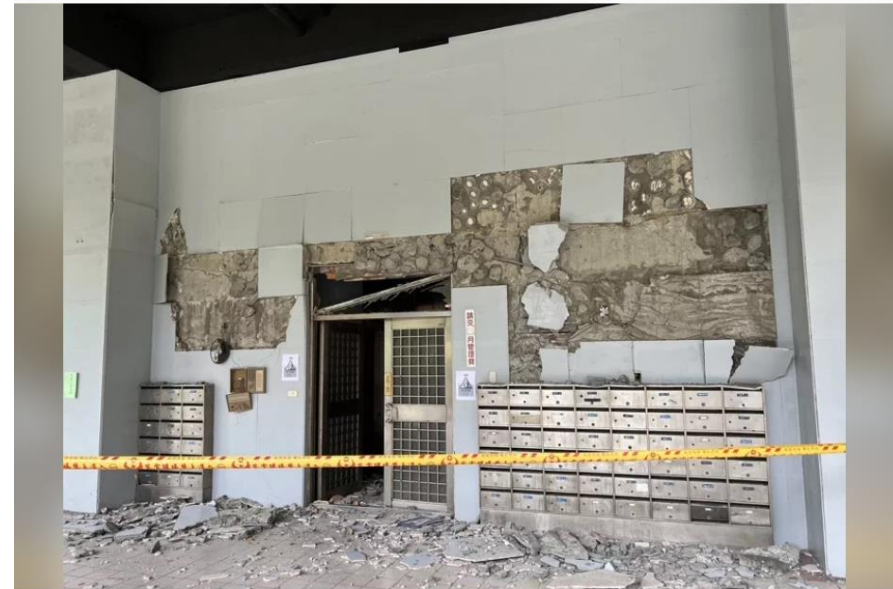
桃園市八德區「三元吉第大廈」內發生大面積磁磚脫落，只見大樓一樓入口外的牆壁磁磚掉滿地，大廈樑柱磁磚也剝落。圖／讀者提供

Exterior wall tiles fell off

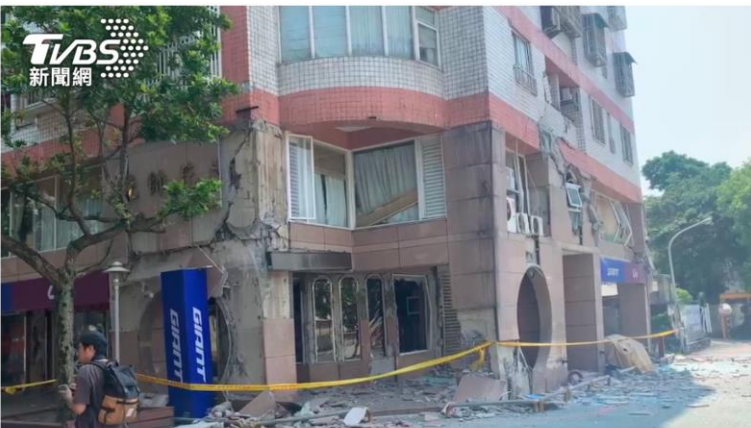
Residential bldg.-Hualien City, Hualien County

花蓮大樓外牆磁磚剝落。(圖/葉軍宏攝)

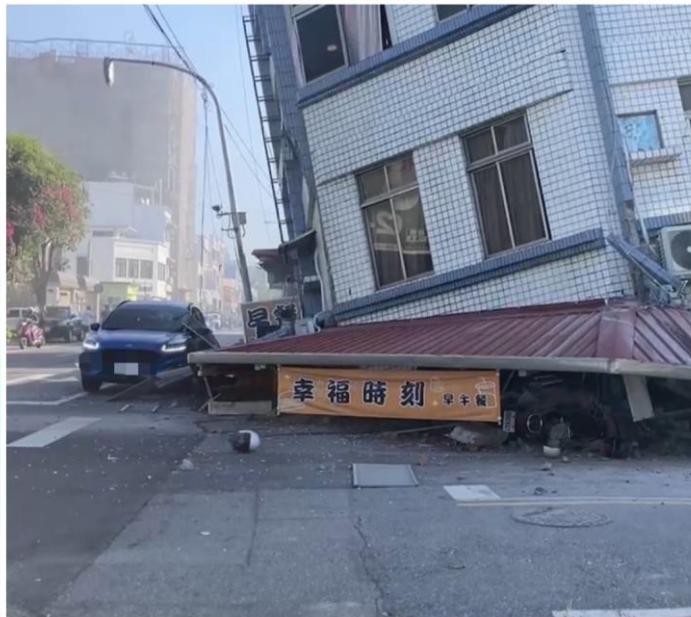
花蓮北濱街地震，早餐店傾斜。(民眾提供)

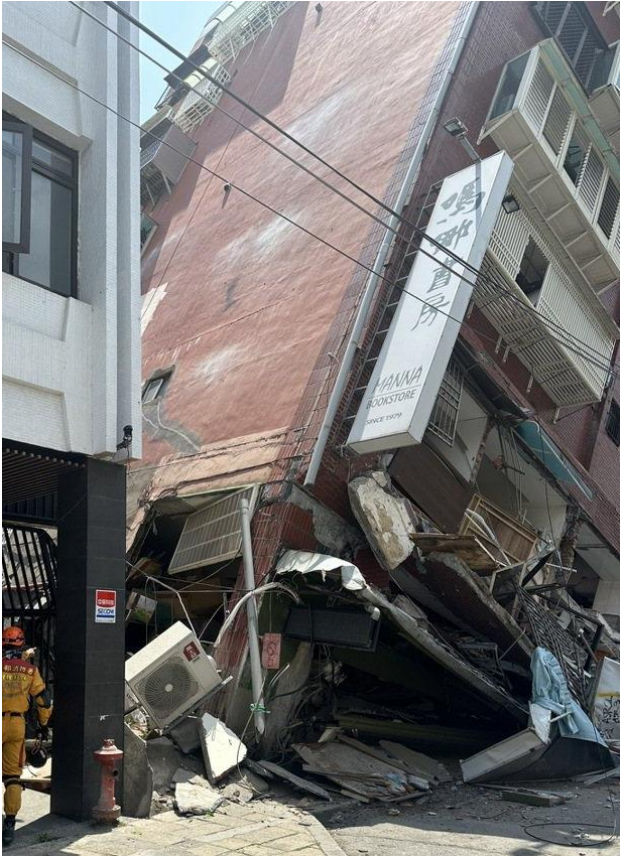
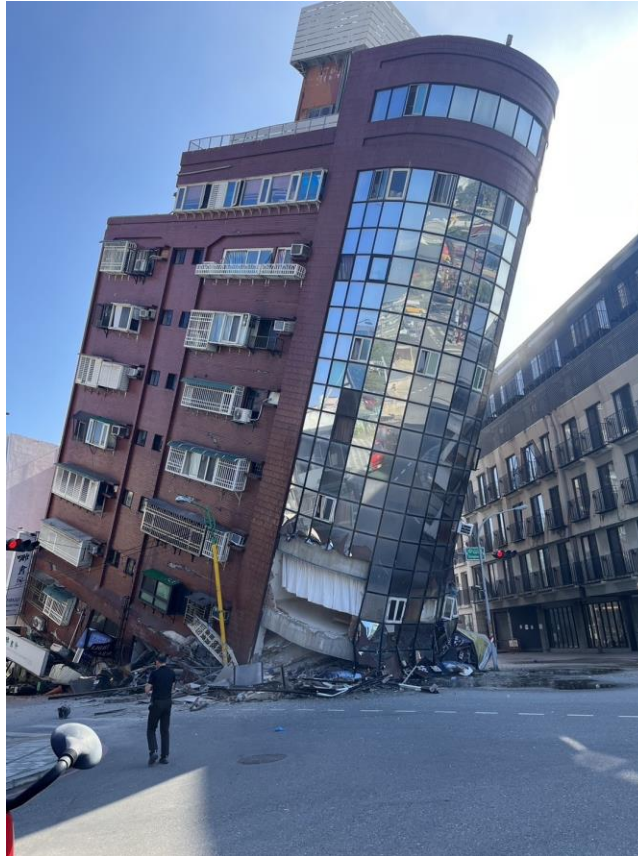
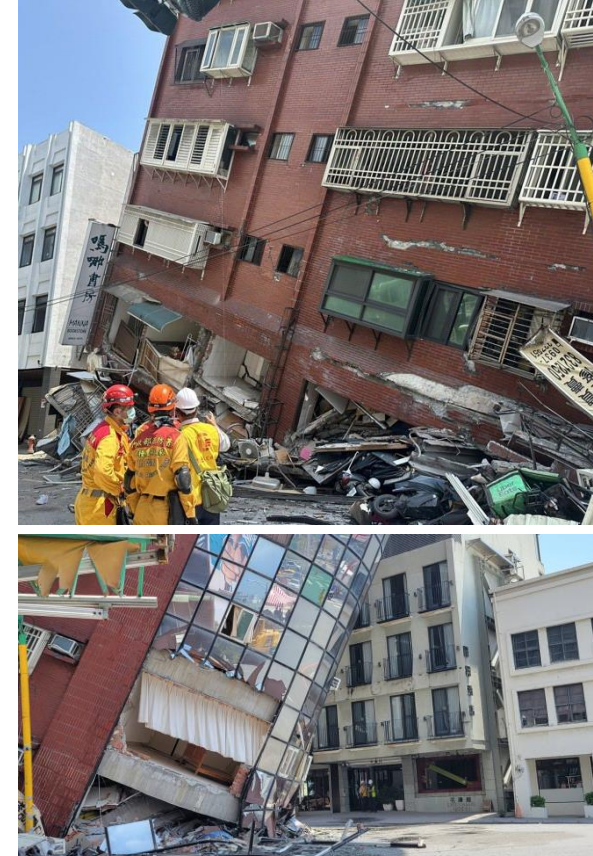
Residential bldg.-Hualien City, Hualien County

Collapsed due to the weak first-story columns

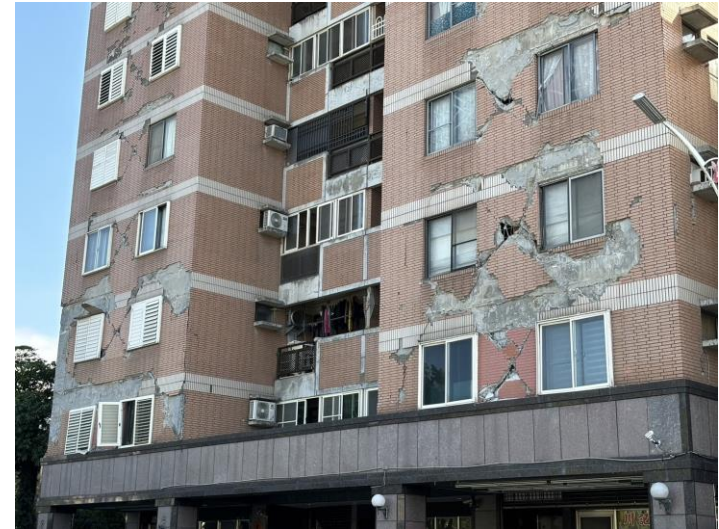
Ji'an Township, Hualien County

Exterior wall shear failure and tile fell off

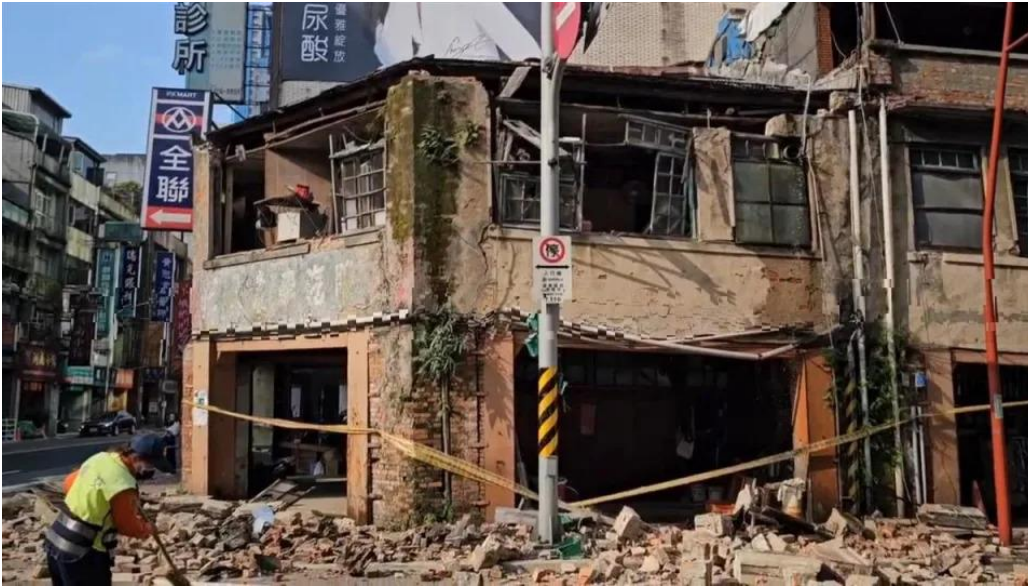
After the earthquake

The beams and columns on the 2nd floor of the brick building were damaged and fell off

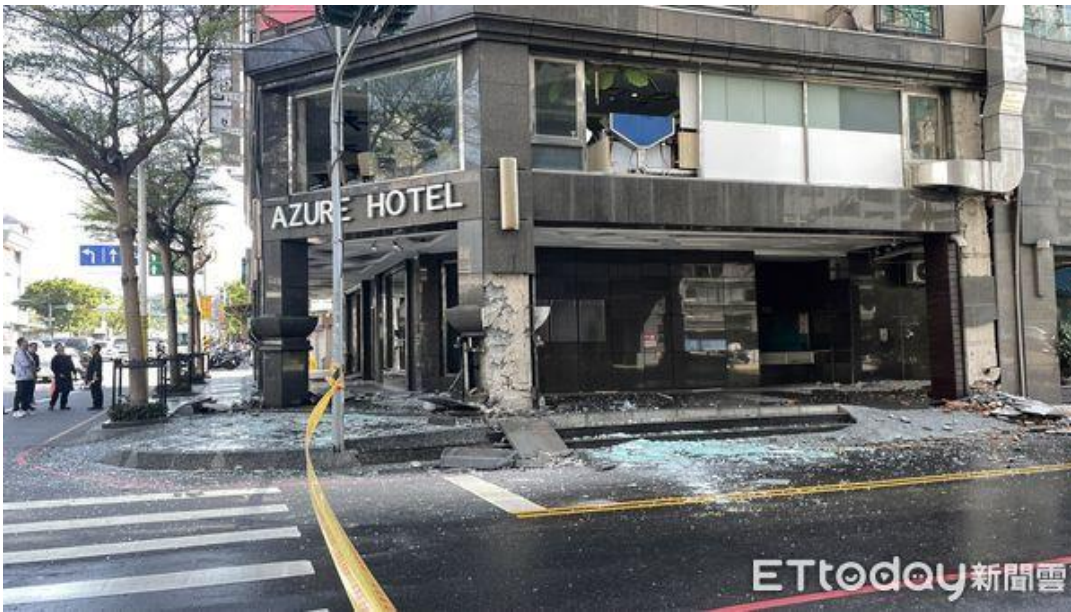
The column cladding stone fell off, the protective layer of concrete cracked, and the column stirrup spacing was too large.

Column cladding stone fell off

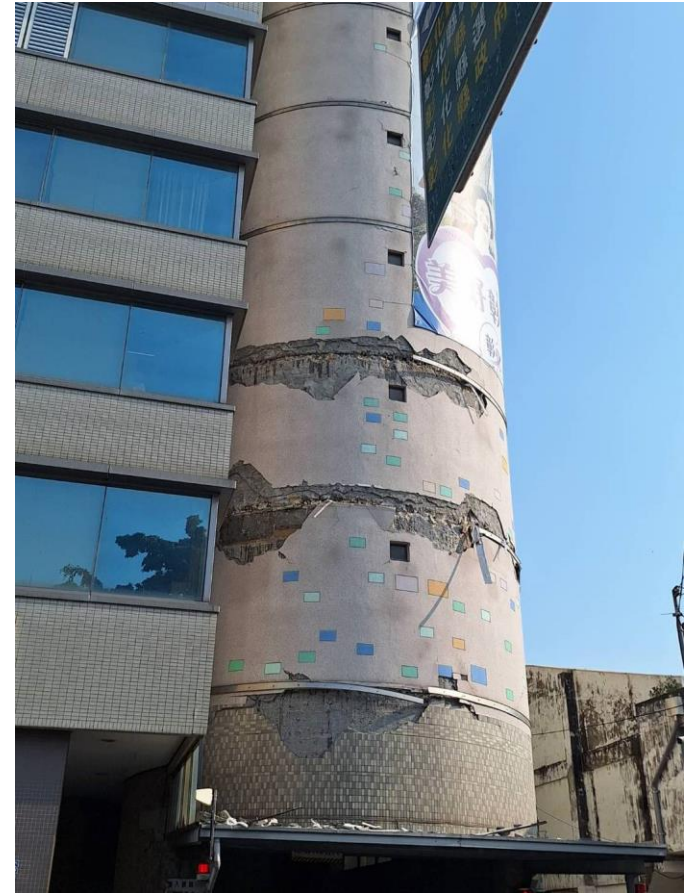
Office bldg.

Tiles fell off

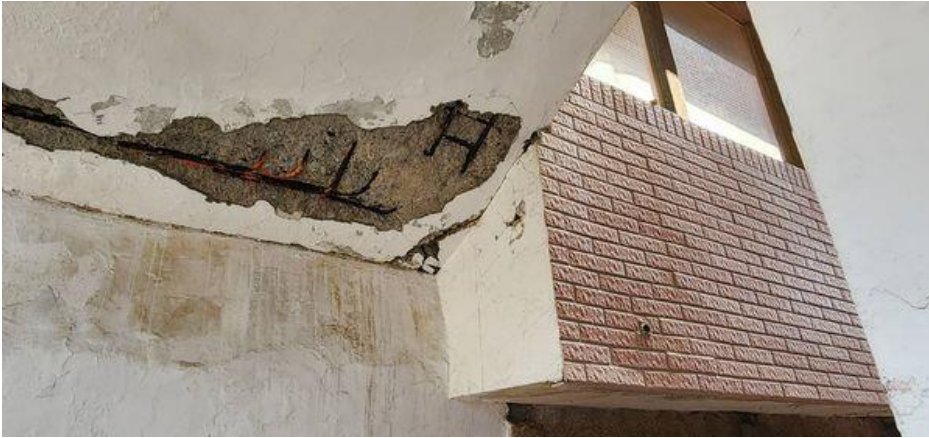
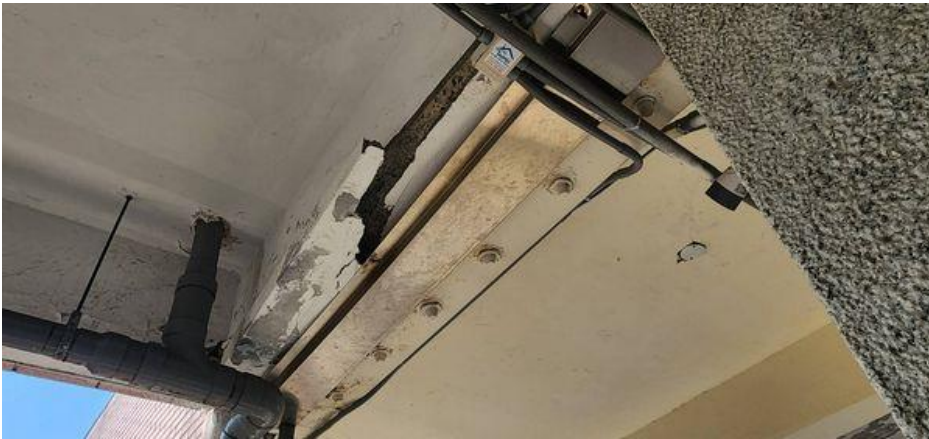
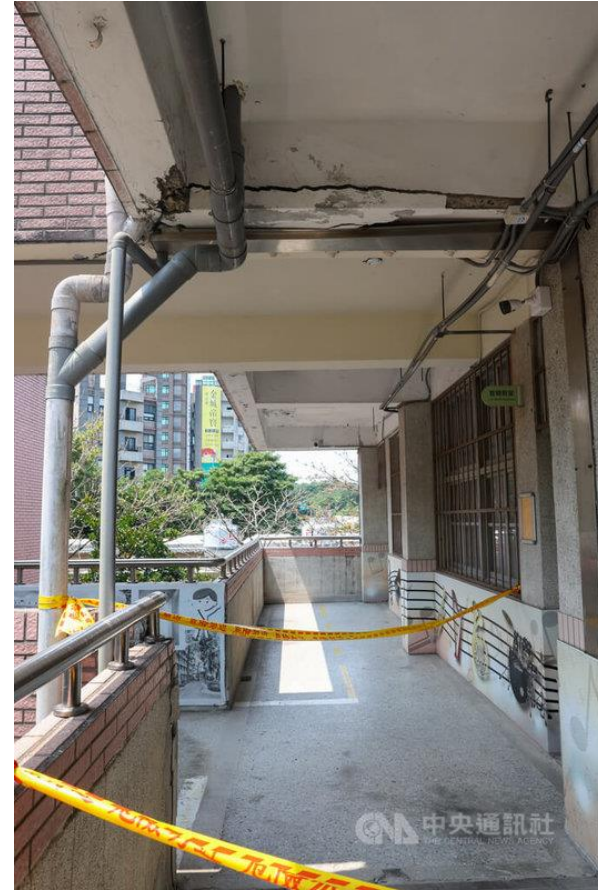
School bldg.

Building collision causing protection layer of concrete to fall

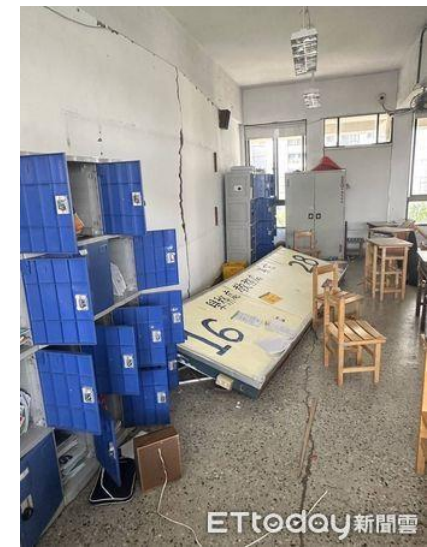
Cracks appear at the discontinuities in the building's structural facade, cracks appear in the floor, and the brick walls were convex and tilted.

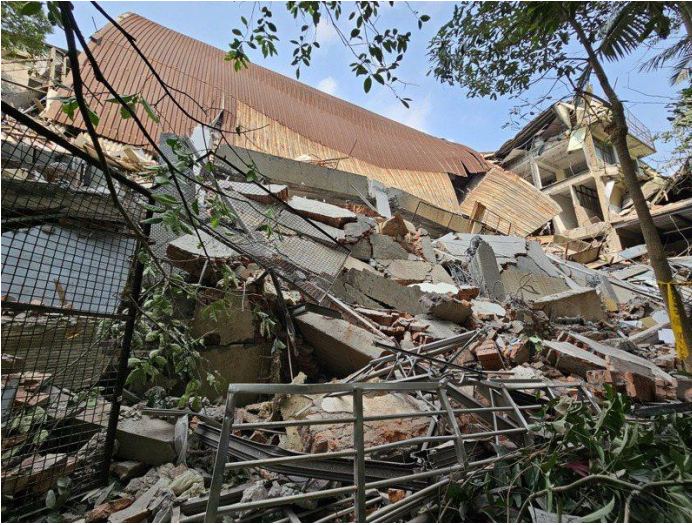
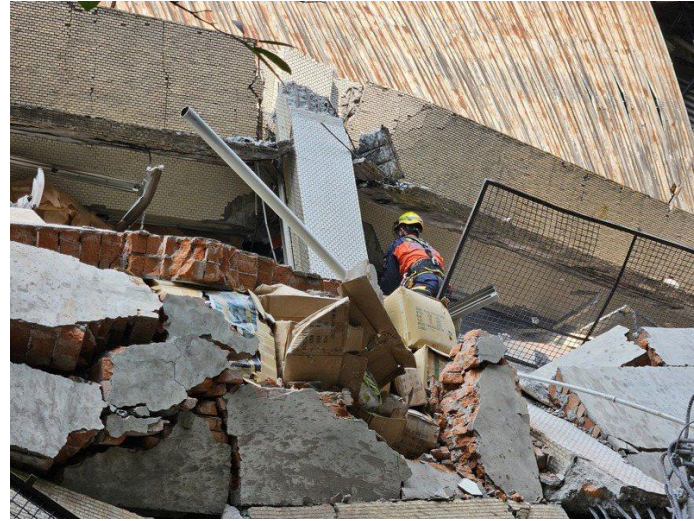
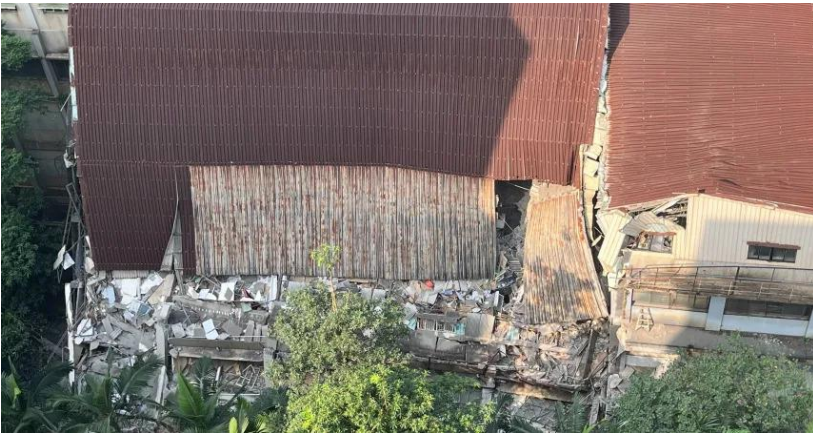
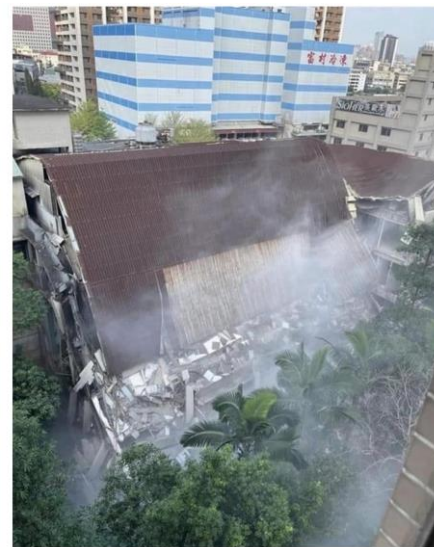
Zhonghe Dist., New Taipei City

**The rear half of the 5-story factory
storehouse collapsed**

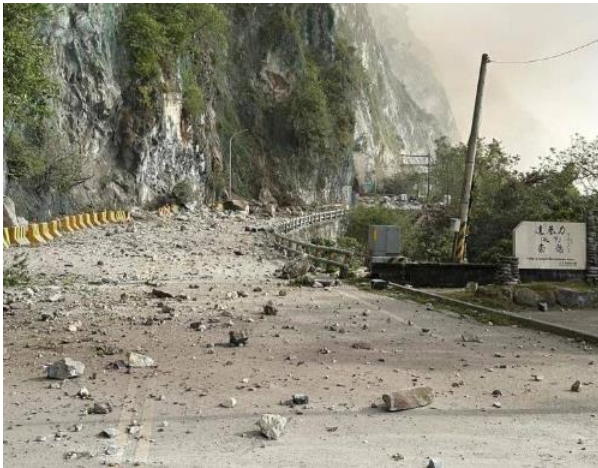
- Severe landslides occurred along Suhua Highway. Massive rock blocked the entrance of the Chongde Tunnel. The loss of roadbed occurred about 30 m in front of the north entrance of Daqingshui Tunnel; the roadway entirely disappeared.

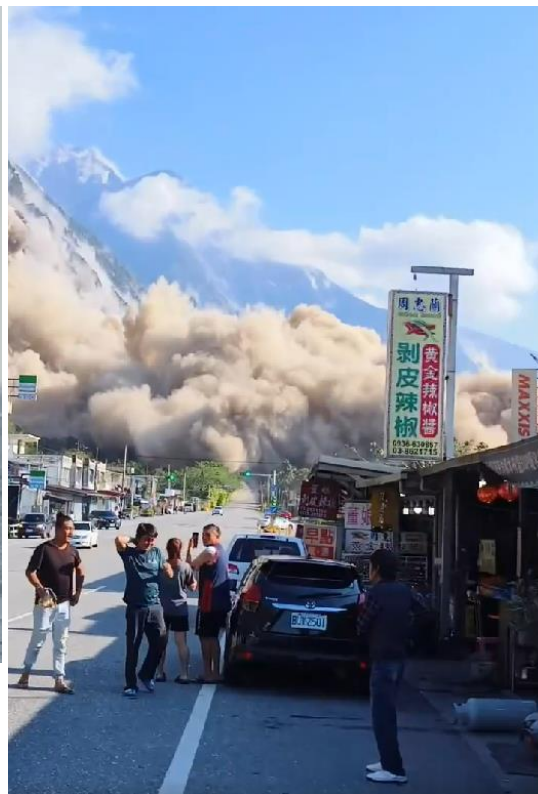
- Severe landslide events occurred at multiple mountains caused transportation disruptions of highways and railways.
- Guishan Island
- Mt. Chongde, Hualien
- Kangle Village, Xincheng, Hualien

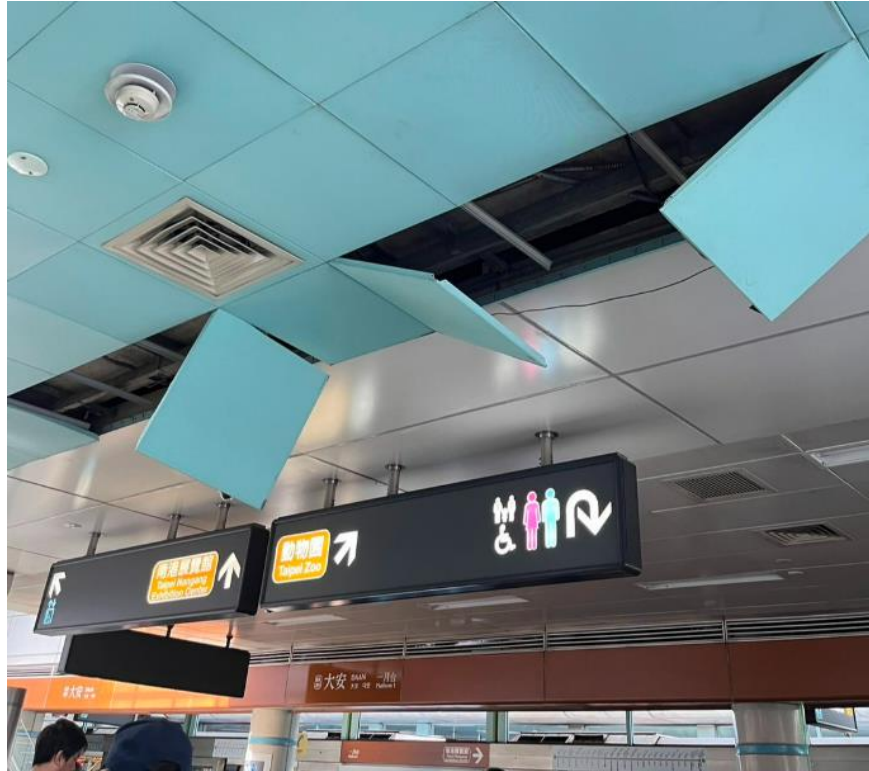
3. Taipei MRT Daan Station

Some ceiling panels were dislodged or even fell down at Taipei MRT Daan Station.

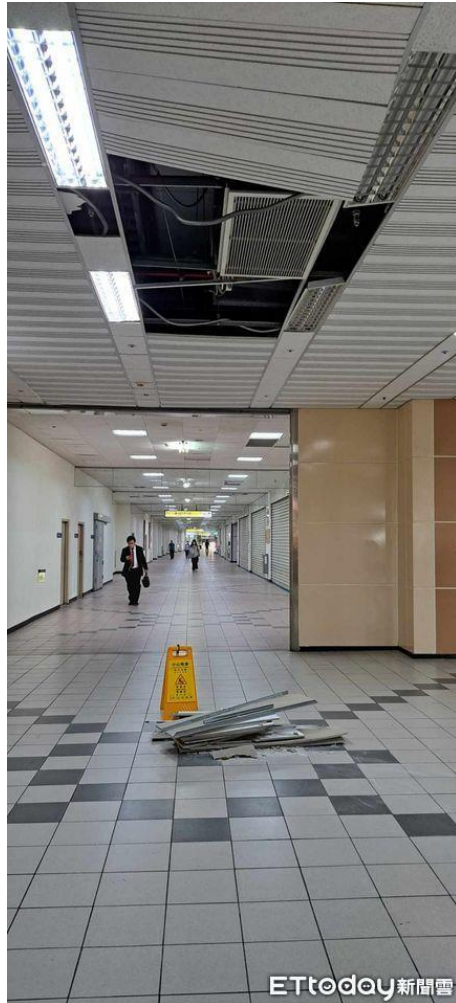
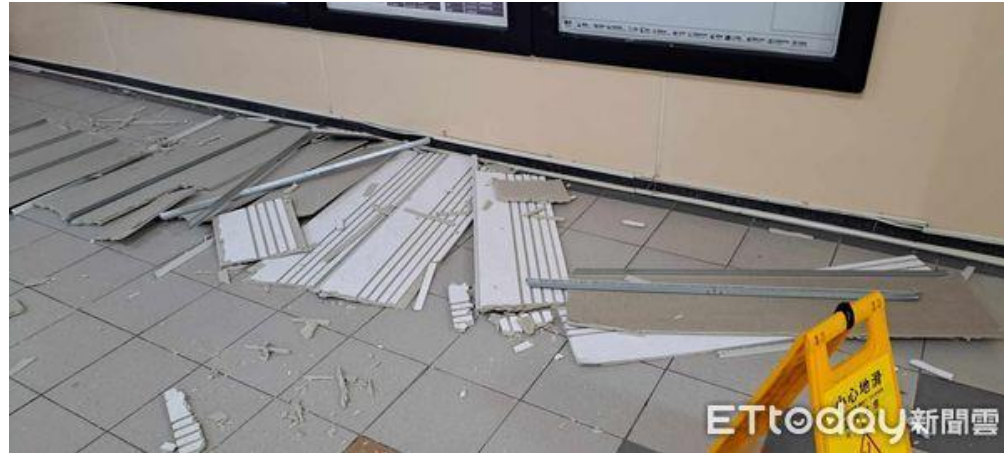
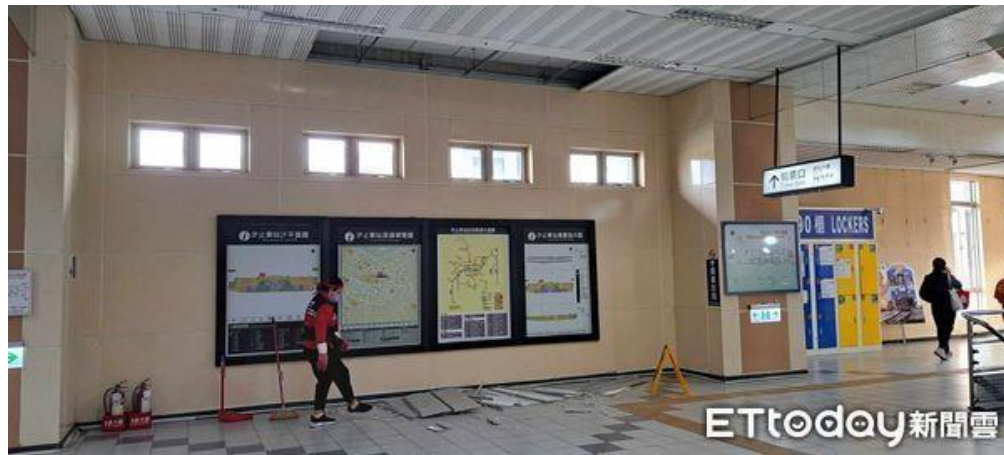
4. Taiwan Railway (TR) Xizhi Station

Ceiling panels and grids fell down in the lobby of TR Xizhi Station in New Taipei City.

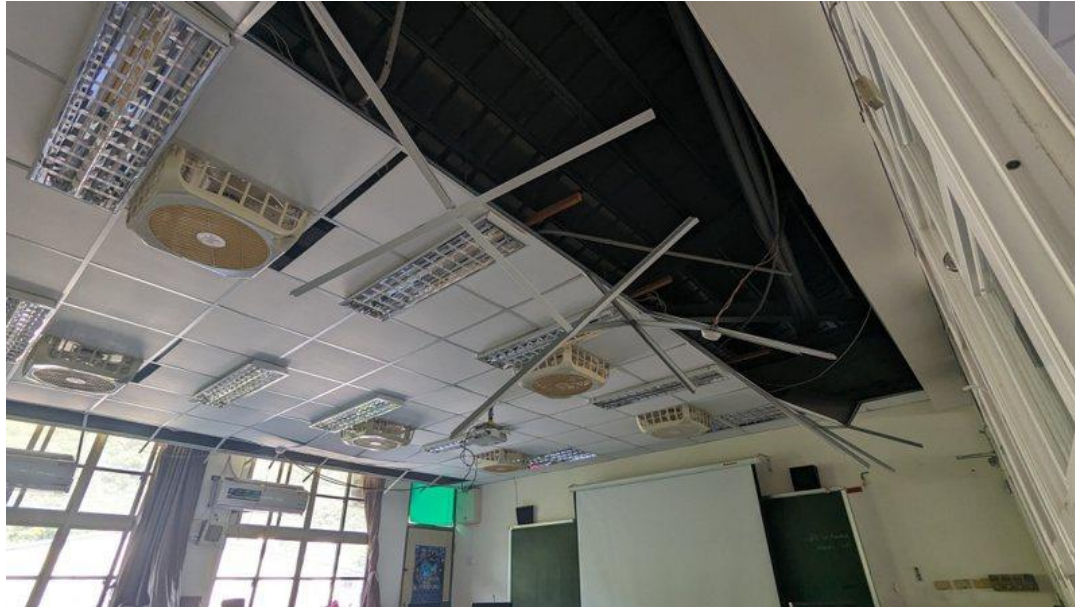
5. Suao Elementary School

Some ceiling panels and grids were dislodged or even fell down in the fourth-floor classrooms of Suao Elementary School in Suao Township of Yilan County.

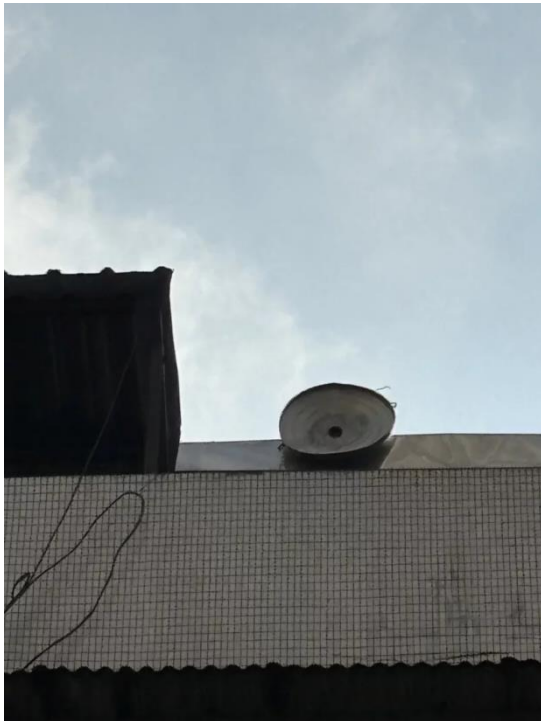
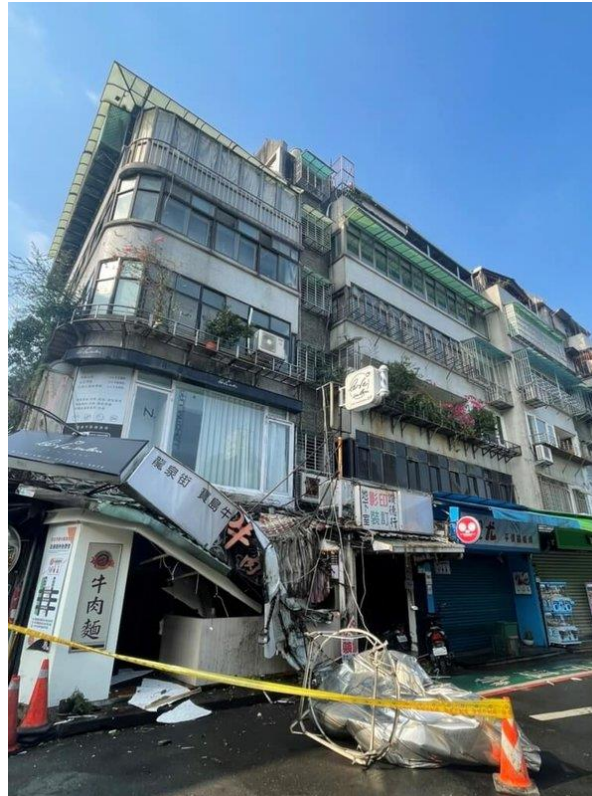
8. Residential buildings in Taipei City

A water tank collapsed at the top of the residential building on Kangle Street in Neihu District of Taipei City.

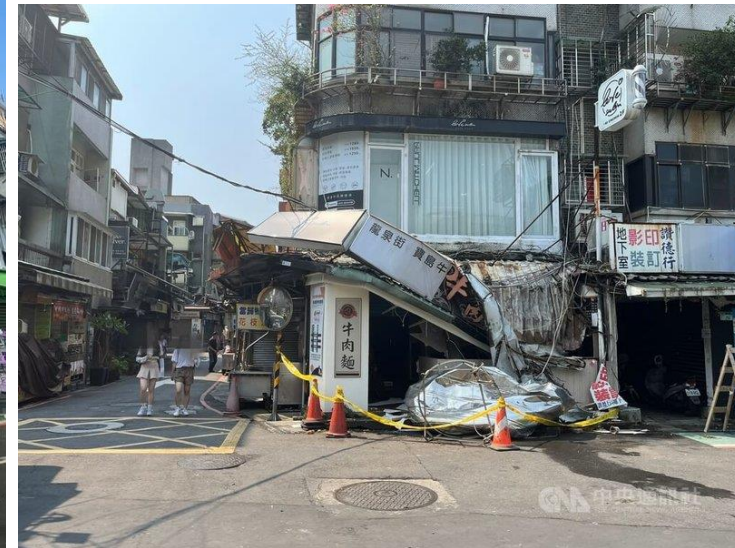
A water tank dropped from the top of the building in Daan District of Taipei City.
