Reconnaissance Report on Seismic Damage Caused by Guanshan Earthquake and Chihshang Earthquake, Taiwan, 2022 (third edition, v3.0)

Chung-Che Chou, Chiun-Lin Wu, Juin-Fu Chai, George C. Yao

**NCREE, Taiwan
September 23, 2022**

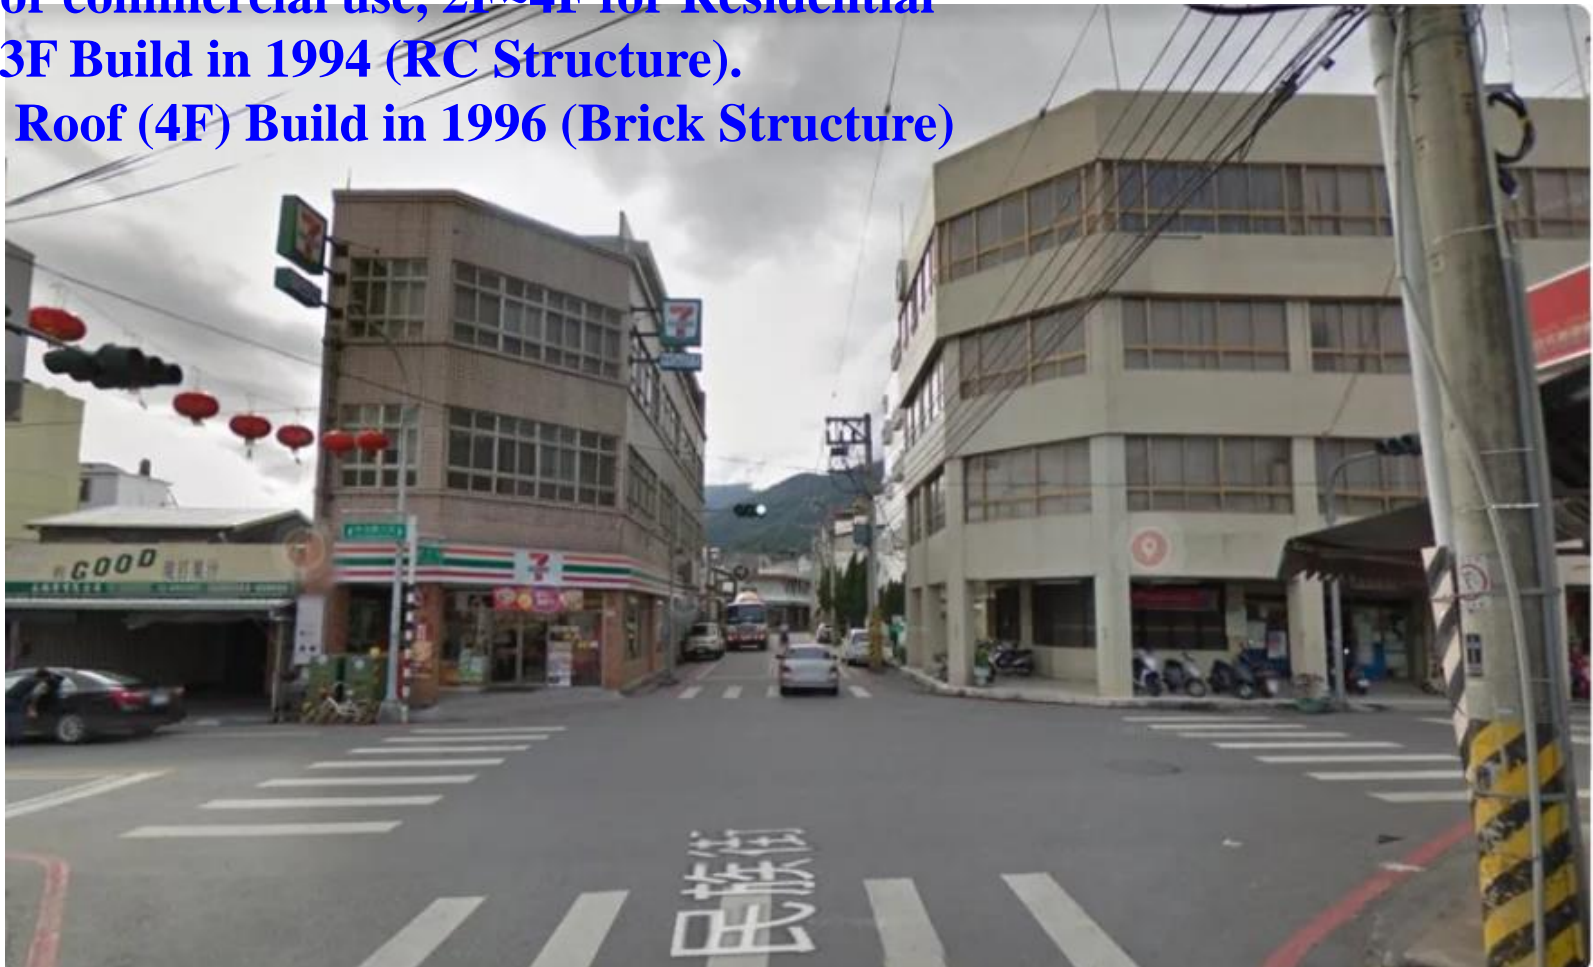
- Reinforced Concrete (RC) Structure
- 1F for commercial use, 2F~4F for Residential
- 1F~3F Build in 1994 (RC Structure).
- The Roof (4F) Build in 1996 (Brick Structure)

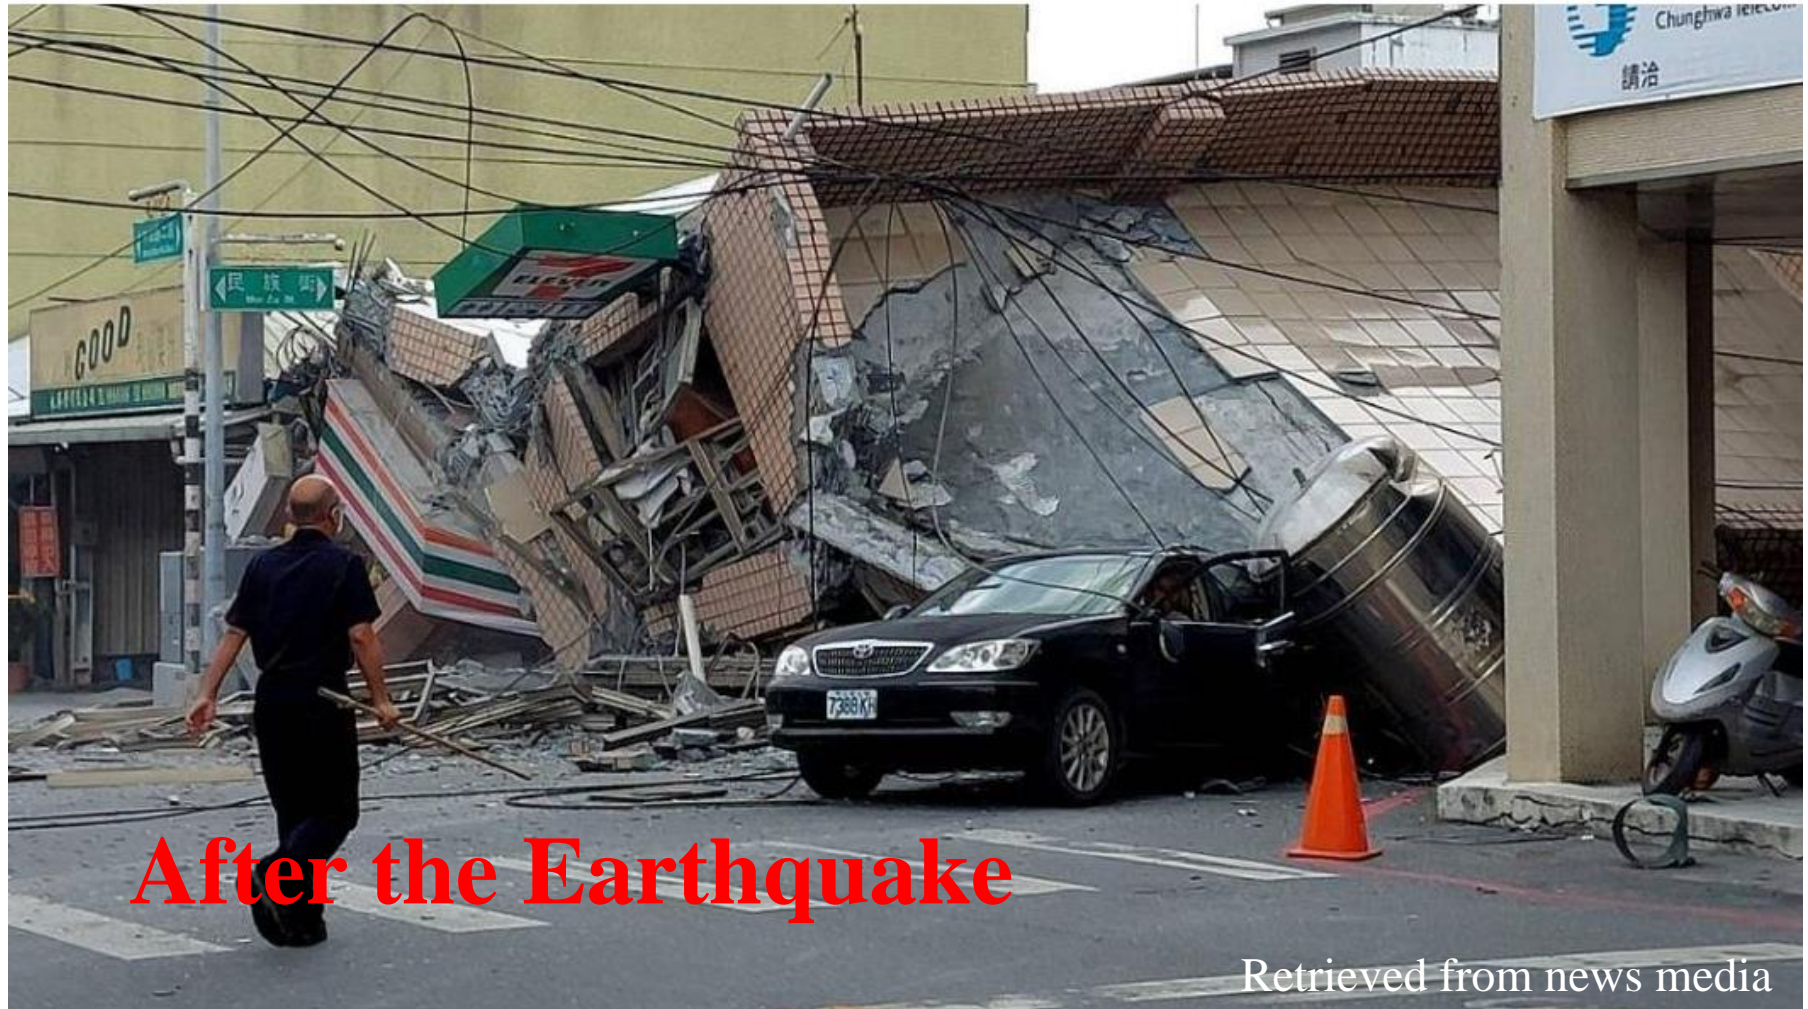
Yuli 7-11 convenience store

Collapse along the transverse direction

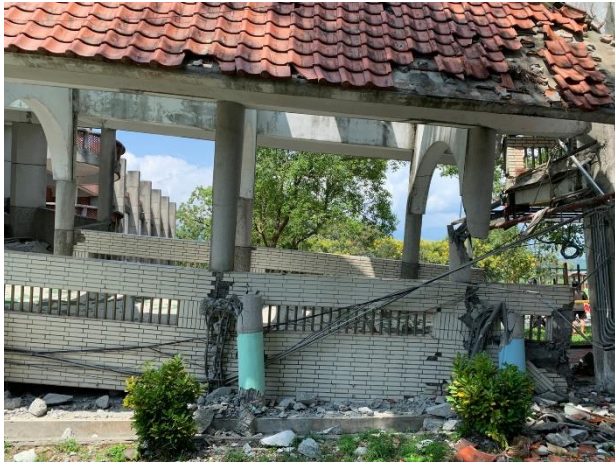
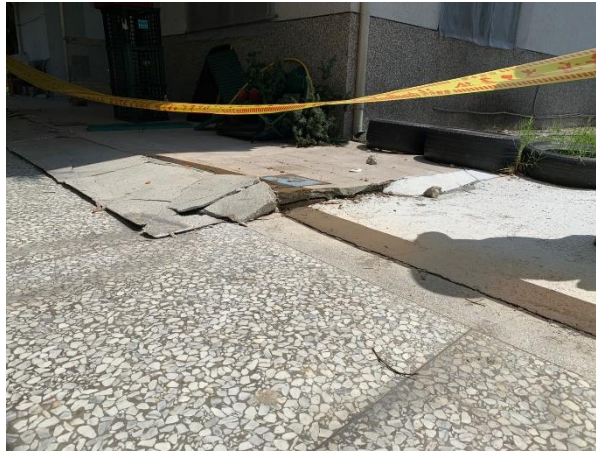
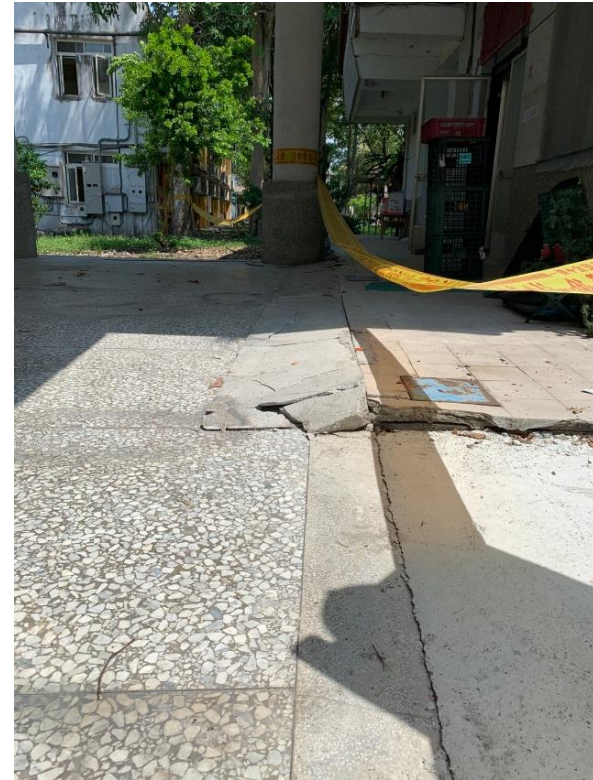
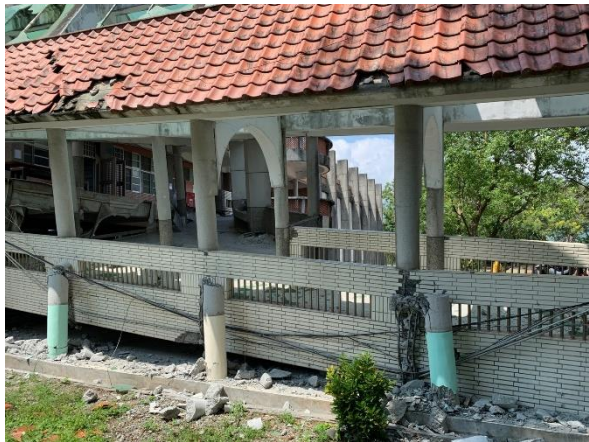
Chun-Rih Elementary School (春日國小)

- The building did not collapse when the M_L 6.4 earthquake occurred on 9/17.
- The M_L 6.8 earthquake on 9/18 caused the collapse of the connecting corridor, and the entire wall was tilted.
- There are many cracks in the kindergarten classrooms, toilets, and kitchens adjacent to the collapsed corridor.

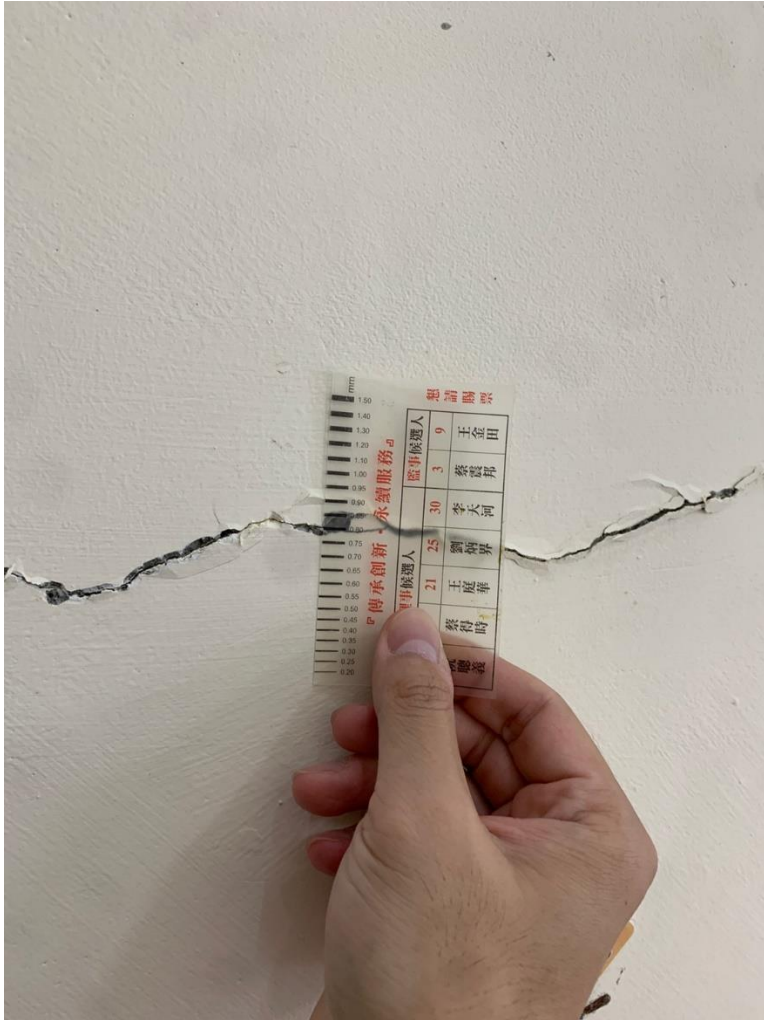
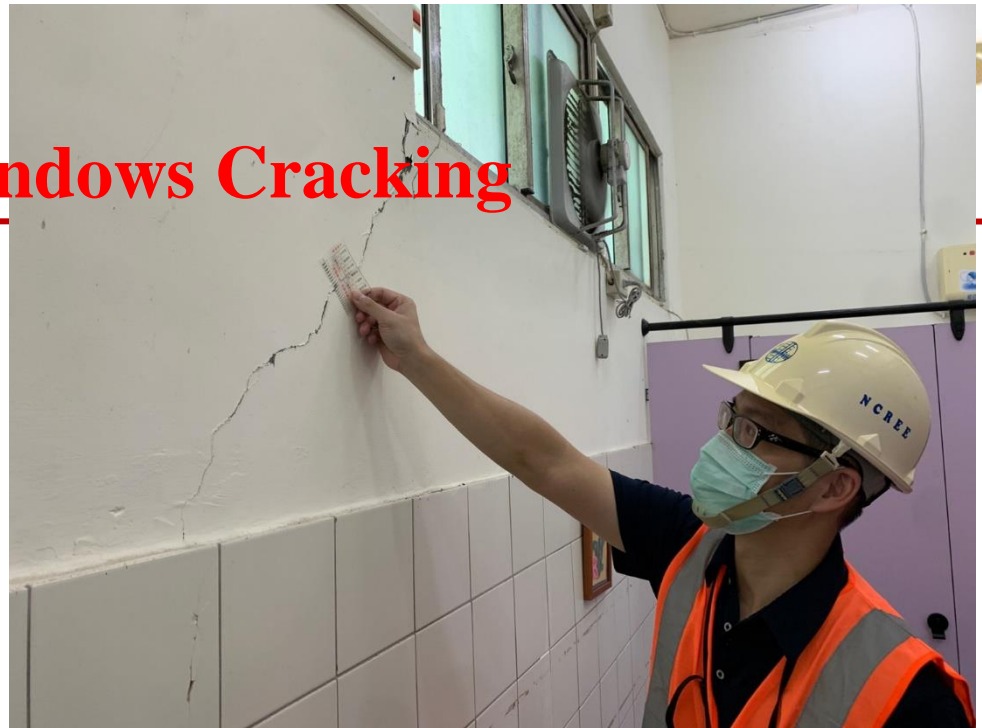
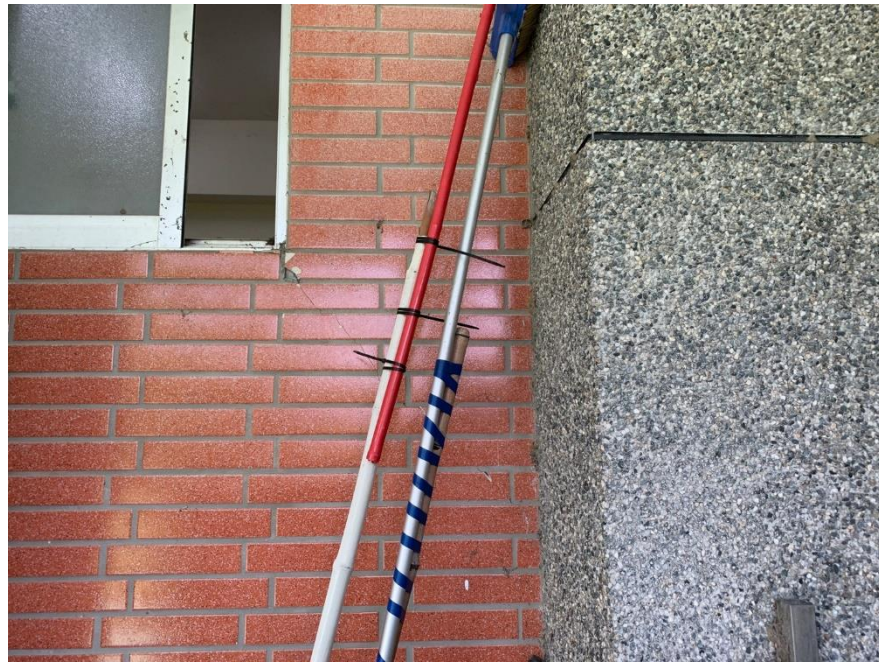
No. 212, Neighborhood 12, Yuli Township, Hualien County

● Ground Uplift

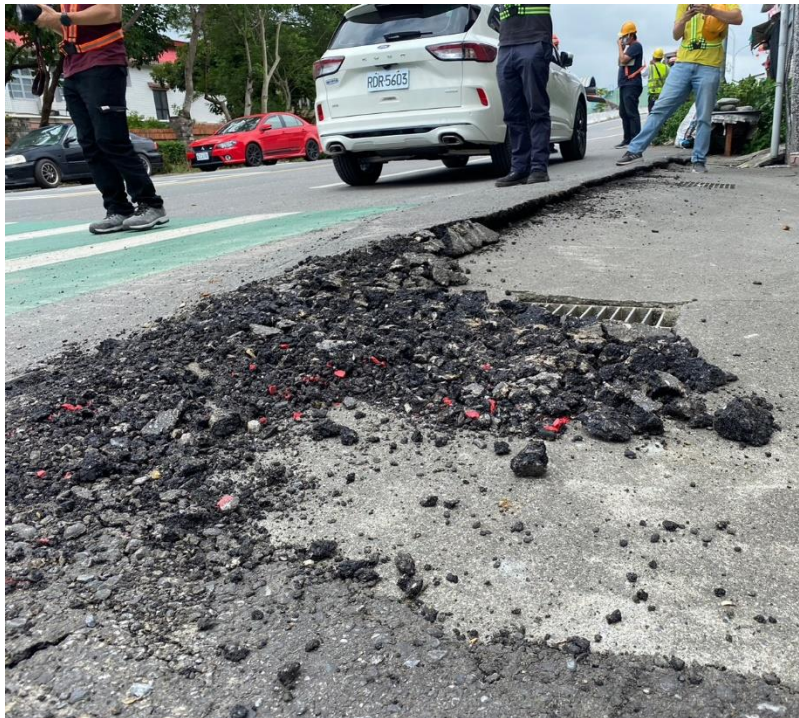
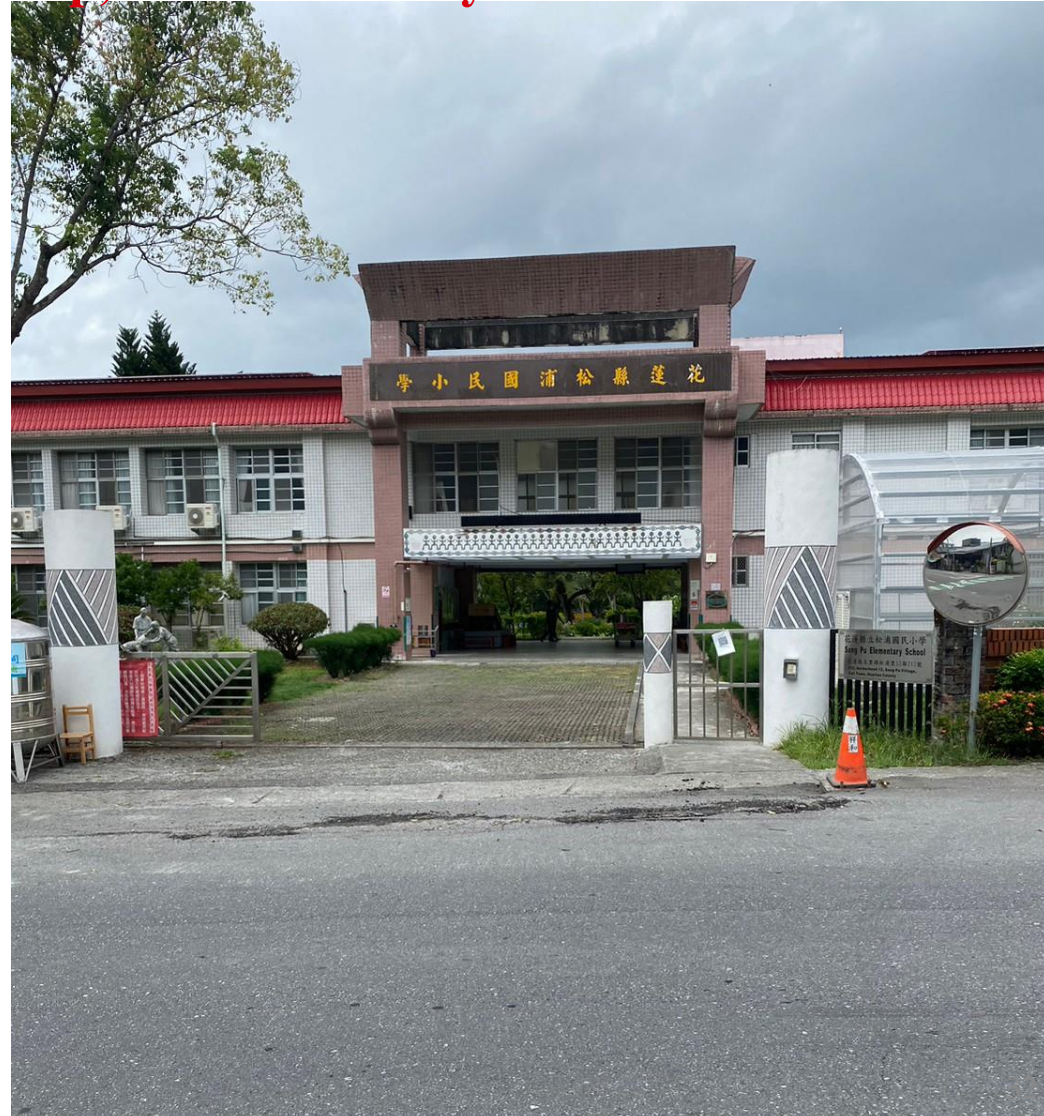
No. 174, Songpu, Yuli Township, Hualien County

- Ground Uplift about 20 cm
- Crack Length about 7 m
- Exterior Wall Sloping

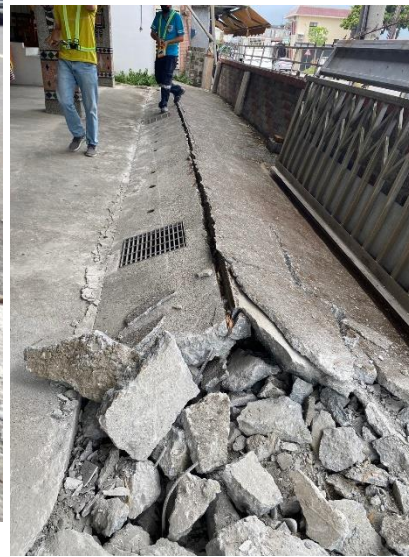
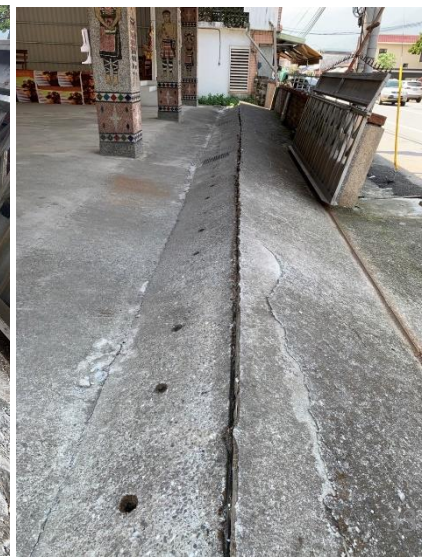
No. 167, Songpu, Yuli Township, Hualien County

- Ground Uplift, and Slope about 2° ~ 14°
- Wall Sloping (about 2°)

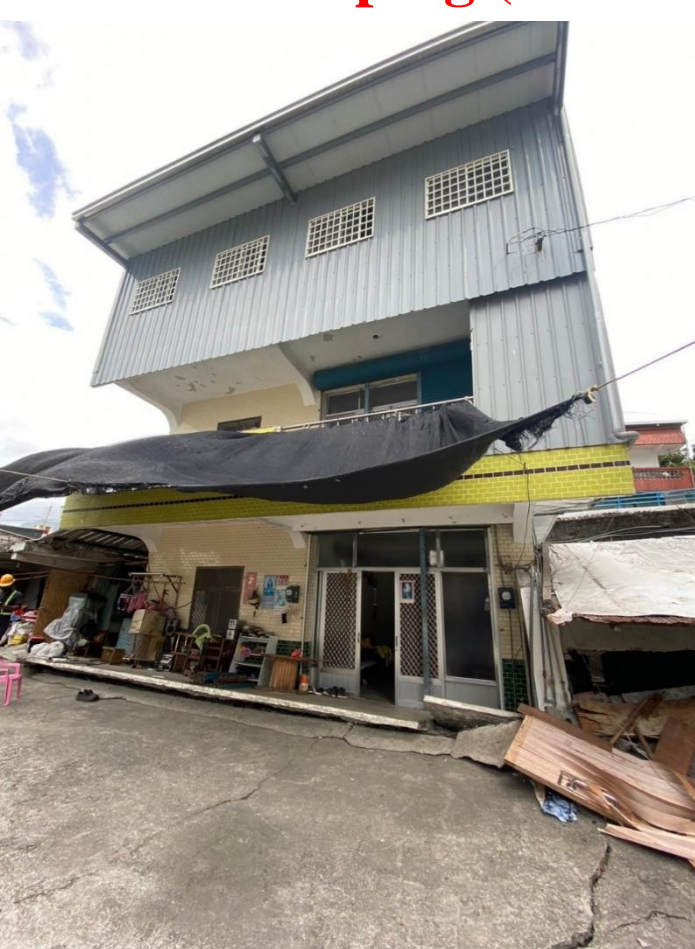
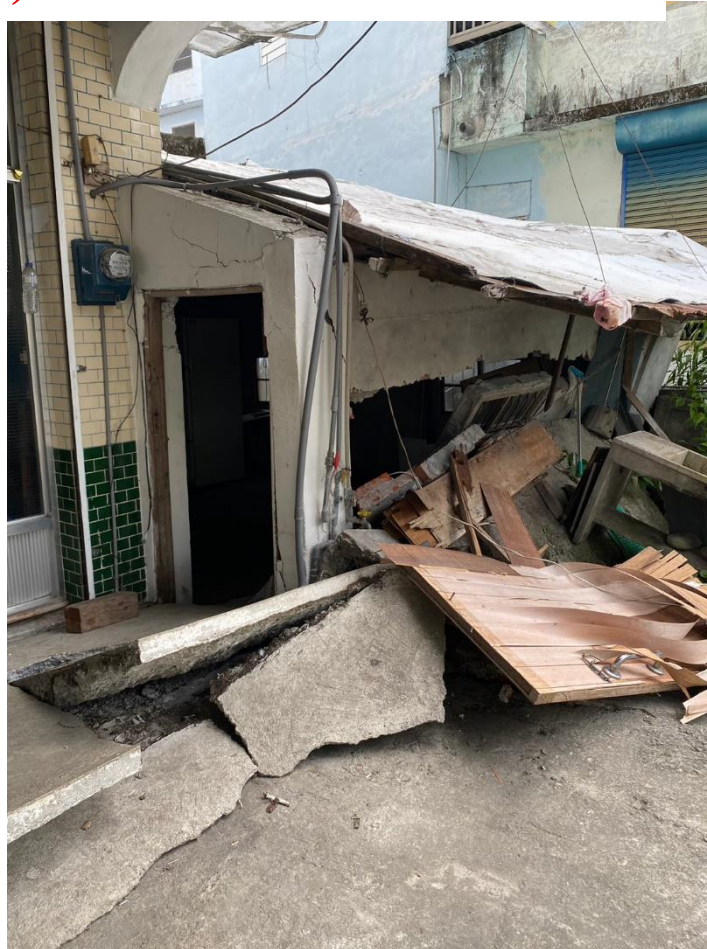
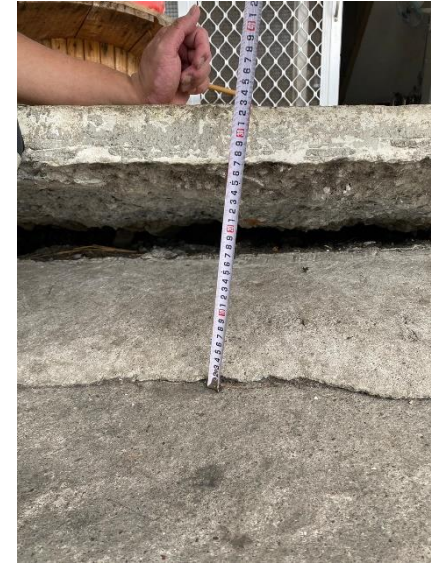
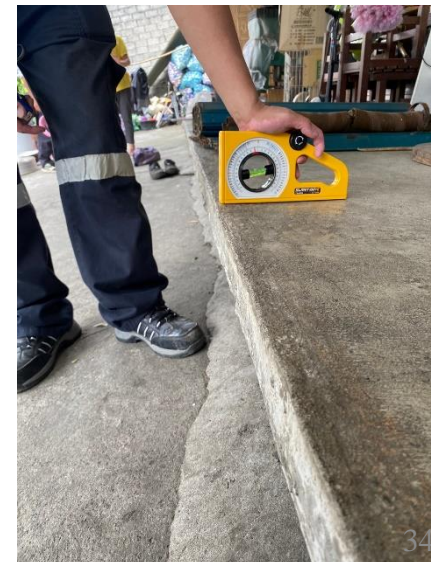
No. 140, Songpu, Yuli Township, Hualien County

- Ground Uplift, Cracking, and Slope about 2°
- Brick Wall Collapsed

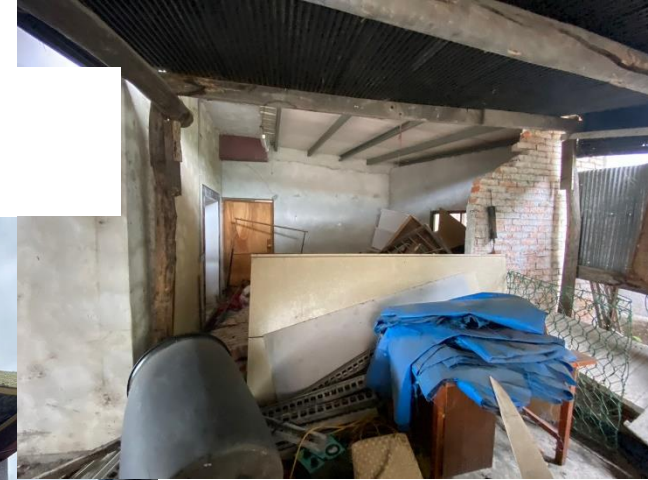
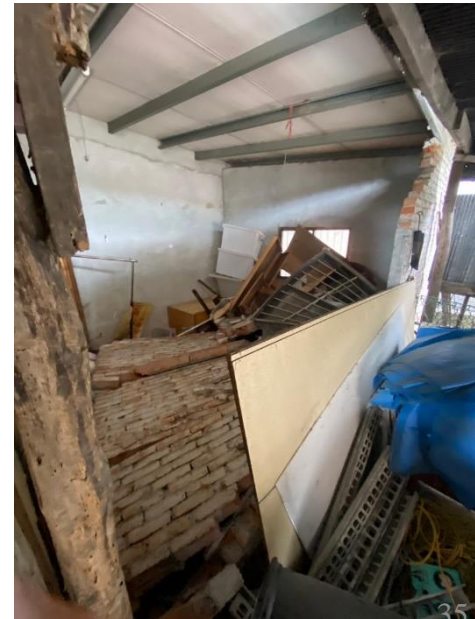
No. 141, Songpu, Yuli Township, Hualien County

- Ground Uplift
- Plastic Hinge in Column
- Brick Wall Collapsed
- Rebar rusted

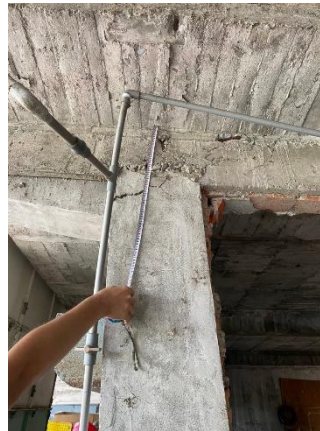
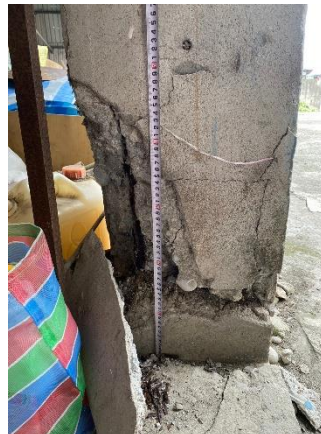
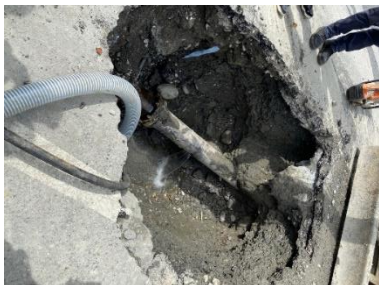
No. 172, Songpu, Yuli Township, Hualien County

- Ground Uplift
- Brick Wall Sloped about 8°

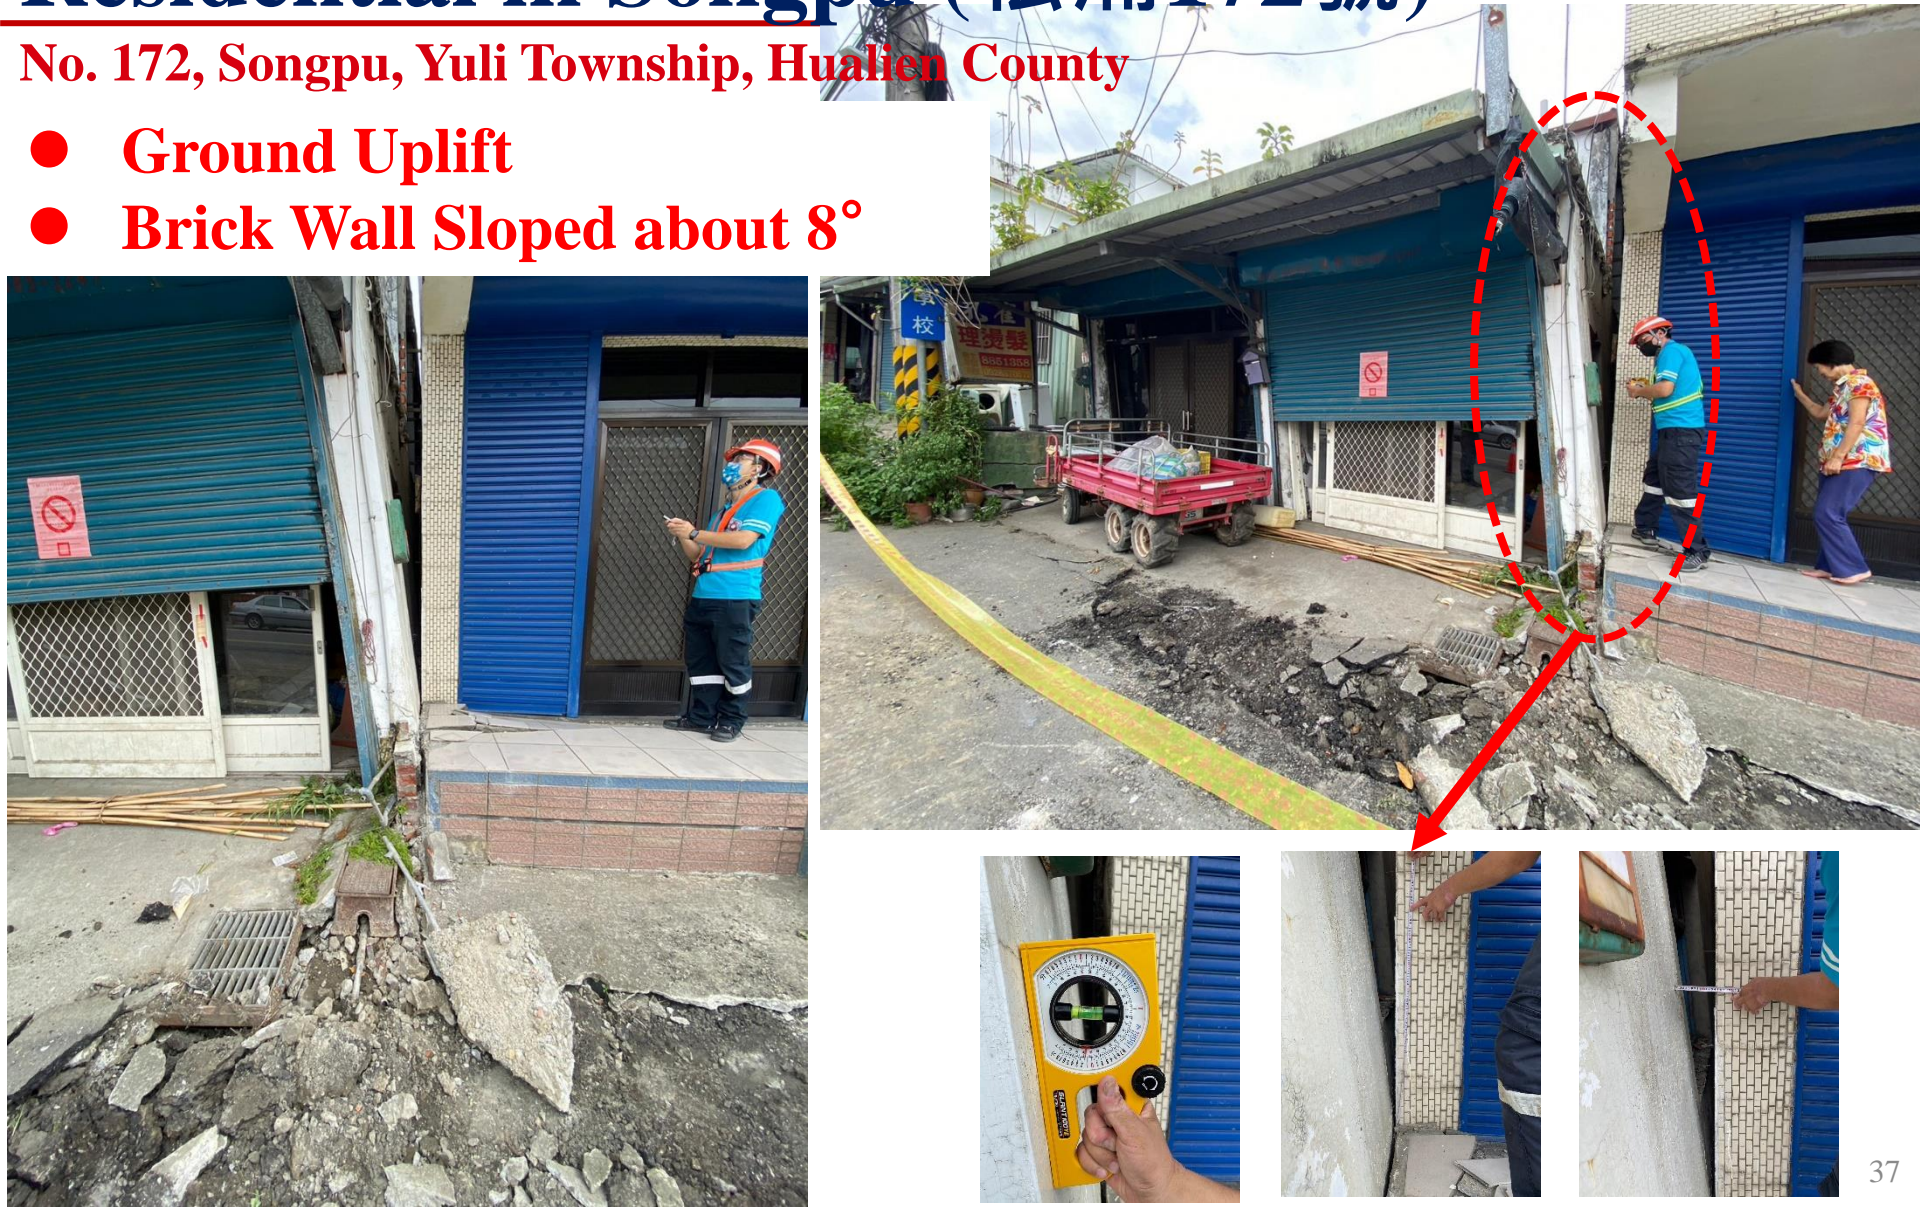
No. 143, Wanli, Yuli Township, Hualien County

- 1F for commercial use, 2F for Residential
- Exterior Cracking, Brick Wall Collapsed

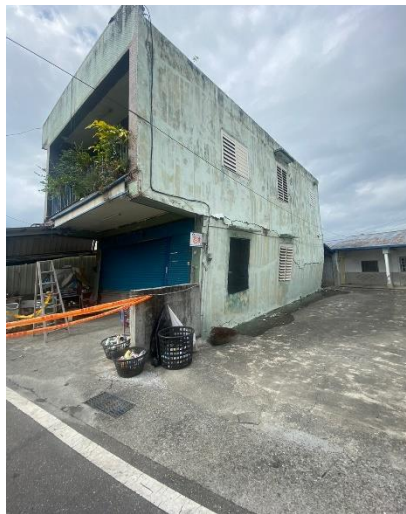
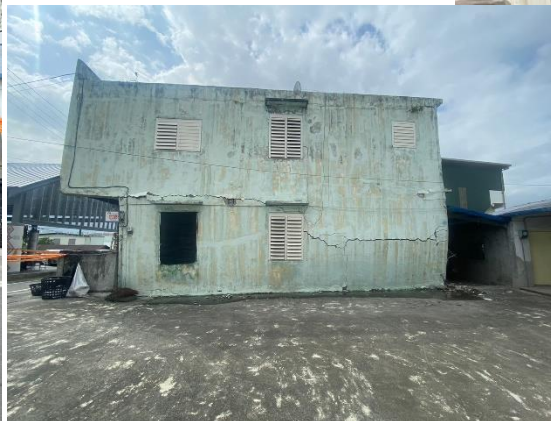
No. 145, Wanli, Yuli Township, Hualien County

- Wood Structure
- Ground Uplift

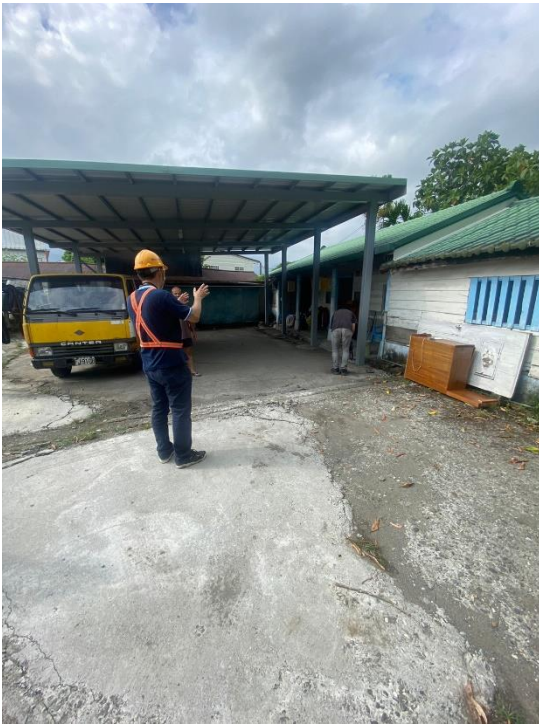
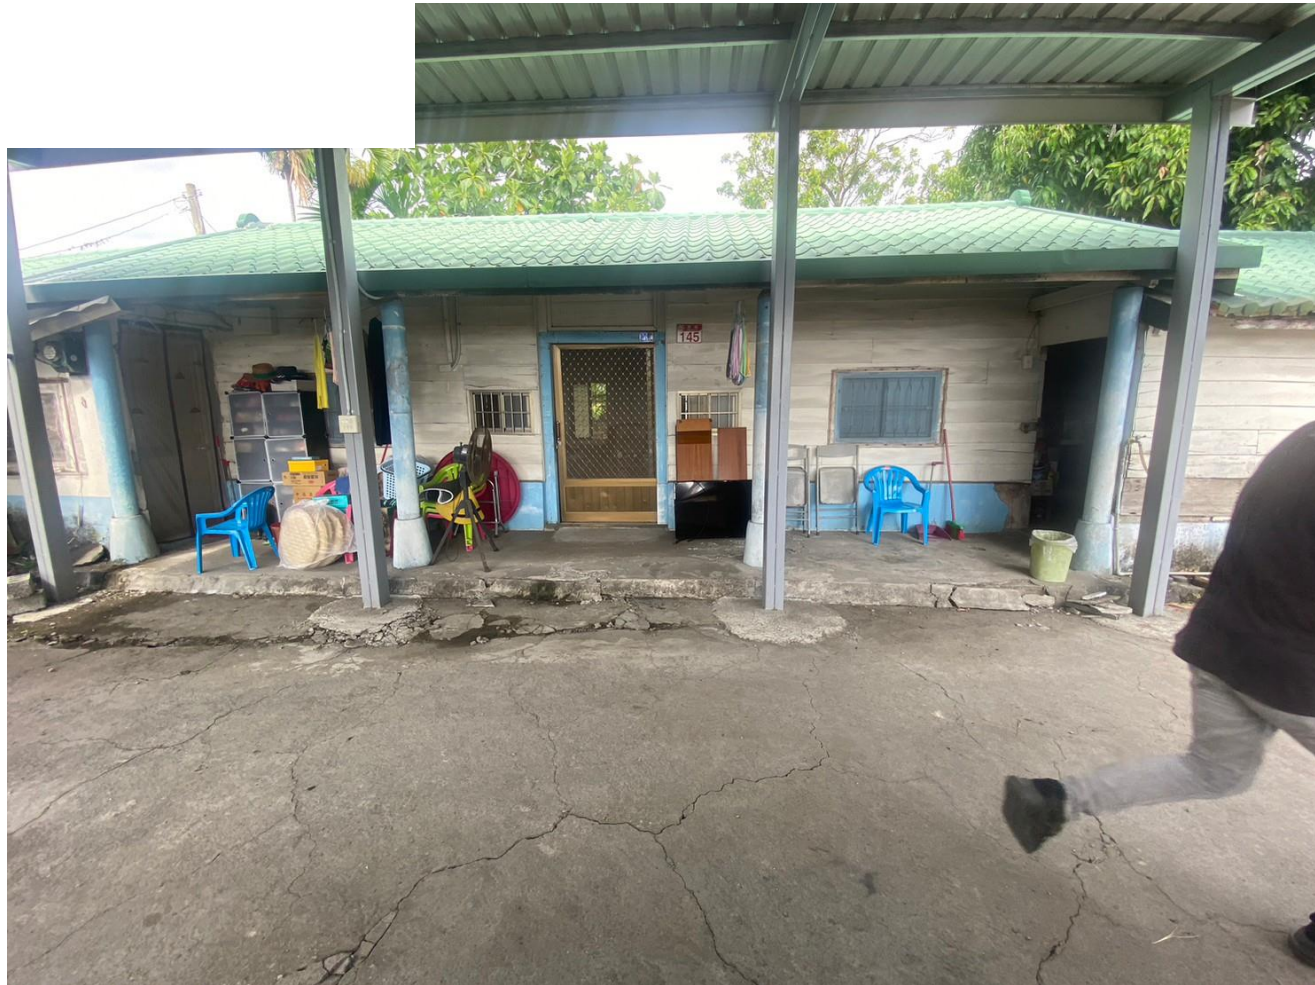
No. 148, Wanli, Yuli Township, Hualien County

- The uplift of the ground raises the structure about 5 cm

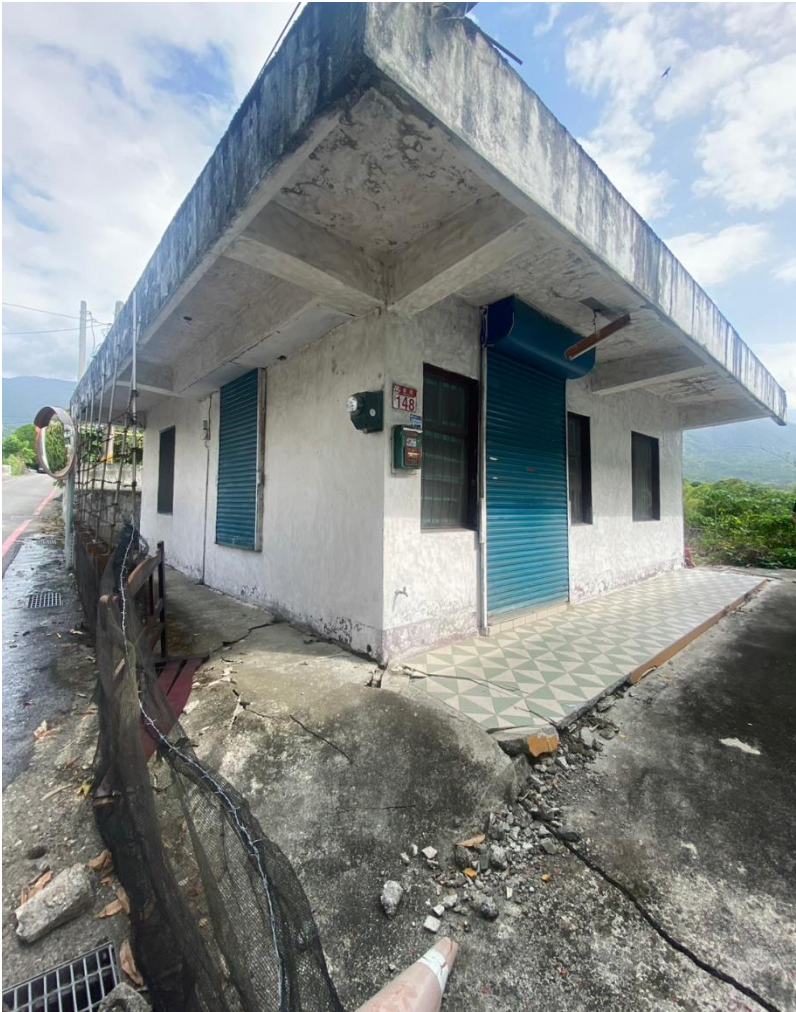
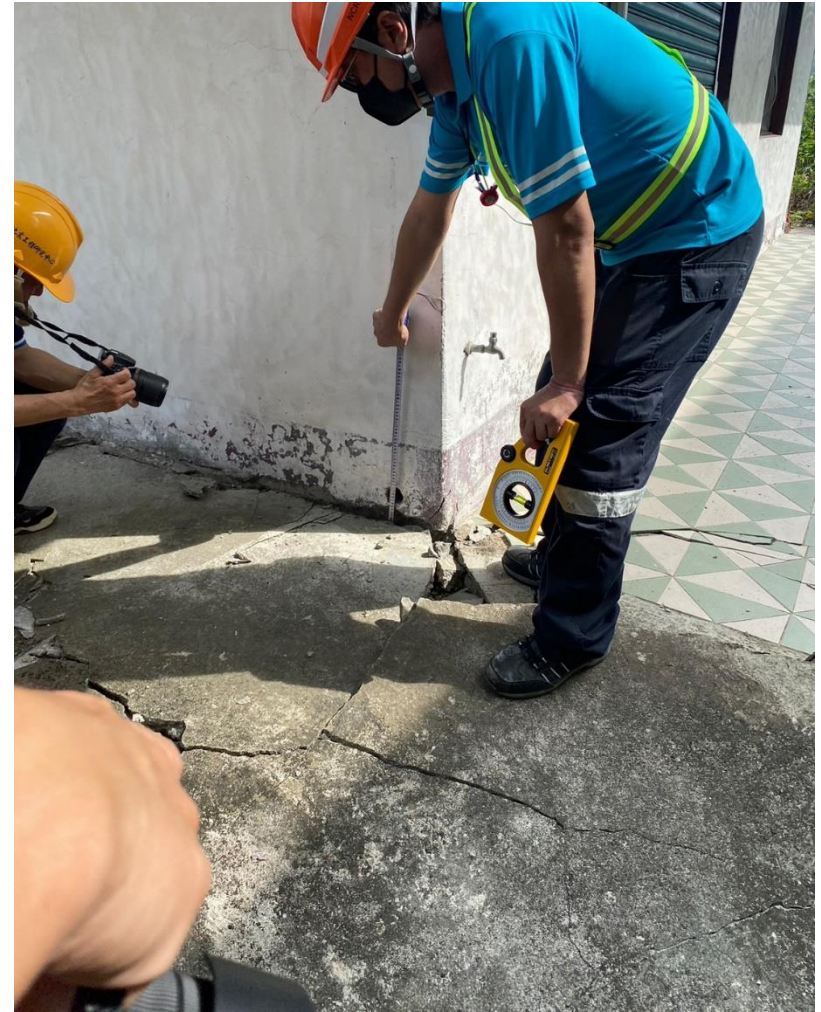
No. 112, Wanli, Yuli Township, Hualien County

● Ground Uplift and Cracking

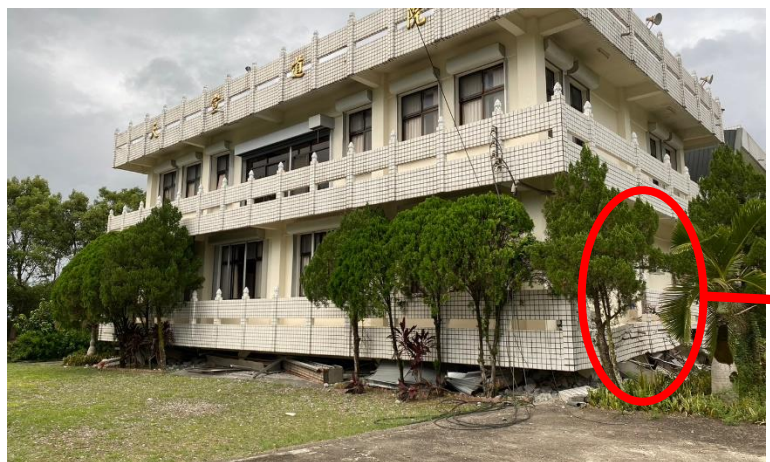
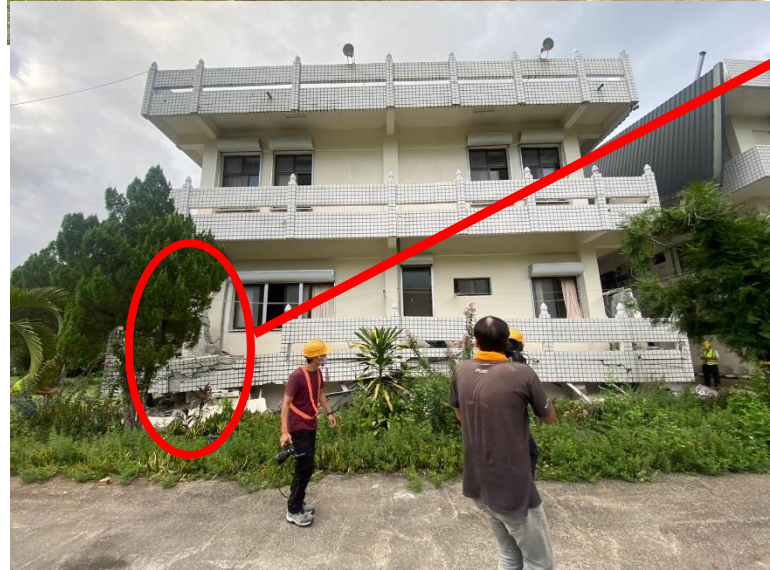
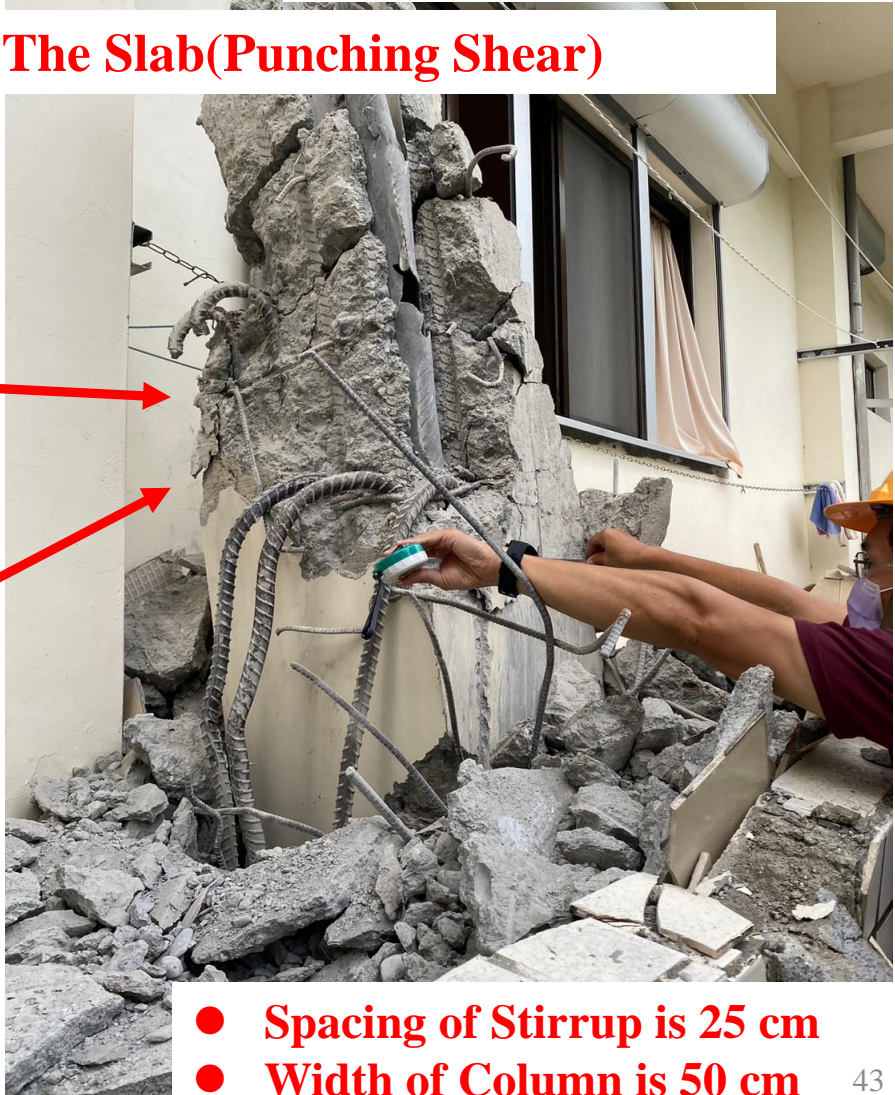
- Longitudinal Rebar is #8
- Transverse Rebar is #3

● The First Floor Column Runs Through The Slab(Punching Shear)

- Spacing of Stirrup is 25 cm
- Width of Column is 50 cm

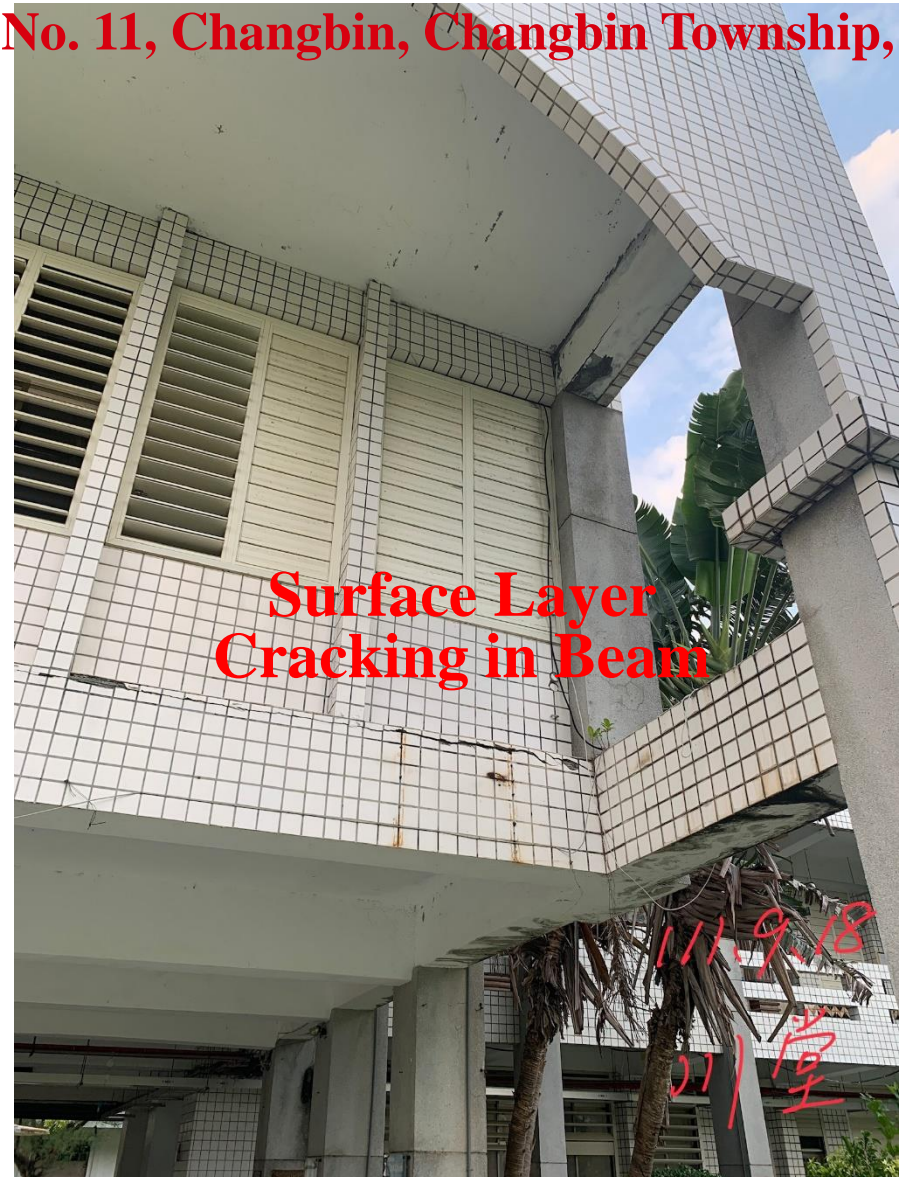
Zhangbin Elementary School (長濱國小)

Flexural Cracking in Beam

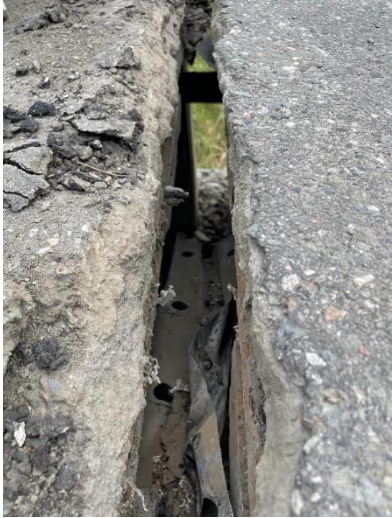
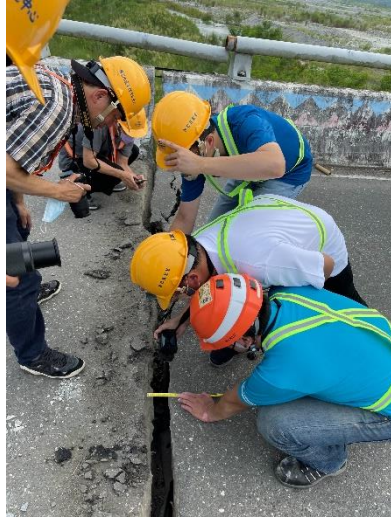
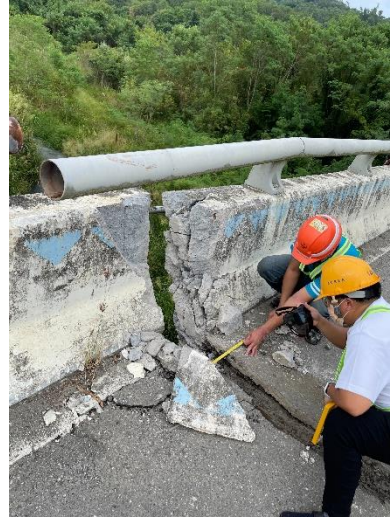
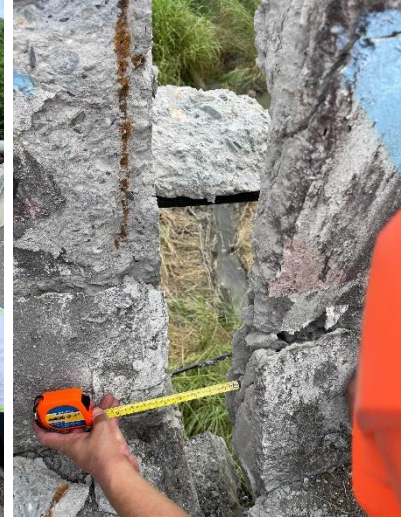
1. Baohua Bridge(2/2)

large displacement at expansion joint, support serious damage
