Reconnaissance Report on Seismic Damage Caused by Guanshan Earthquake and Chihshang Earthquake, Taiwan, 2022 (third edition, v3.0)

Chung-Che Chou, Chiun-Lin Wu, Juin-Fu Chai, George C. Yao

**NCREE, Taiwan
September 23, 2022**

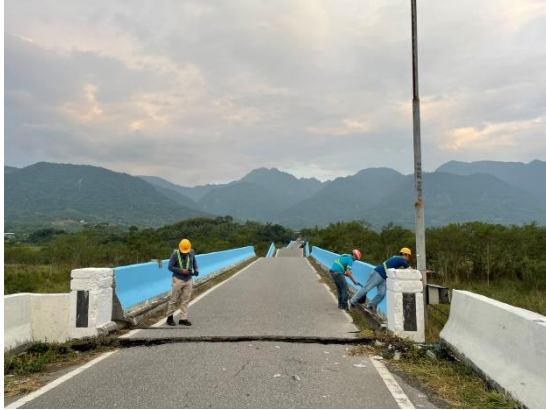
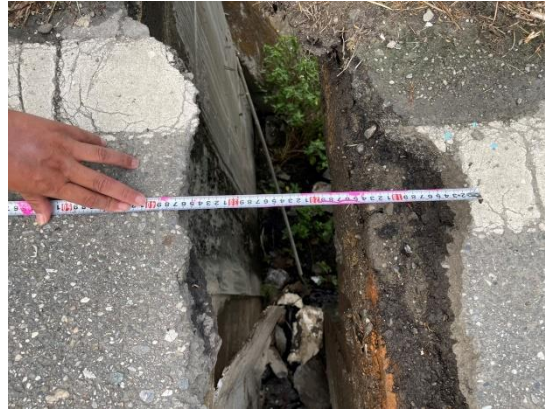
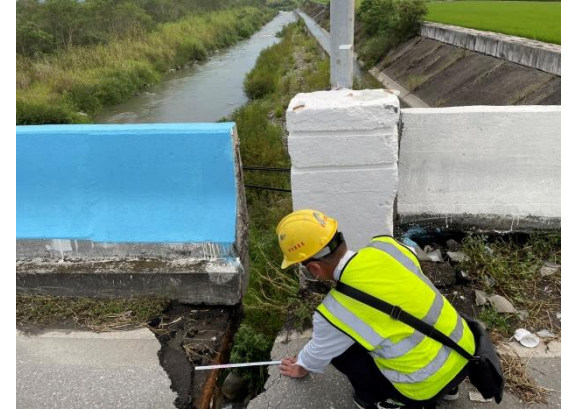
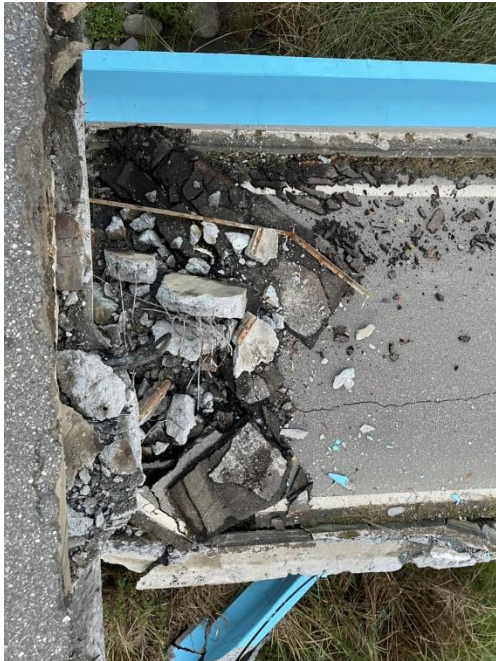
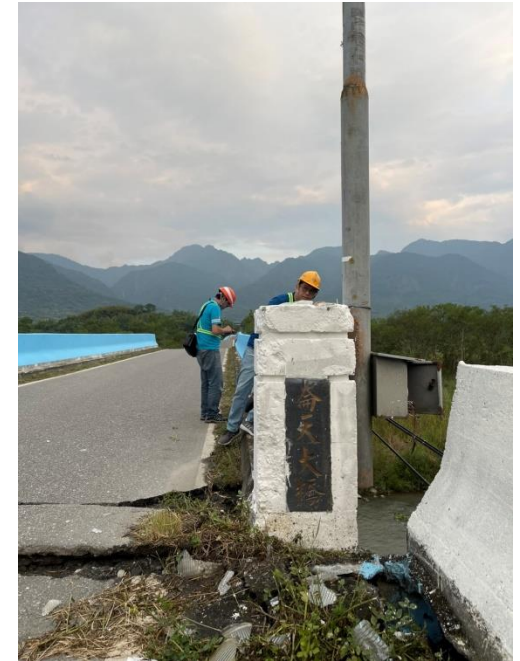
3. Luntian Bridge(2/3)

Bridge falling and large residual displacement

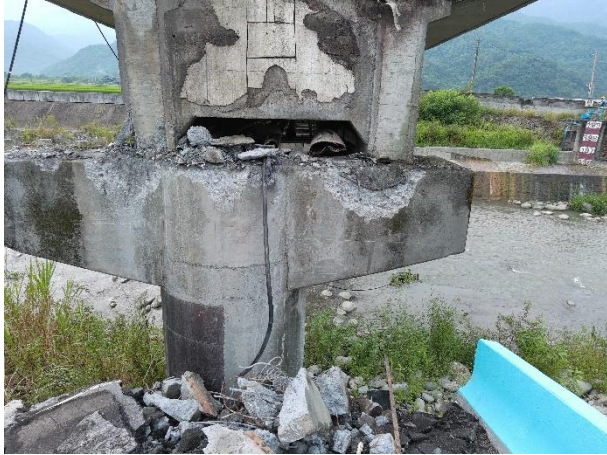
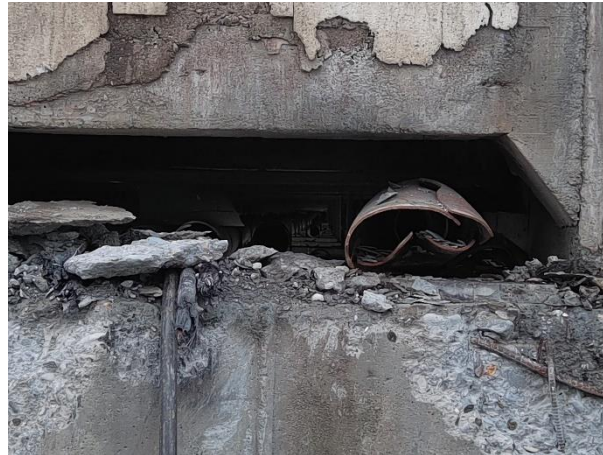
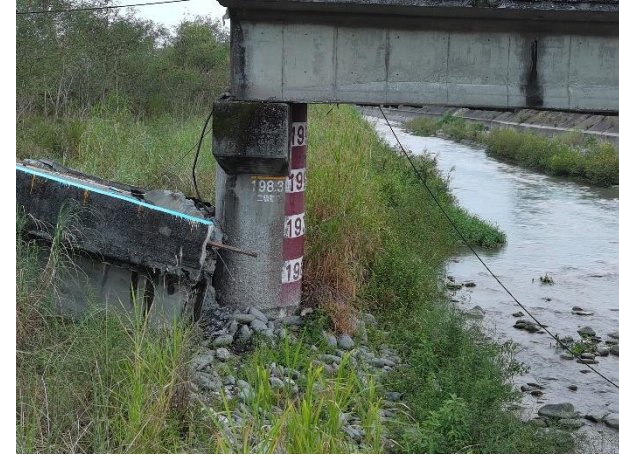
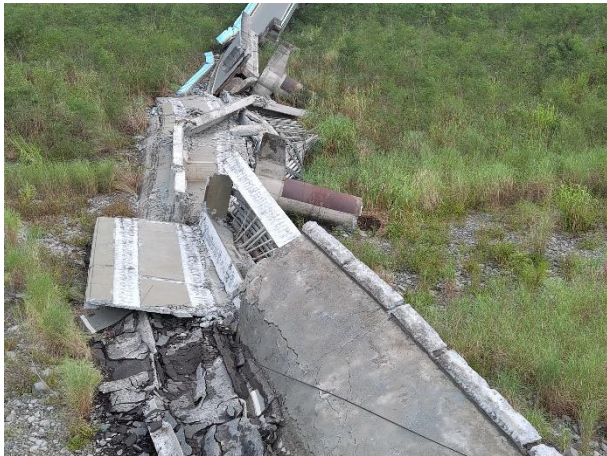
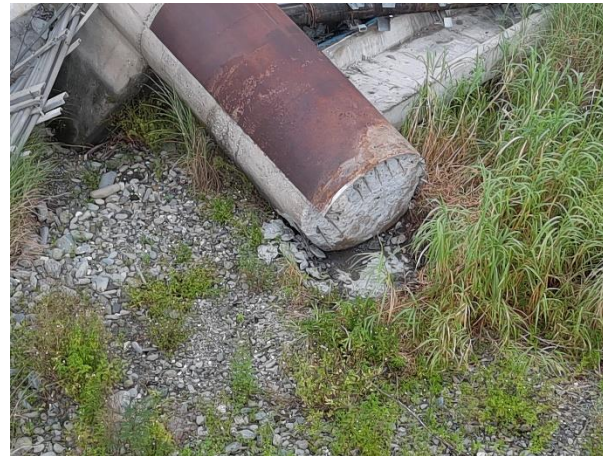
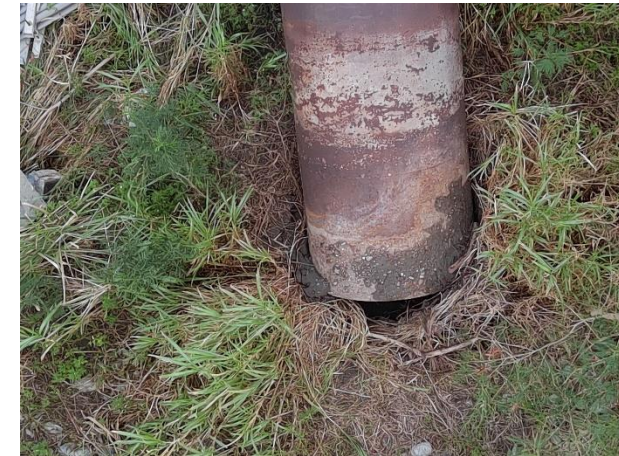
3. Luntian Bridge(3/3)

Bridge falling and bridge column fracture

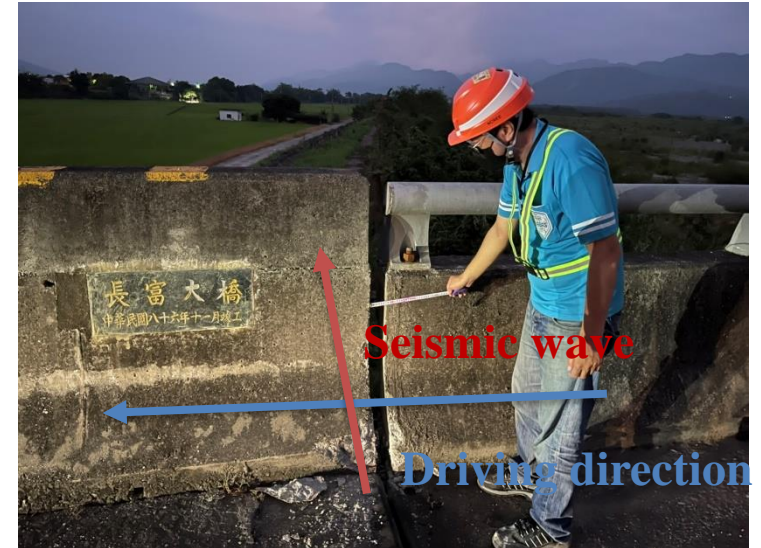
Large displacement at expansion joint

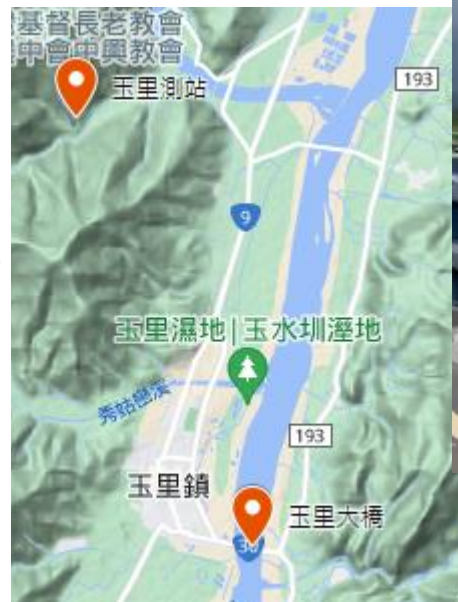
Damage at expansion joint

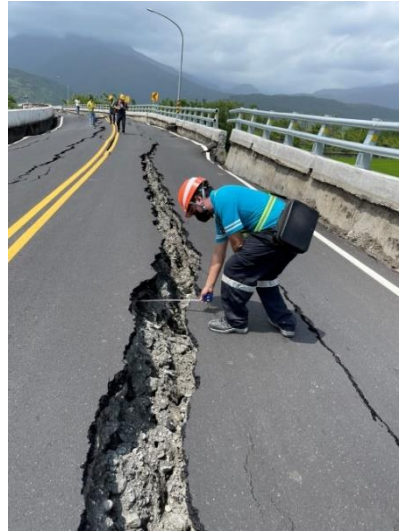
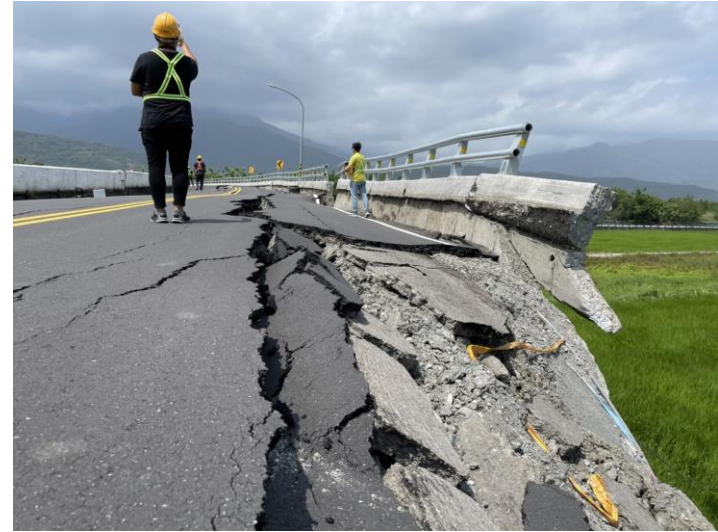
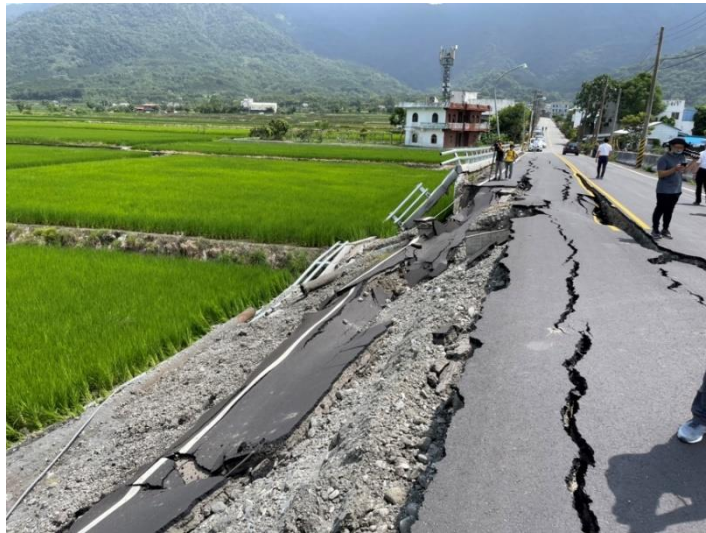
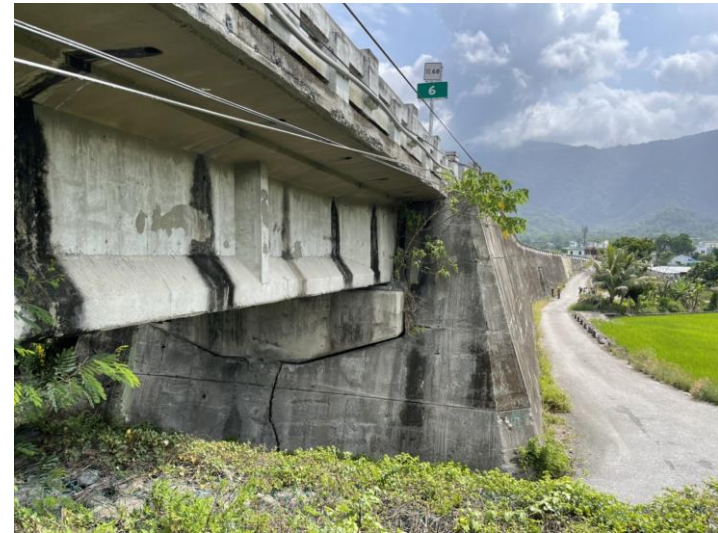
East Abutment : pavement and retaining wall collapse

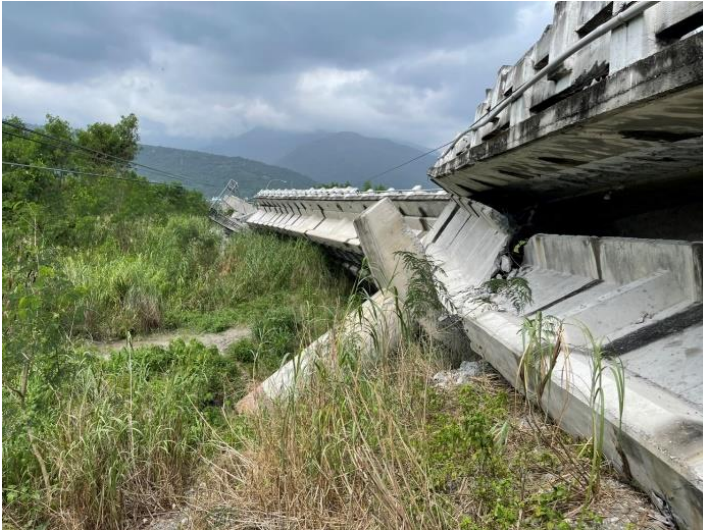
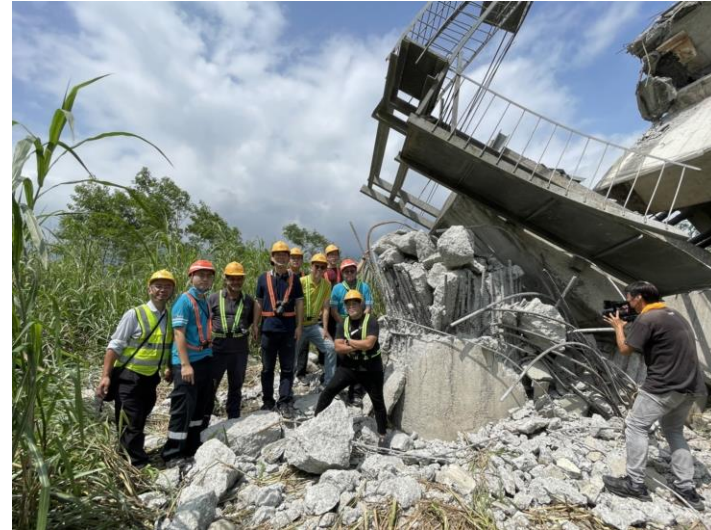
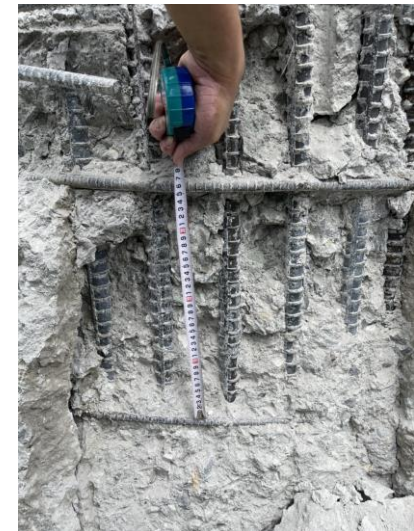
**Upstream
direction**

Column and Base : Collapse 、 Fracture

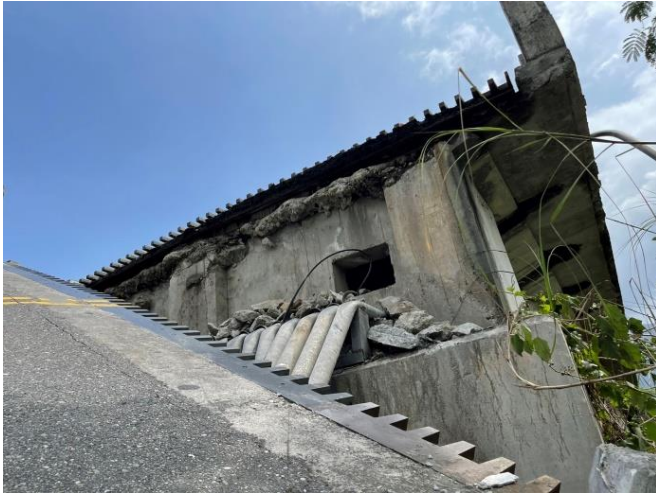
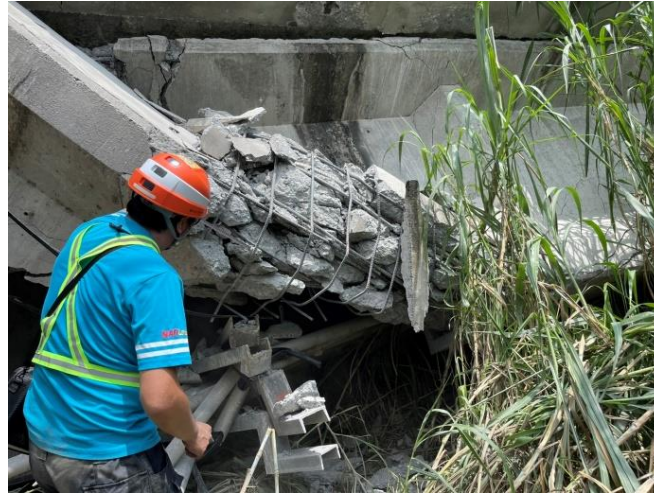
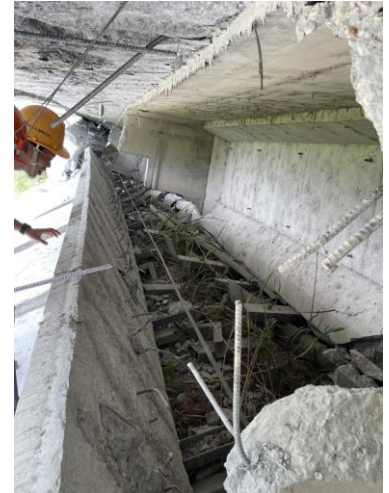
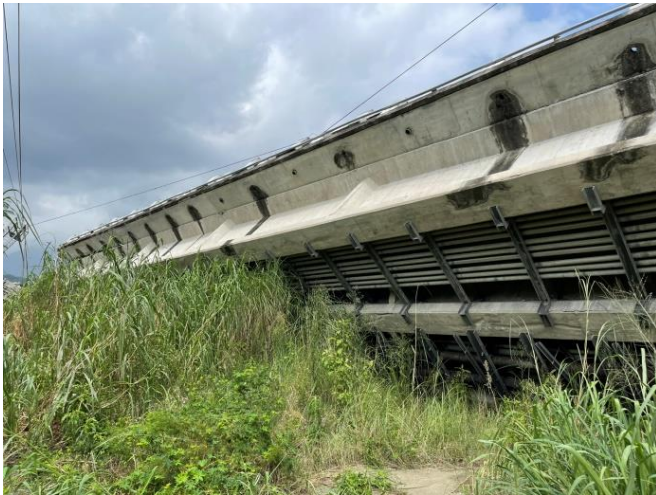
Bridge falling

Superstructure : Bridge falling, collapse

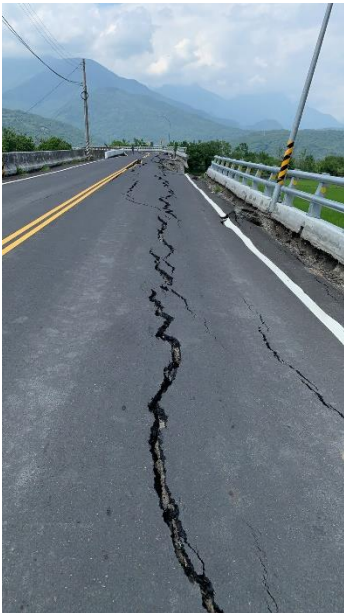
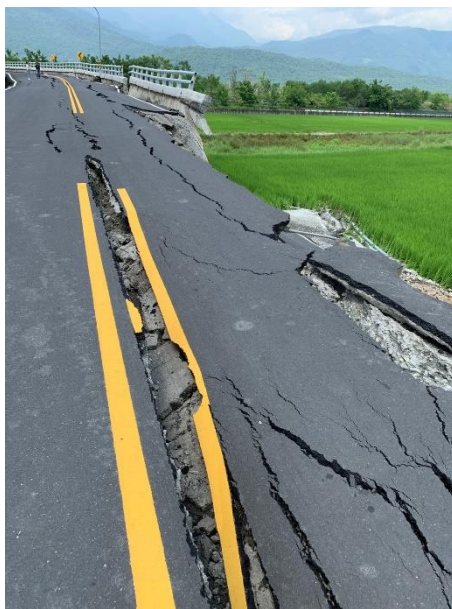
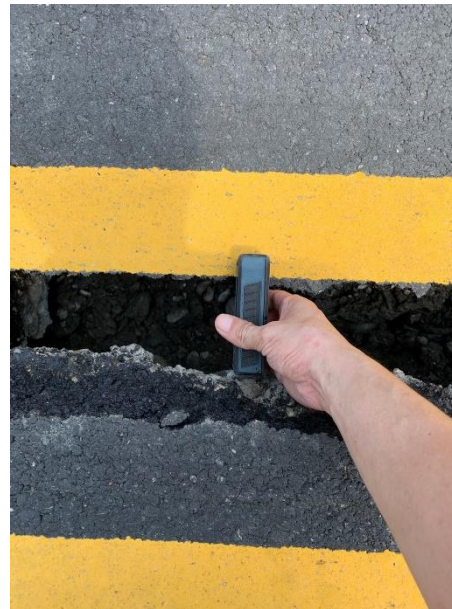
Gao-Liao Bridge (East side)

- Soil loss due to the collapse of the second retaining wall on the east entrance of the bridge.
- The retaining walls were pushed out by the earthquake (mainly pushed toward north).
- The maximum subsidence of the subgrade elevation of the entry wall is about 1 meter.

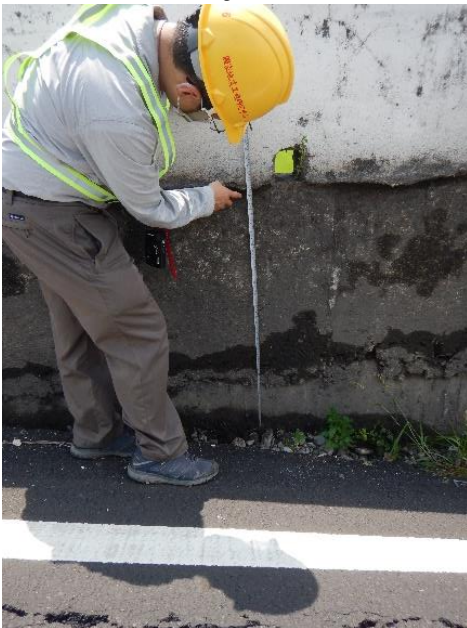
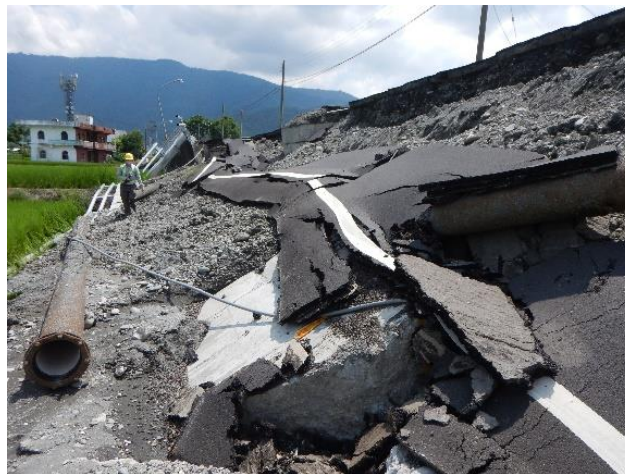
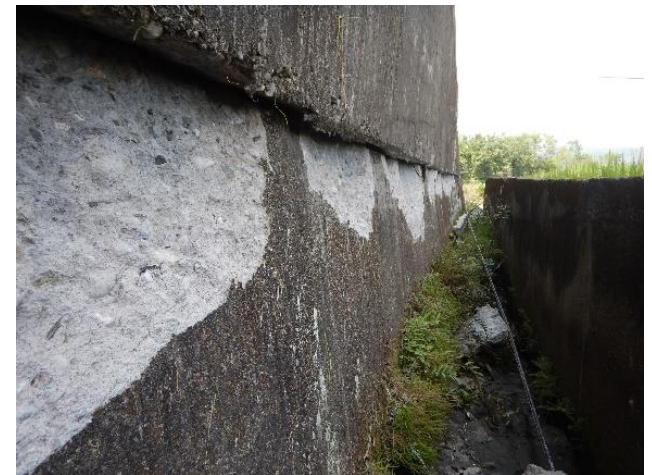
Gao-Liao Bridge (East side)

- Compared with the south and north retaining walls on the outside of the culvert under the abutment, there is an inward shrinkage.
- The difference between the south retaining wall and the culvert is about 15 cm. The difference between the north retaining wall and the culvert is about 45 cm.

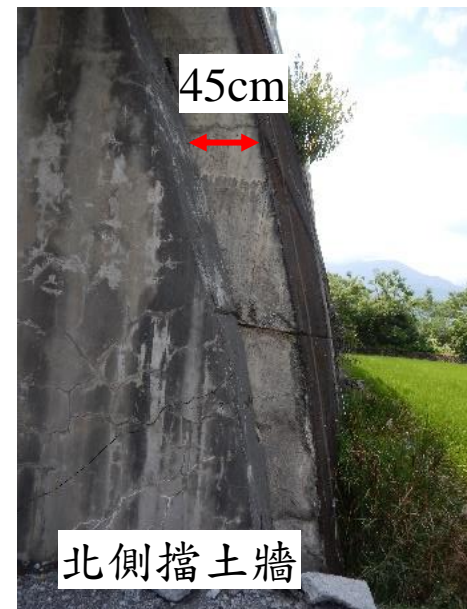
Gao-Liao Bridge (East side)

- Three piers from the east abutment were completely destroyed.
 - The first pier is located at the border of the bridge deck and is covered with steel plates. The pier is completely collapsed, but there is no obvious structural damage.
 - The second pier was located in the middle of the deck and was damaged by shear force.
 - The third pier was not clad with steel plates, and the damage was similar to the first pier.

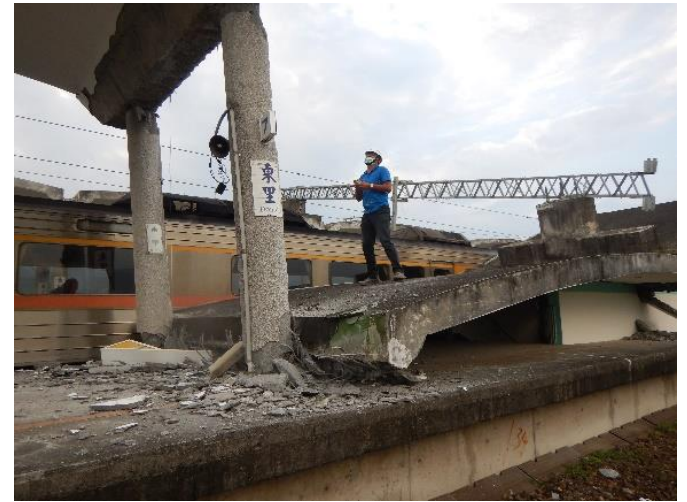
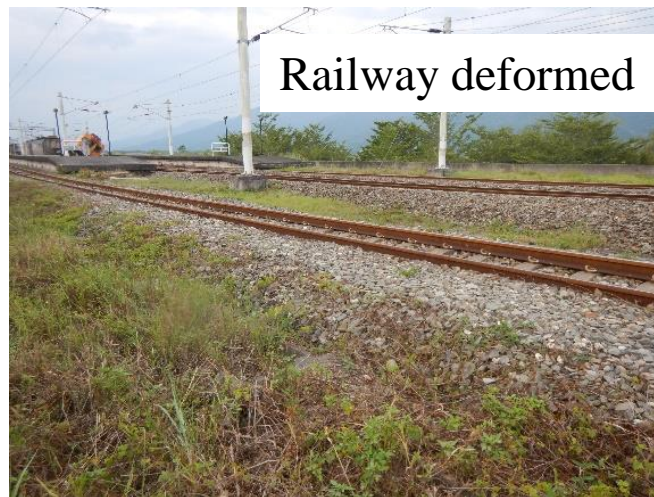
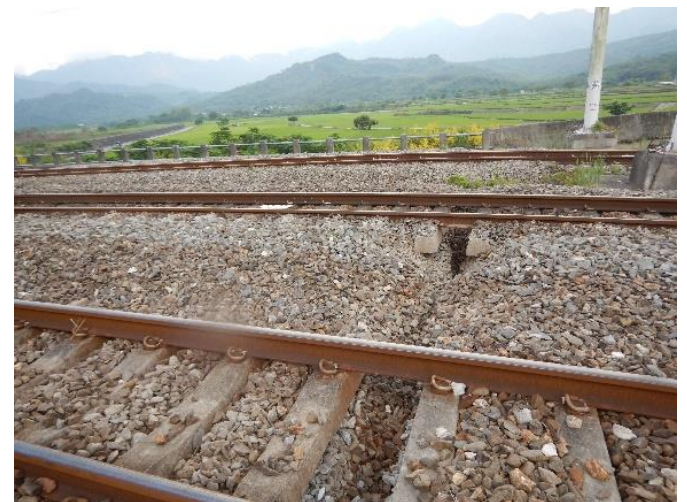
Dong-Li Train Station

- The roof of the train station platform fell and the train derailed.
- The railway is seriously deformed.
- The base unit carrying the ballast is separated, resulting in the loss of ballast.

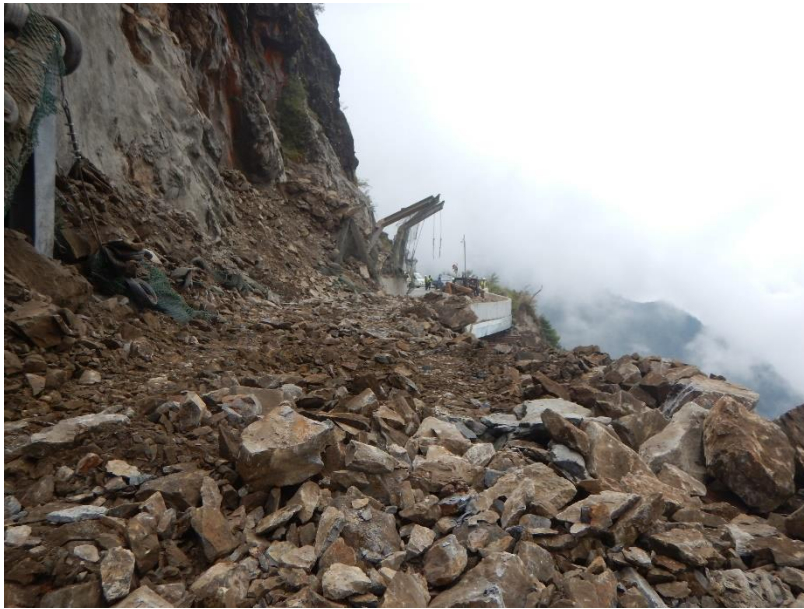
141K+500

- The rockfall materials can be roughly categorized into rocks (metamorphic sandstone, schist) and river grade gravel.

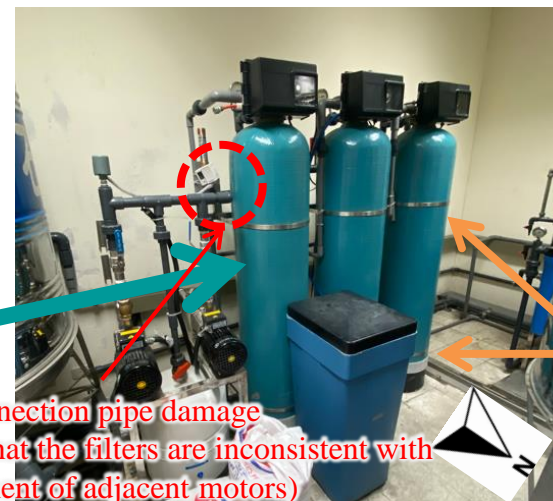
Comparing to the freestanding RO water filters in Taitung Hospital Chenggong Branch, the connection pipe was damaged during 0323, 2022 Hualien Earthquake.

Connection pipe damage
(It is speculated that the filters are inconsistent with movement of adjacent motors)

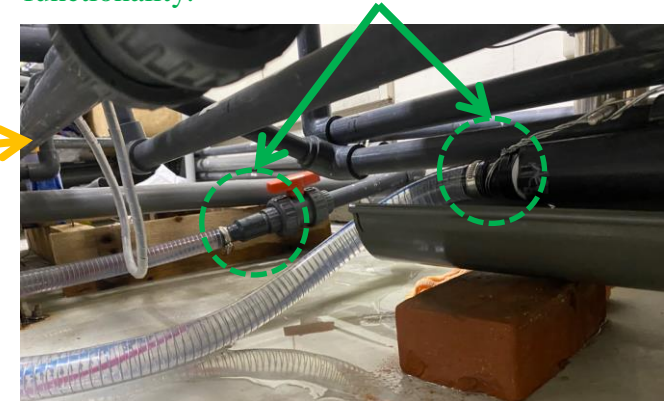
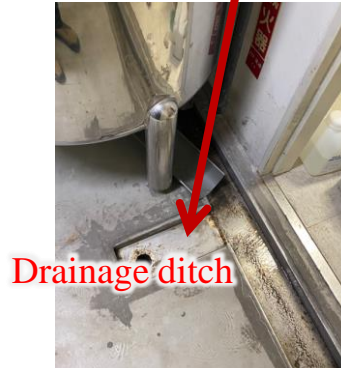
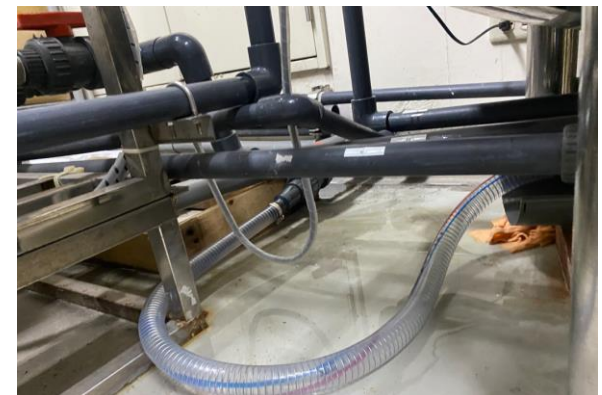
Freestanding RO water tank
(without any anchorage)

Originally, the two ends marked with green circles were connected to each other with a pipe. After earthquake, the pipe was broken and a transparent hose connection was temporarily used to keep its functionality.

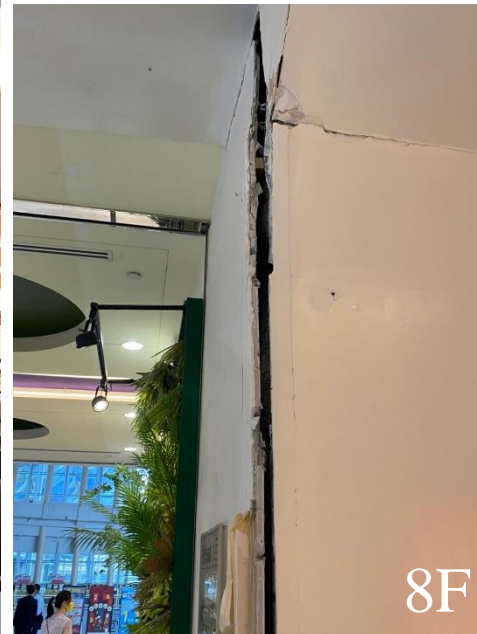
Damage to the interior veneer and ornamentations was investigated due to the relative displacement of expansion joint on 5th, 8th and 9th floor.

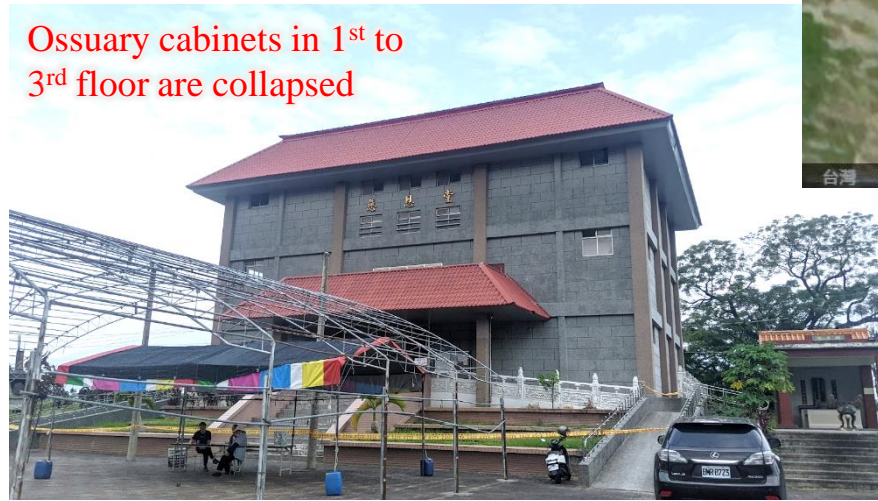
Ossuary cabinets in 1st to 3rd floor are collapsed

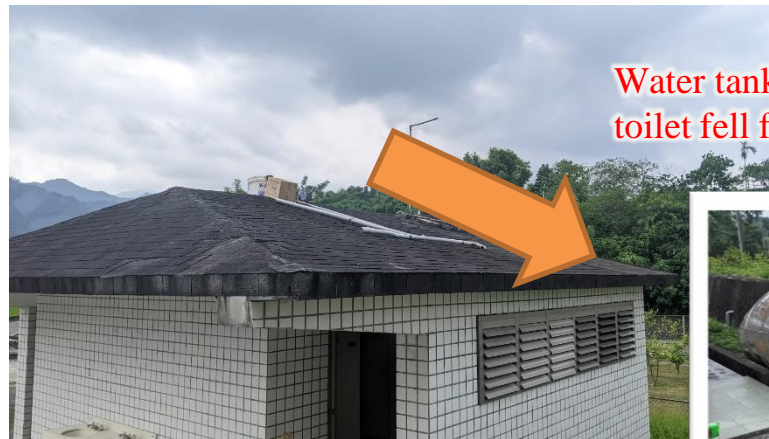
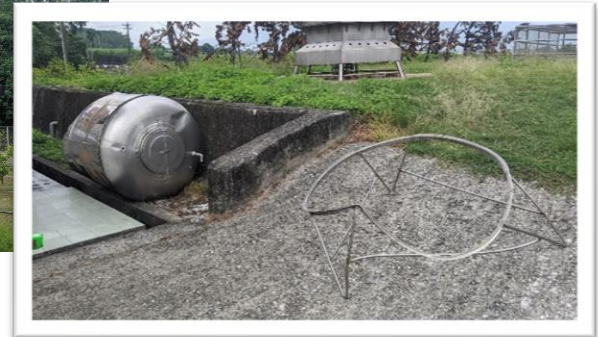
Water tank of outdoor public toilet fell from the roof

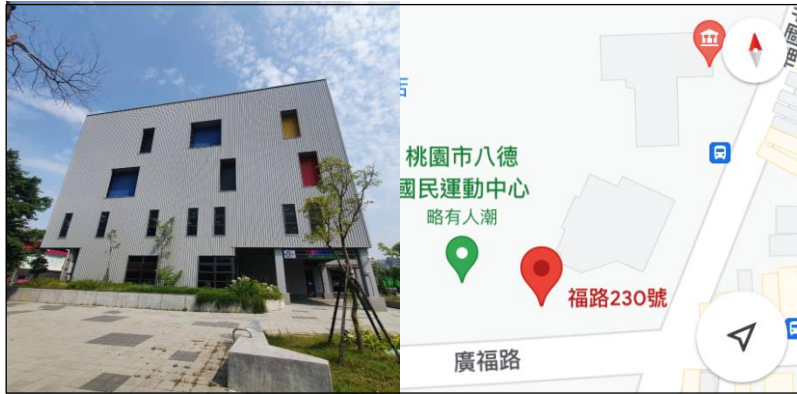
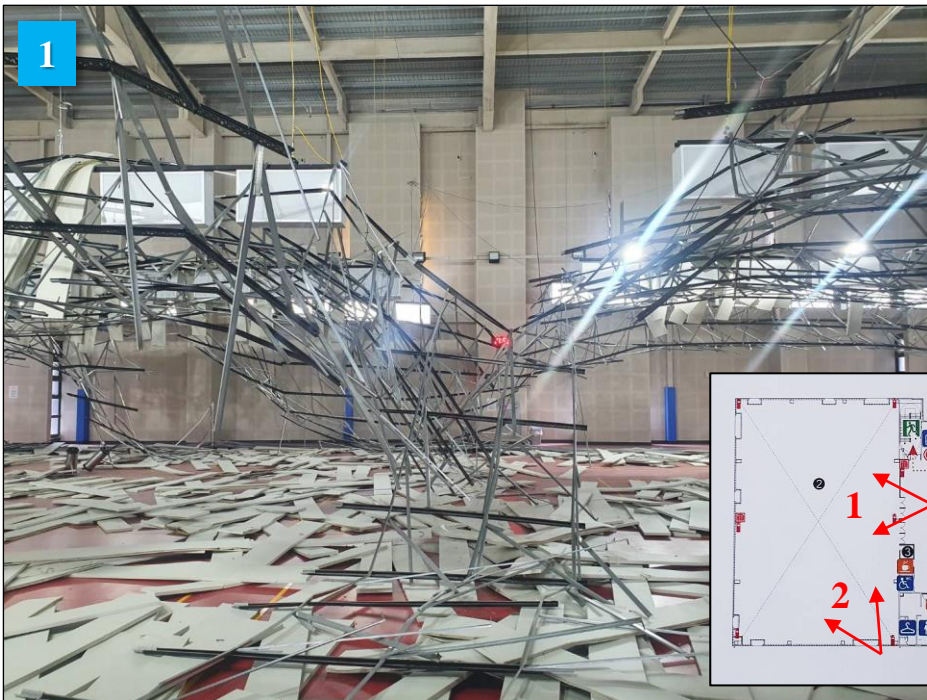
Taoyuan/Bade (八德) Civil Sports Center

The ceiling was completely collapsed during the ChihShang Earthquake

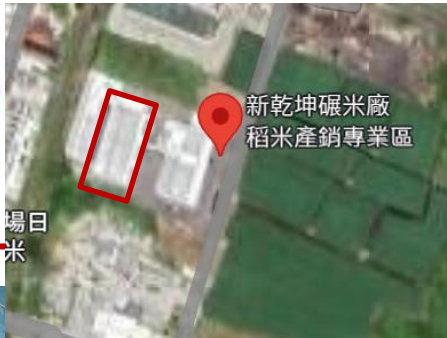
Xin-Qian-Kun (新乾坤) rice mill

The failure of the supporting frame underneath the tanks led to the grain tanks collapsed toward southwest in 9/17 event.

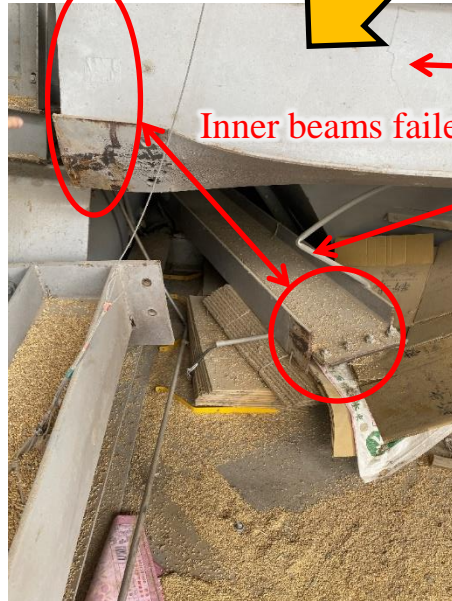
Xin-Qian-Kun (新乾坤) rice mill Guan-Shan township, Taitung County

- The inner beams were secured on a tiny steel plate, which were simply welded to the outer beam, with 4 bolts.
- The welding strength was not sufficient, and the beams fell during the earthquake.

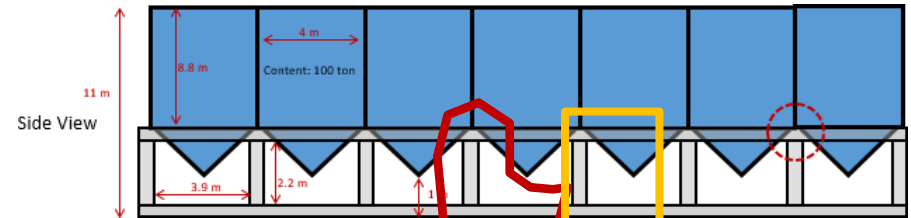
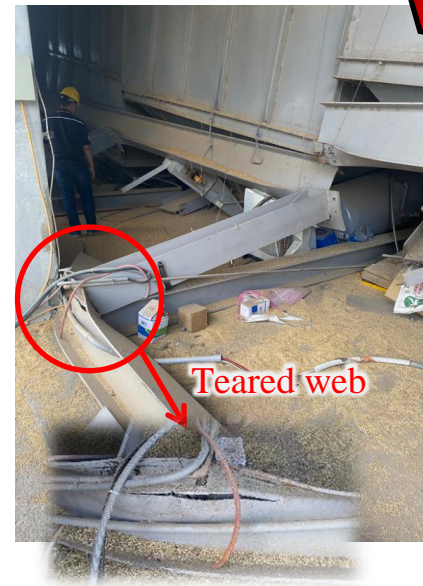
- Some of the bolts used to secure the columns and beams were sheared.
- The lower beams were just placed on the floor without any anchorage.

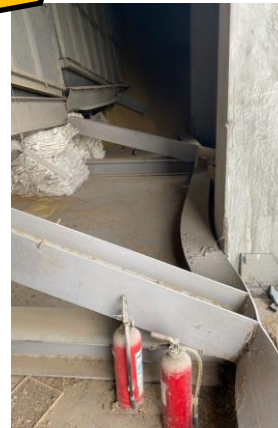
Buckled H-beam

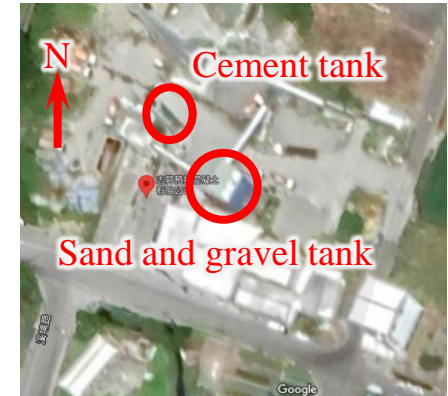
Zhi-Sheng (志昇) ready mixed plant Guan-Shan township, Taitung County

- Storage tanks of gravel and cement collapsed.

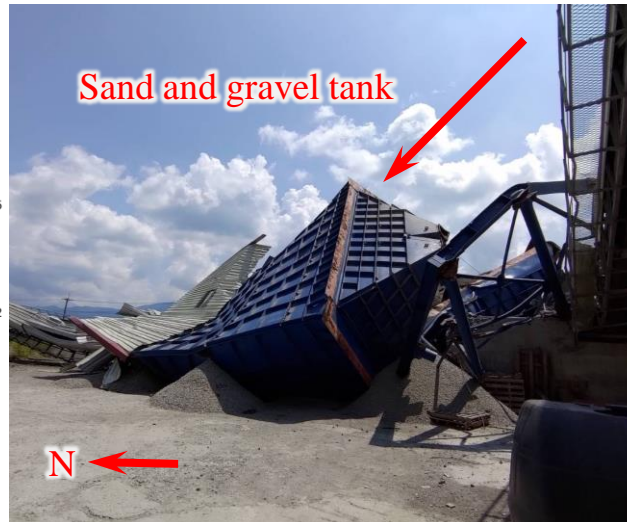
Sand and gravel tank

- The tank was supported by a steel frame, and there were 12 steel posts underneath it.
- The bolts pulled off due to the tensile force.
- The posts ruptured at the welding spots.
