國家地震工程研究中心

2023-02-06土耳其地震事件 彙整報告 (Version 3.0)

2023/02/14

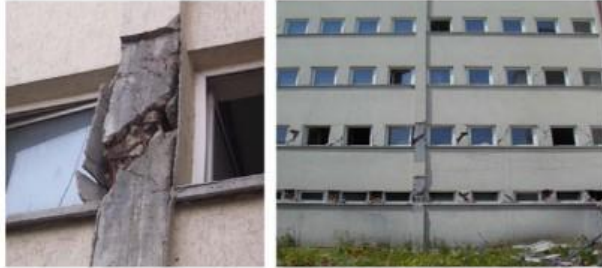
Figure 8. Captive column effect and buckling of longitudinal steel in Bolu (view from the courtyard).

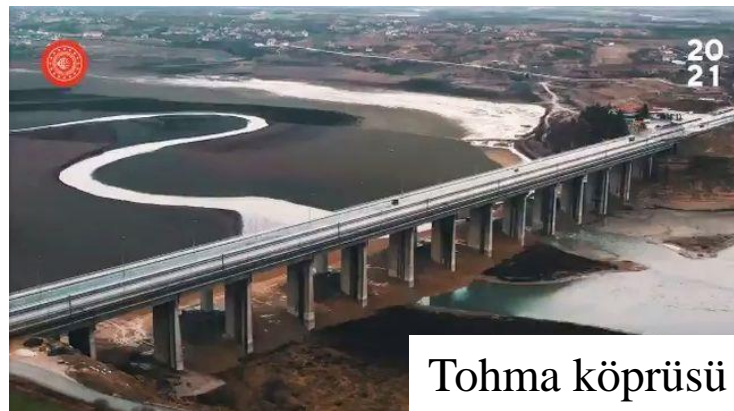
- 截至臺灣時間2月10日9點50分，尚無中文或英文報導關於橋梁損傷的新聞，故僅能藉由土耳其當地官方道路封閉新聞找出下列震損橋梁
- Bulam 3 Köprüsü
- Balıkburnu köprüsü
- Tohma köprüsü
- Başpınar Viyadüğündeki
- Şehitler Viyadüğü
- Recepbey Köprüsü
