# Summary Report of Hualien Earthquake in Taiwan on April 3, 2024 (2<sup>nd</sup> edition, V2.0)

**Chung-Che Chou, Chiun-Lin Wu, Juin-Fu Chai, George C. Yao**

**NCREE, Taiwan**

**May 25, 2024**

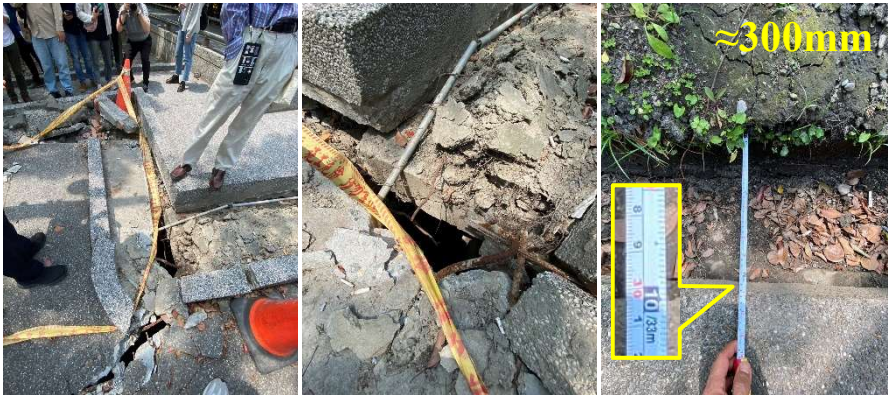
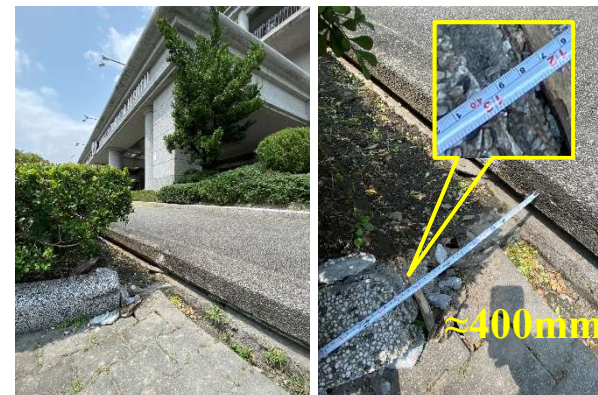
# Hualien Tzu Chi Medical Center

- Without any structural damage and damage in isolation system.
- Minor nonstructural damages due to movement of isolation system.

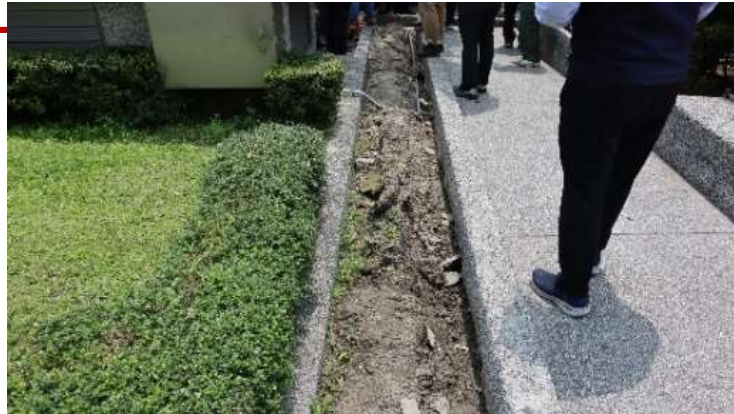
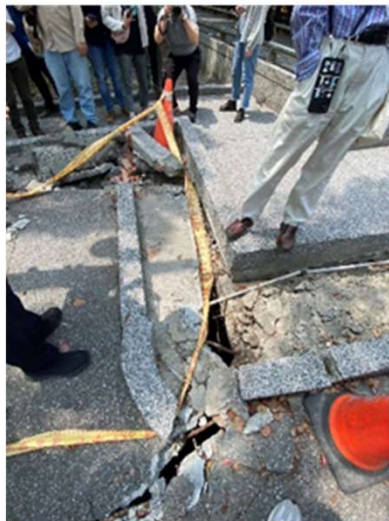
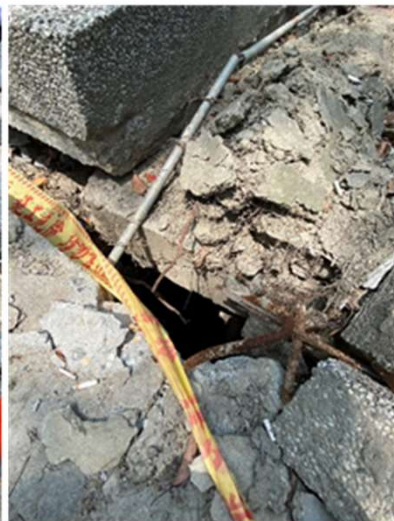
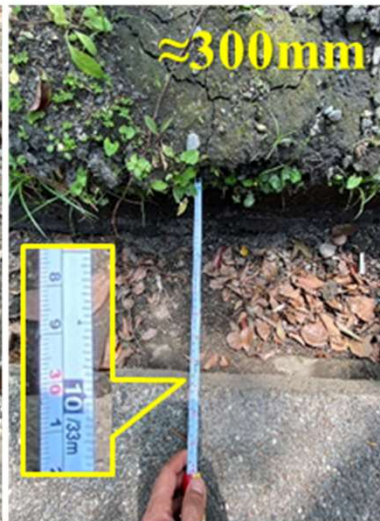
The maximum pushing displacement (isolation displacement) in longitudinal dir. could be roughly measured as 300mm

**Damages of stone slabs due to insufficient isolation moving space**

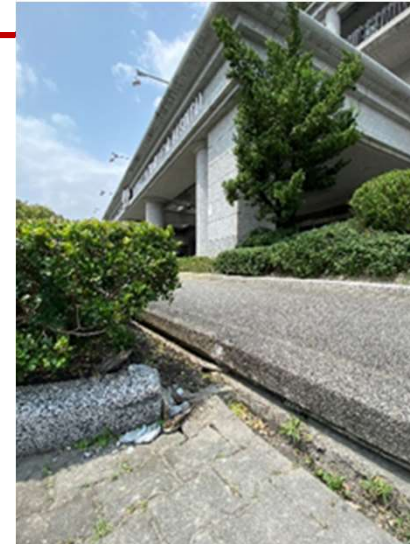
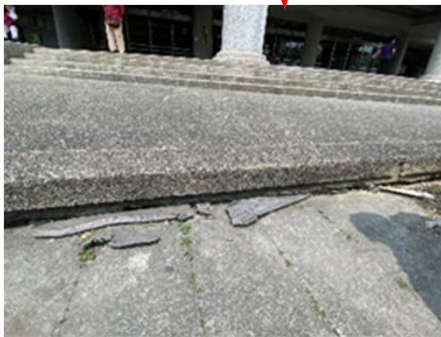
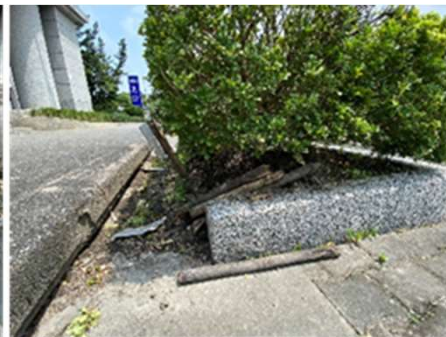
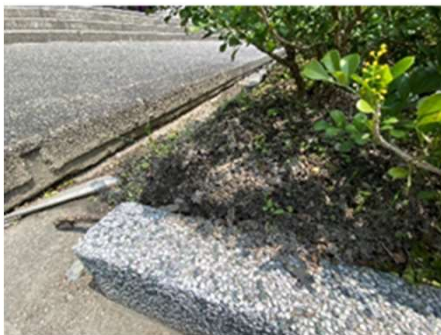
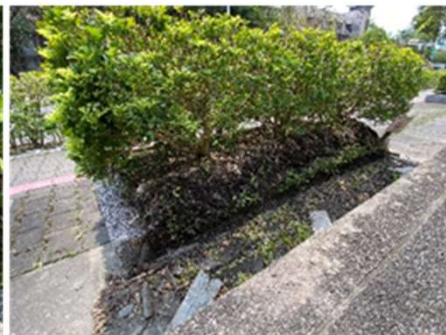
**400mm in  
transverse direction**

**Damages of garden  
stone pillars due to  
insufficient isolation  
moving space**

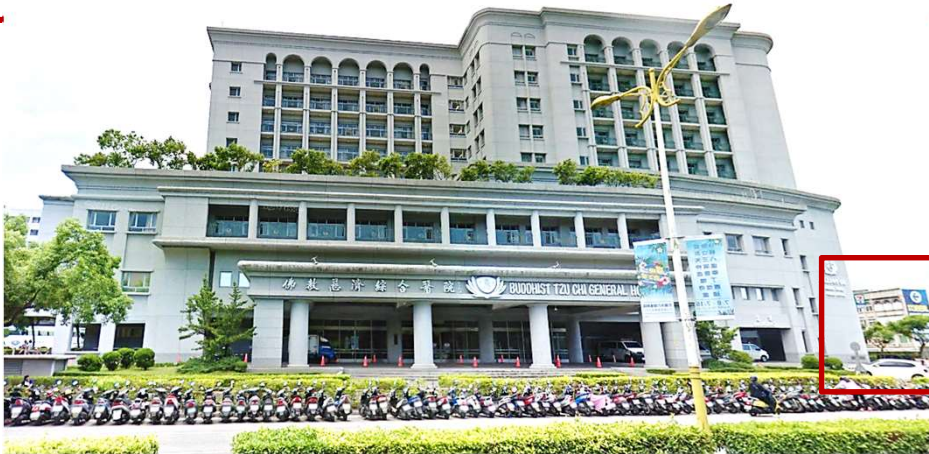
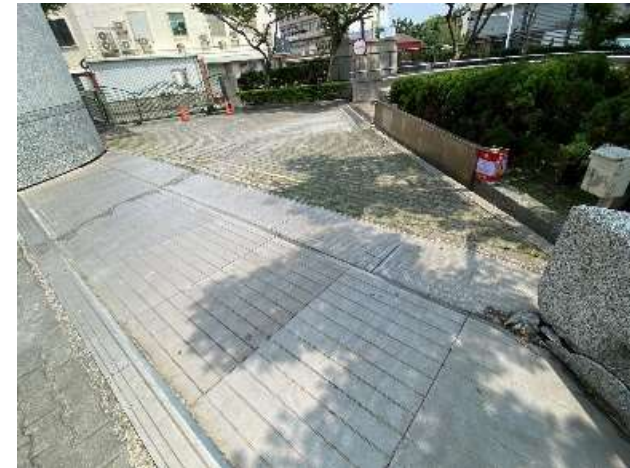
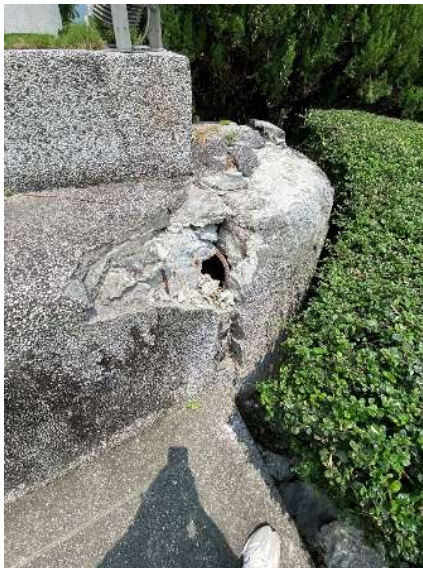
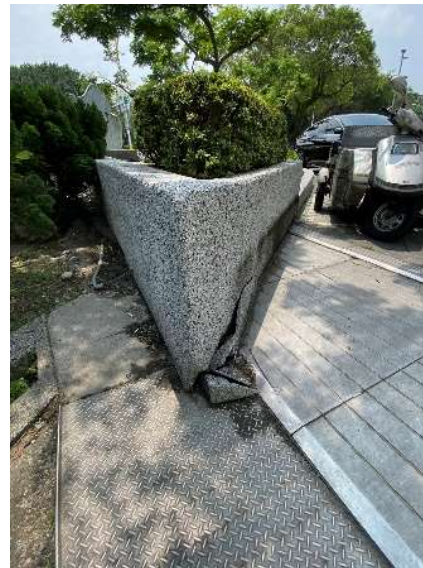
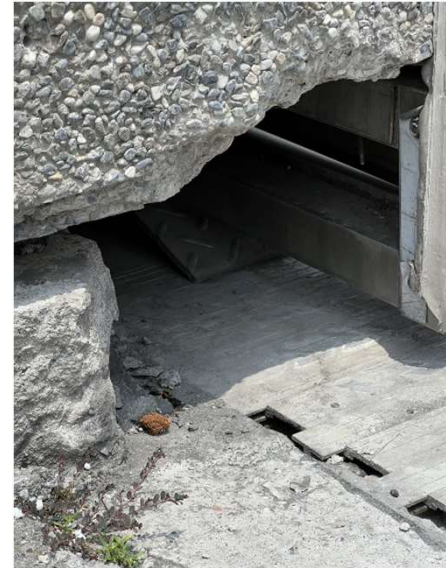
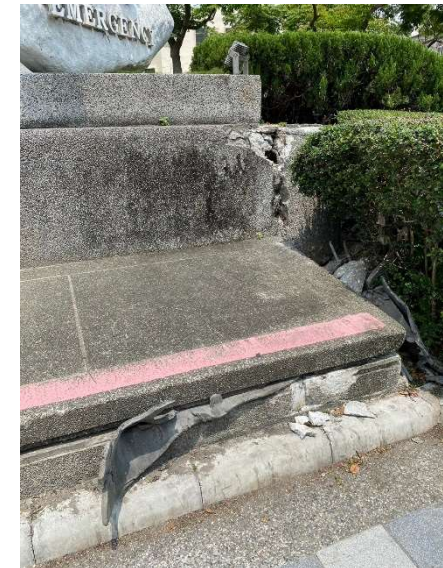
Insufficient isolation moving space

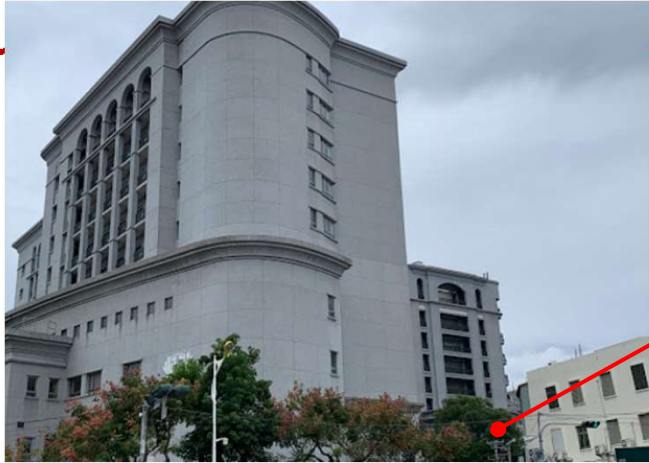
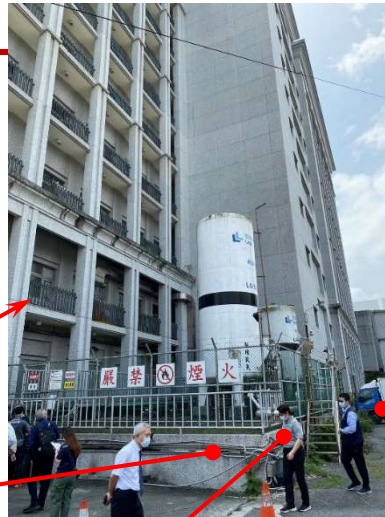
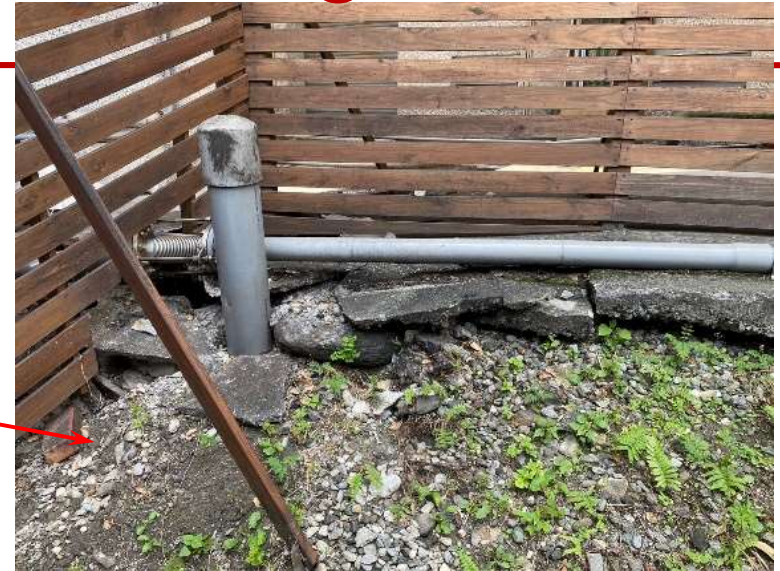
**Insufficient isolation moving space**

**Measured residual displacement :**  
**Longitudinal < 30mm;**  
**Transverse < 50mm**

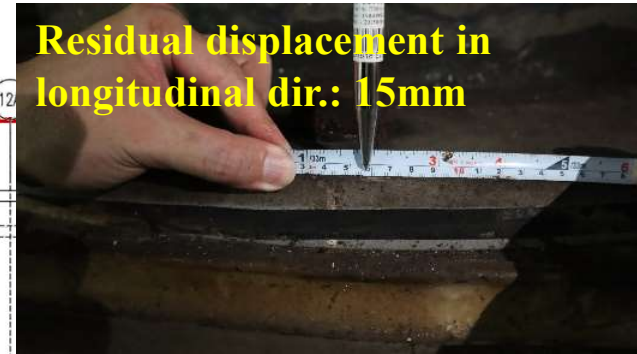
**Residual displacement in longitudinal dir.: 15mm**

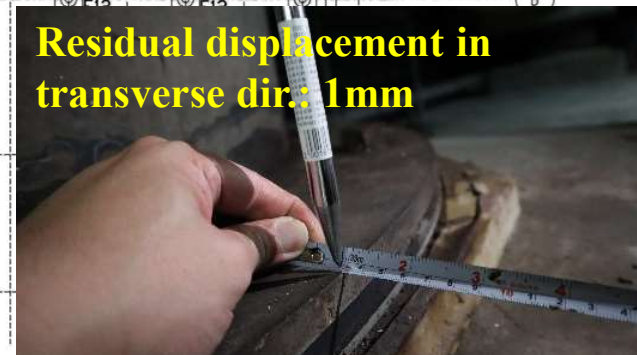
**Residual displacement in transverse dir.: 1mm**

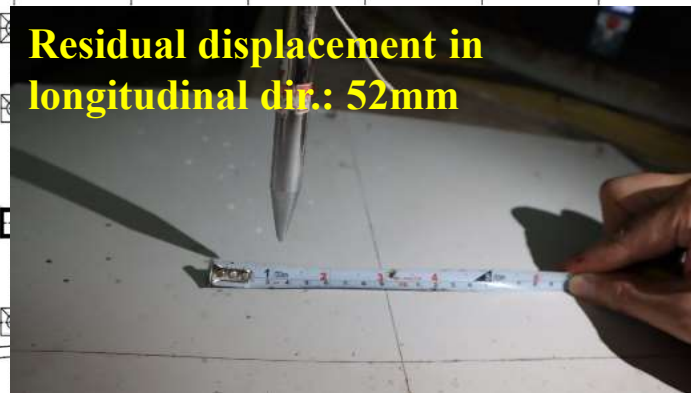
**Residual displacement in longitudinal dir.: 52mm**

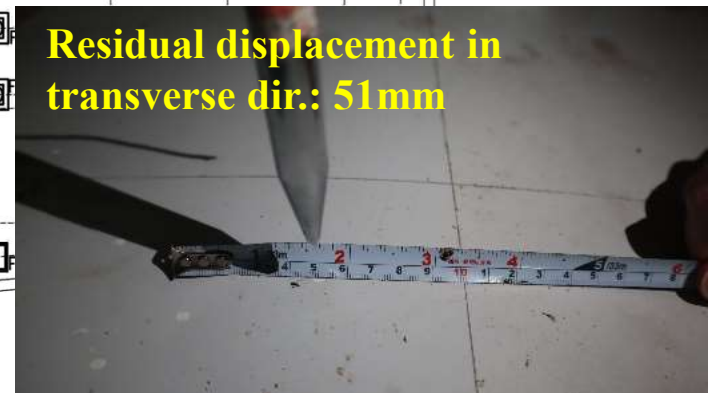
**Residual displacement in transverse dir.: 51mm**

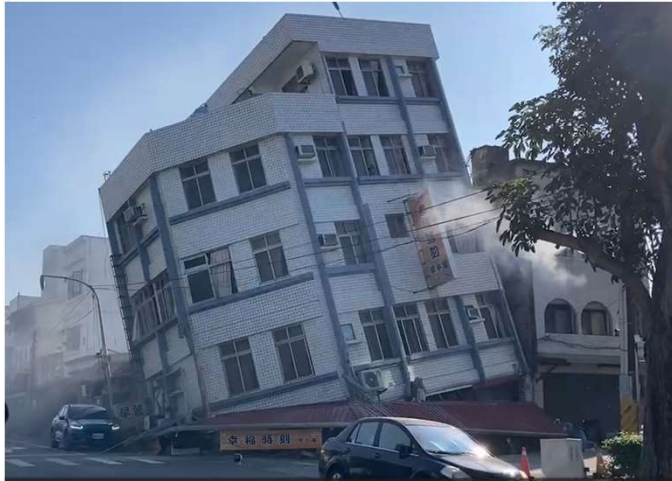
# 5-story Residential bldg. Hualien City

## Soft/weak story failure

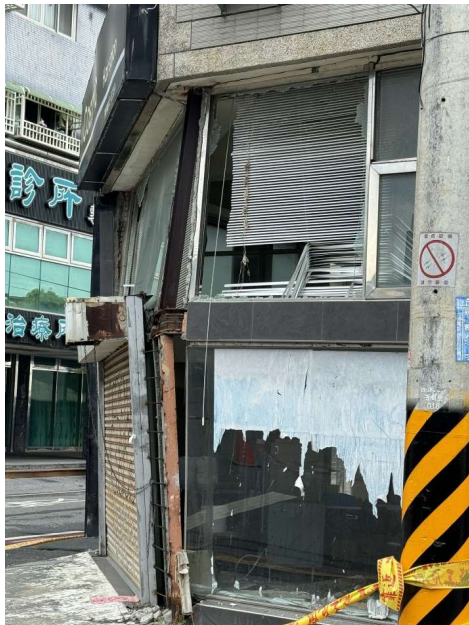
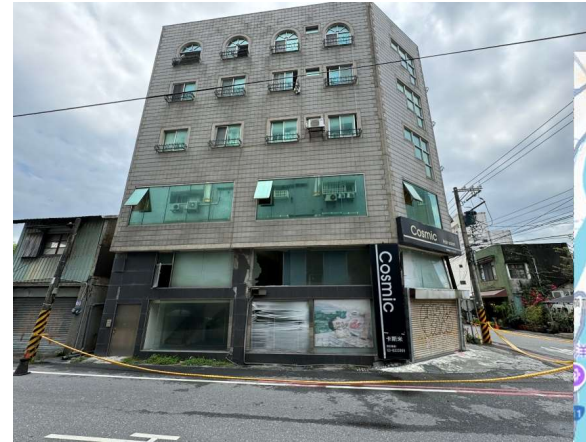
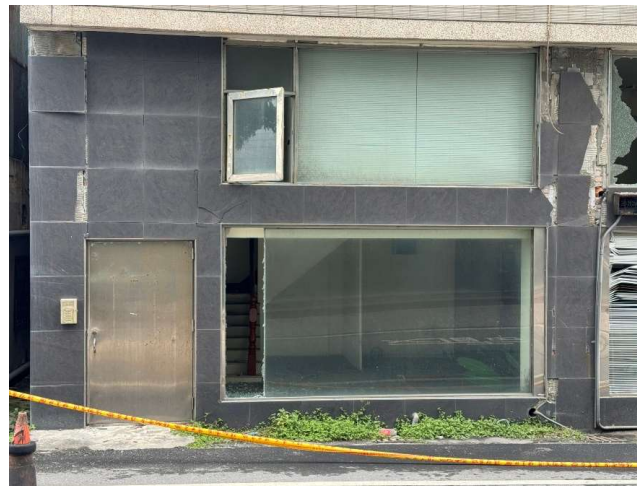
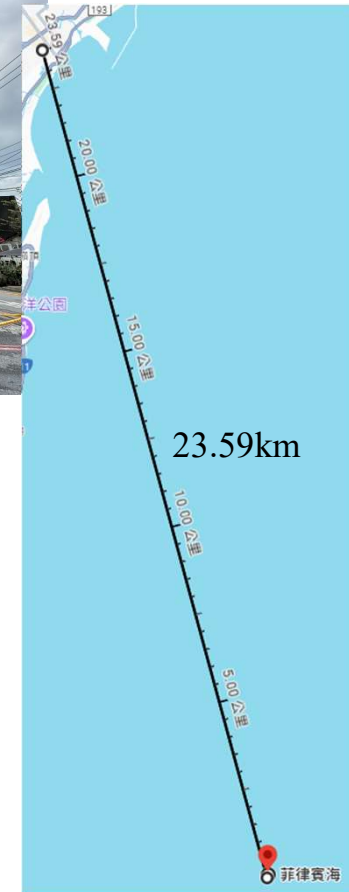
## Hualien City

- RC Column failure
- Bldg. inclined

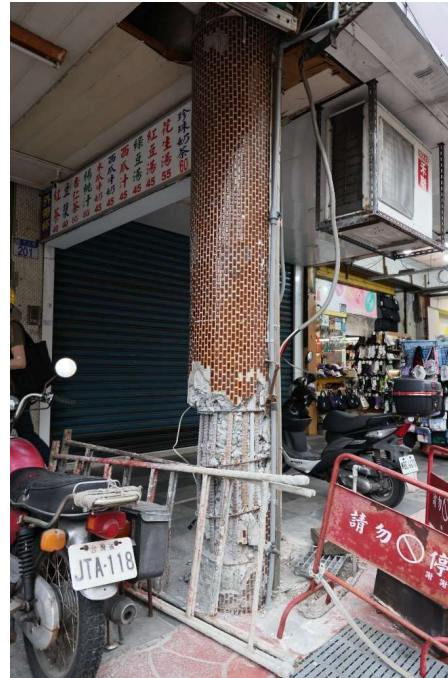
## Column protective layer peeling off

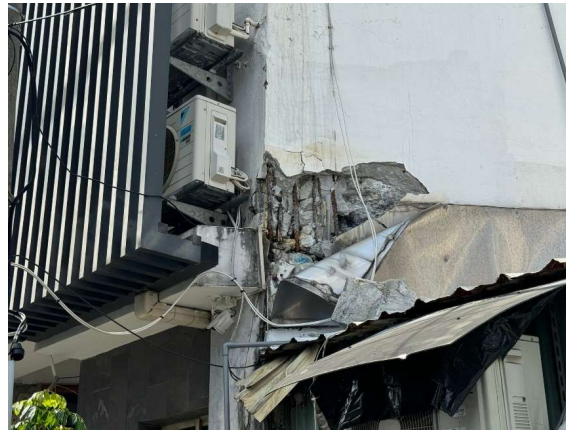
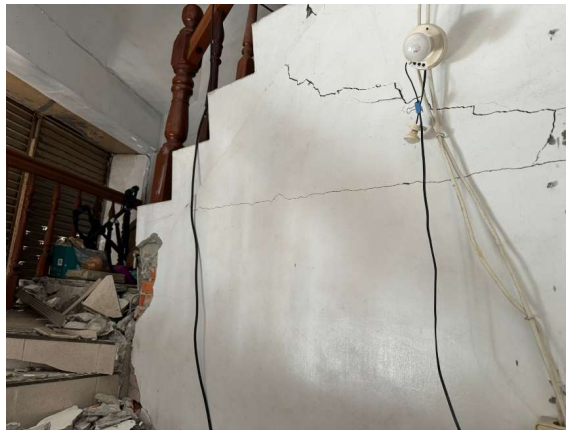
# 4-story Residential bldg. Hualien City

RC Beam-Column Connection Failure

Partition walls damaged

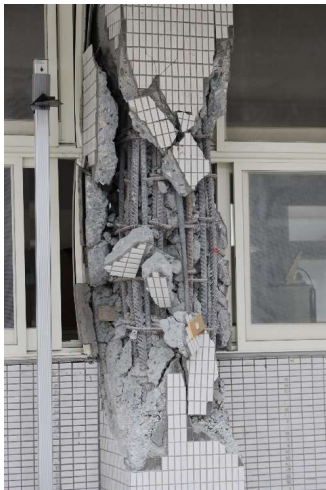
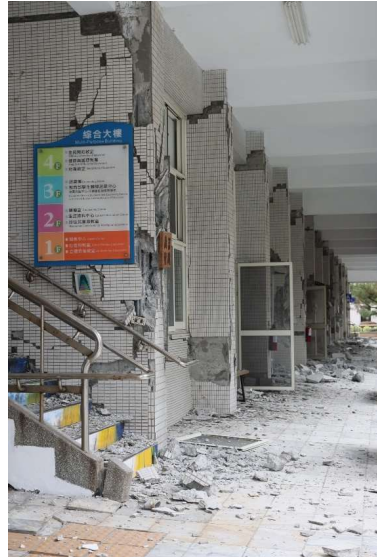
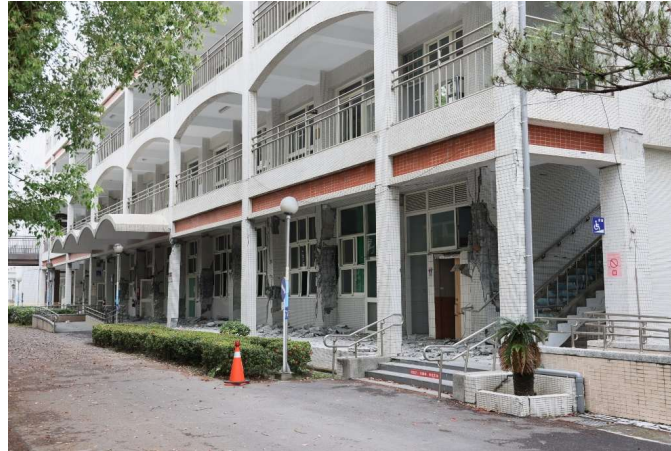
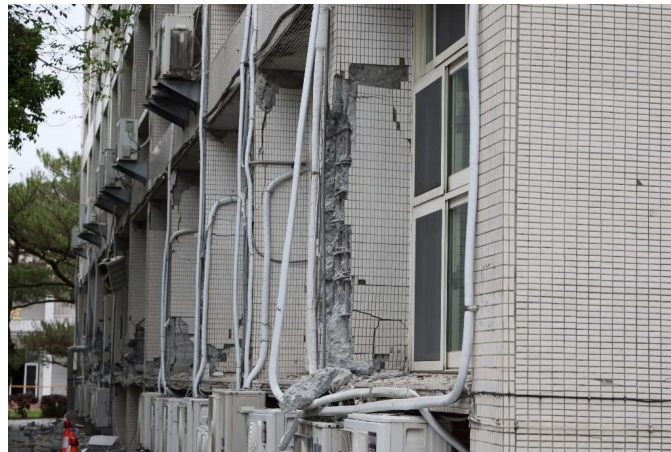
# School bldg. in Hualien City

windowsill shear failure

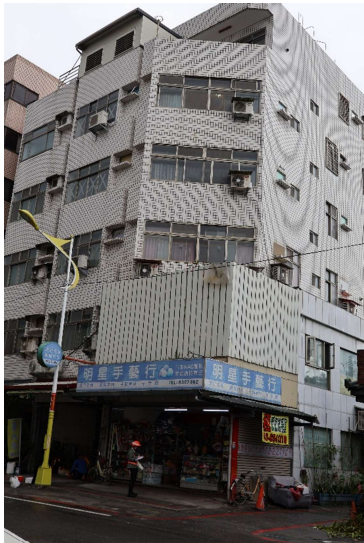
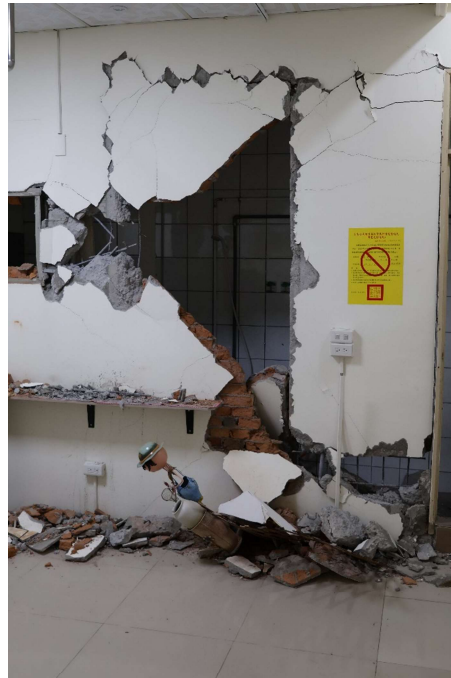
# 6-story Residential bldg. **NAR Labs**

Walls shear failure

Wall protective layer peeling off

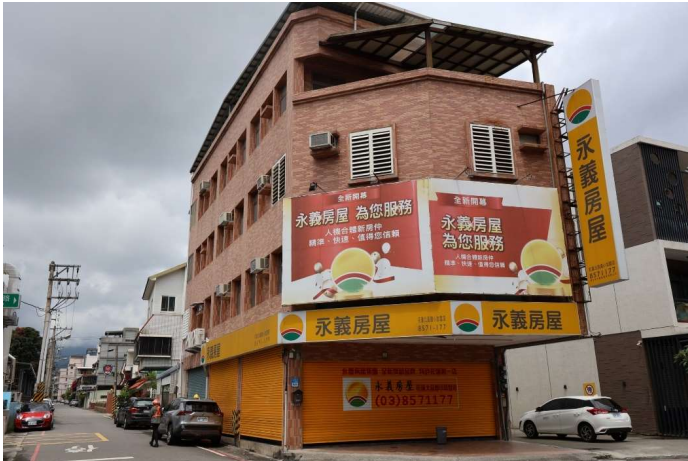
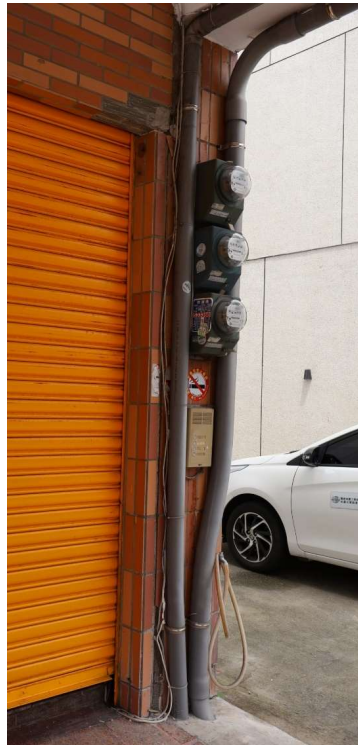
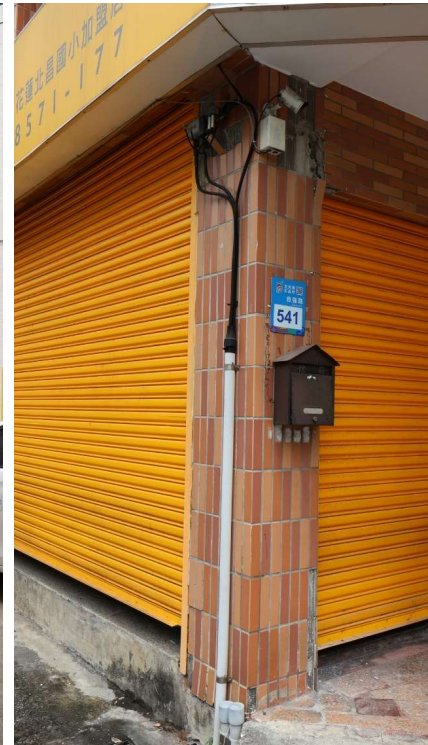
# 4-story Residential bldg. **NAR Labs**

### The bottom of RC column crack

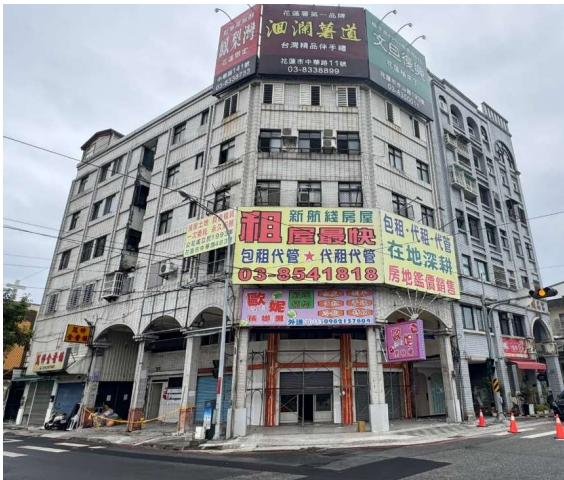
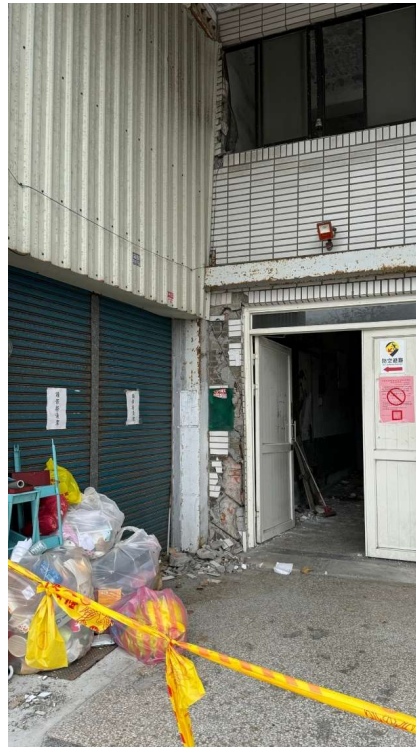
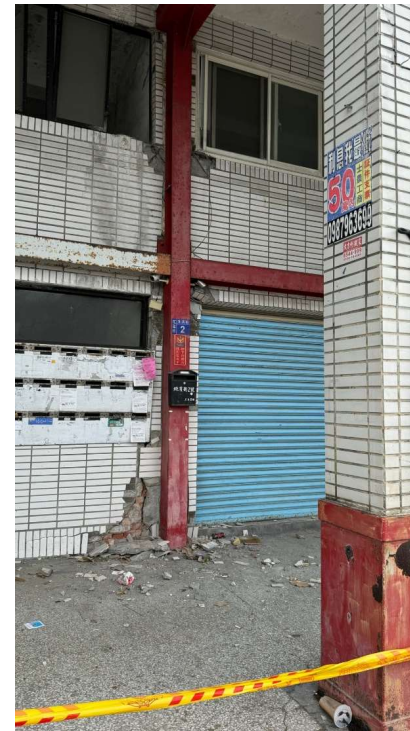
RC columns at 1<sup>st</sup>-story crack  
windowsill shear failure

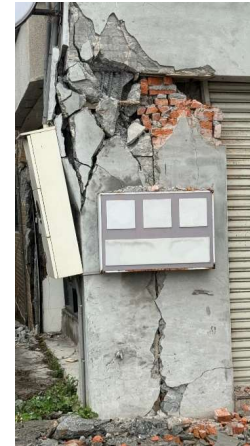
# 6-story Residential bldg. **NAR Labs** Hualien City

## Severe Damage to the Ground Floor

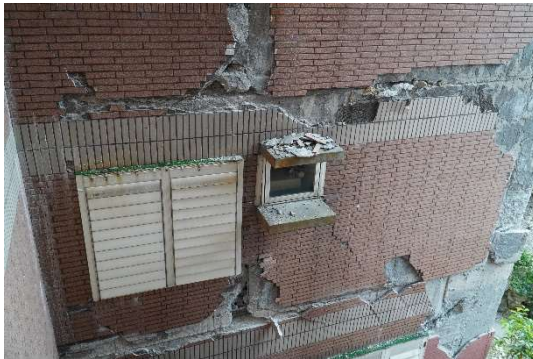
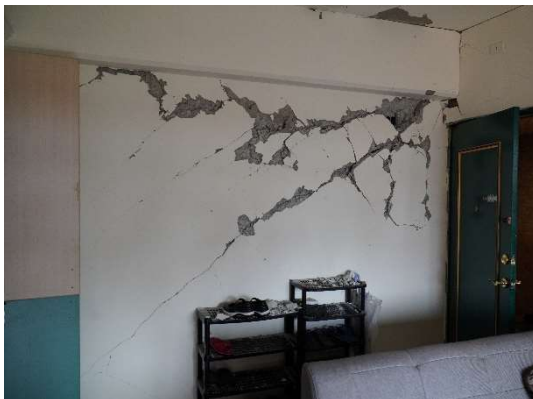
Renli 5<sup>th</sup> St., Ji'an Township, Hualien County

## RC Wall failure

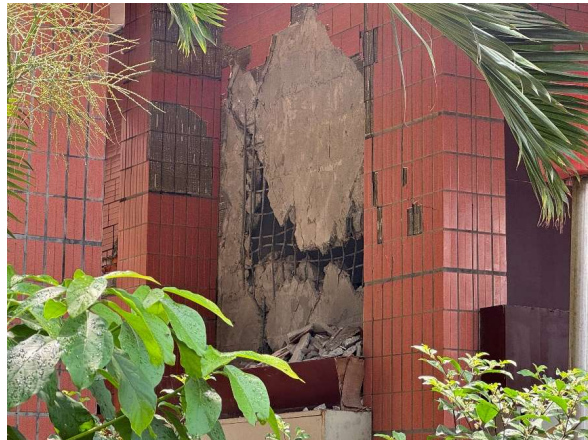
# Residential bldg. Hualien City

- **RC Columns flexural failure**
- **Walls damaged severely**

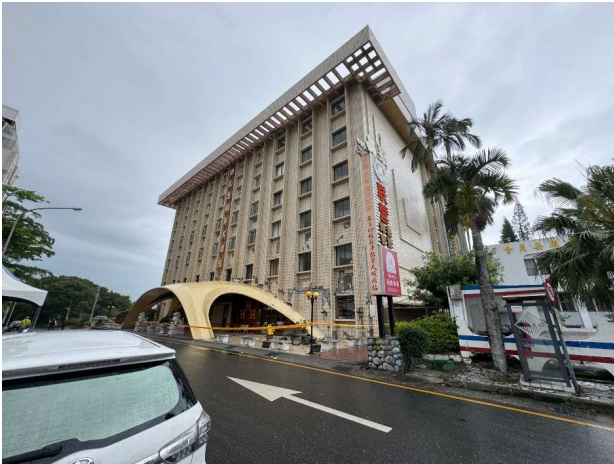
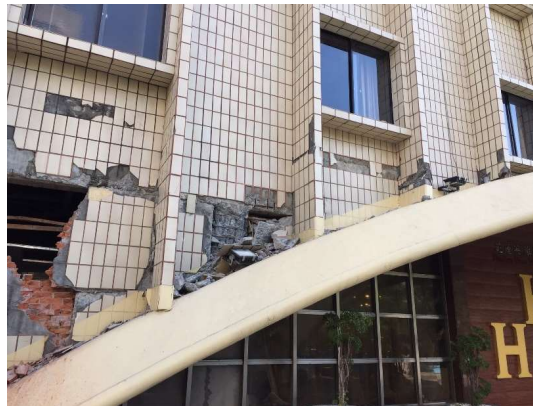
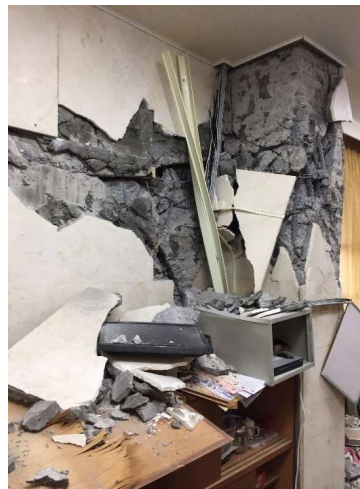
# 6-story Hotel bldg. Hualien City

- RC Columns and walls damaged severely

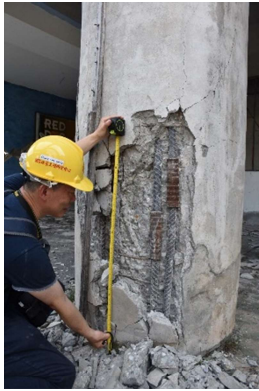
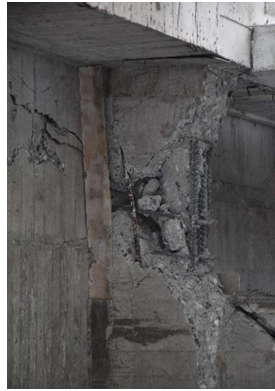
# 12-story Residential bldg. **NAR Labs**

- RC Walls and Partition walls shear failure
- RC Columns shear failure

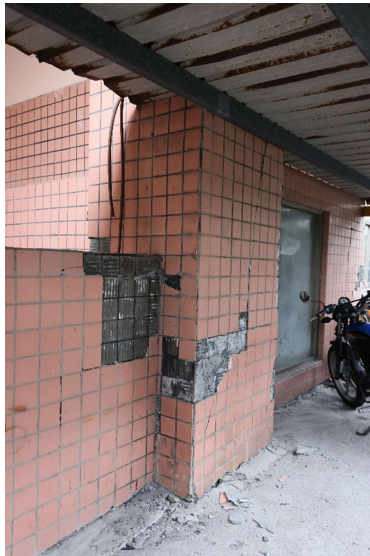
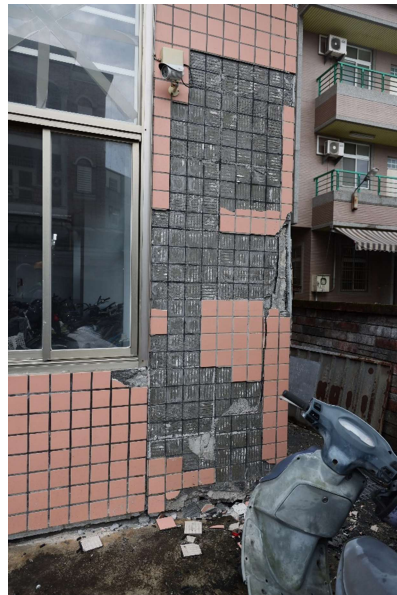
RC Columns shear failure  
Tiles falling

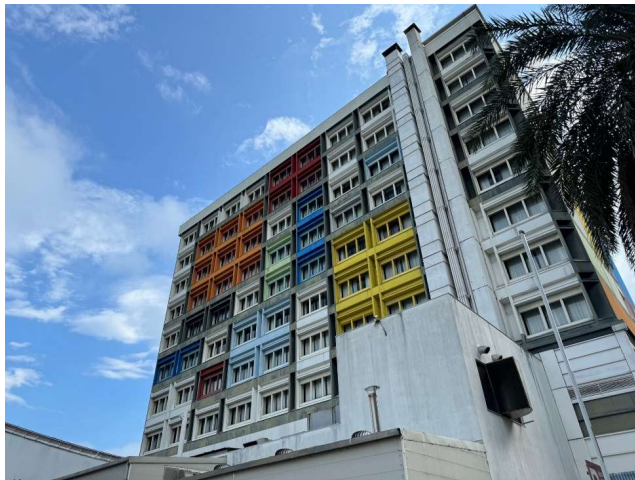
# Hotel bldg. Hualien City

## RC Column concrete bursts, steel bars buckle

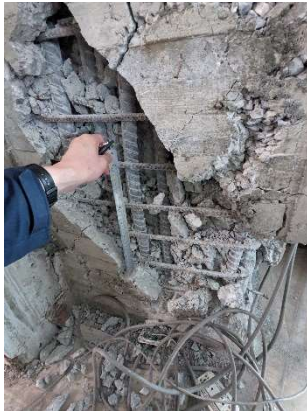
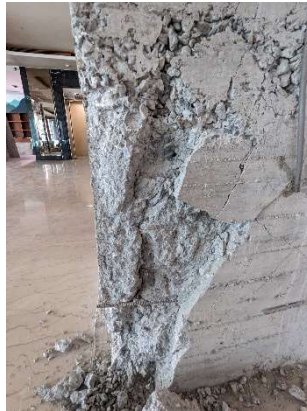
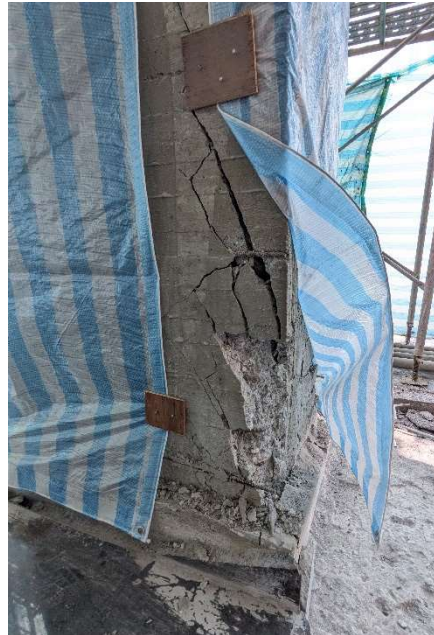
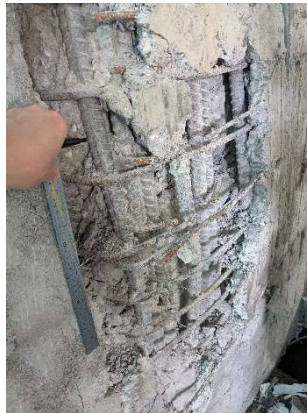
# Hotel bldg. Hualien City

## RC Columns damaged severely

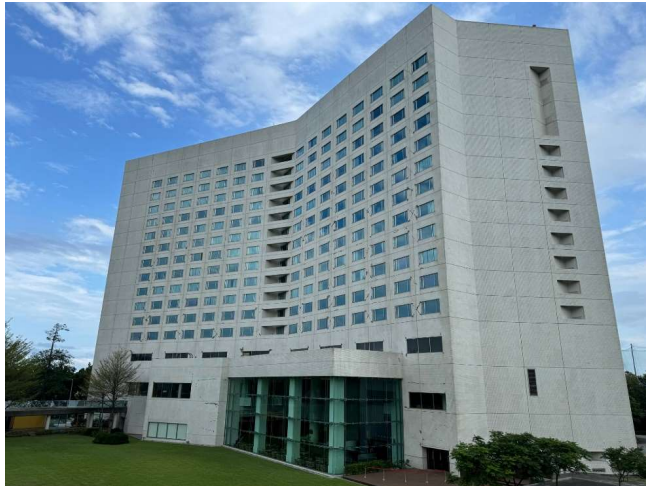
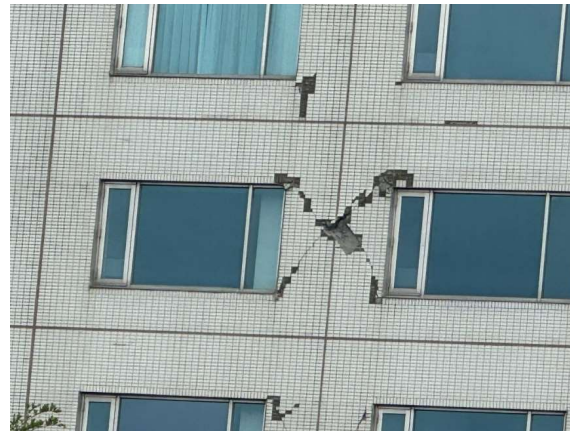
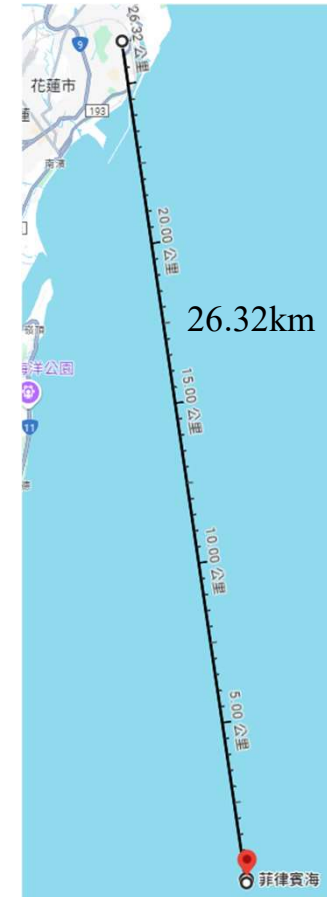
# Hotel bldg. Hualien City

## RC Walls shear failure

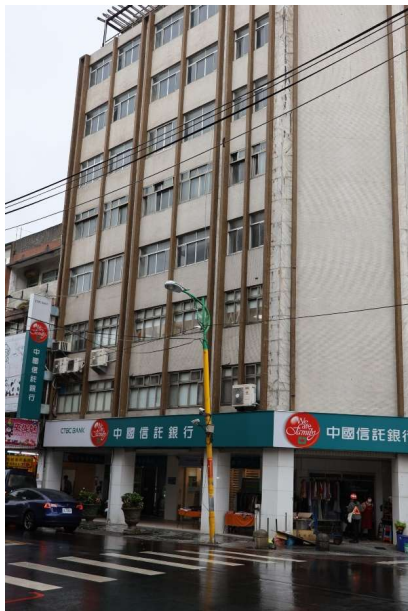
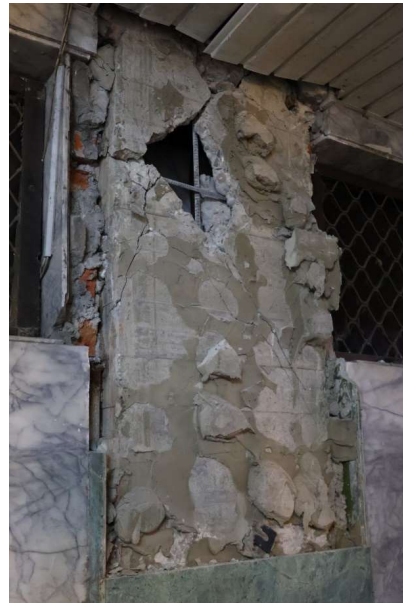
## Non-structural walls damaged

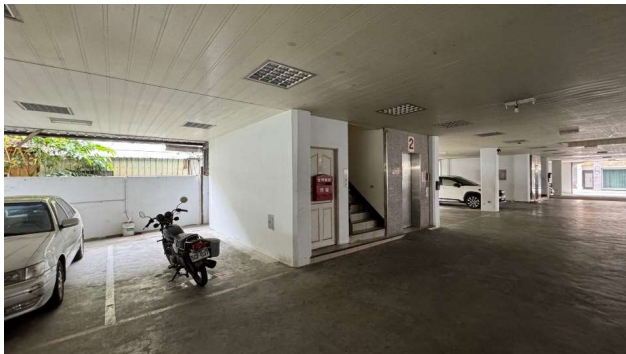
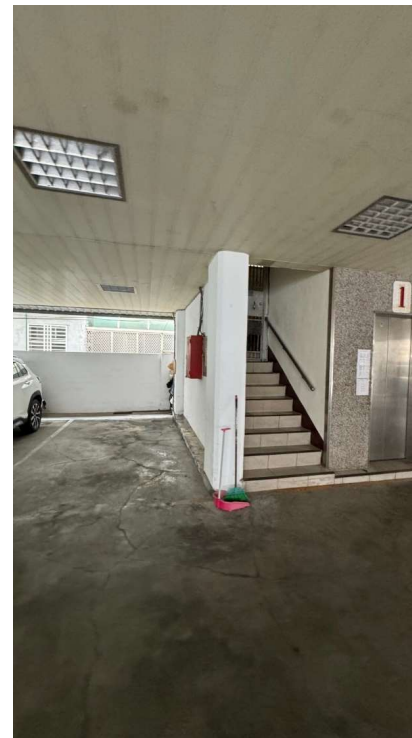
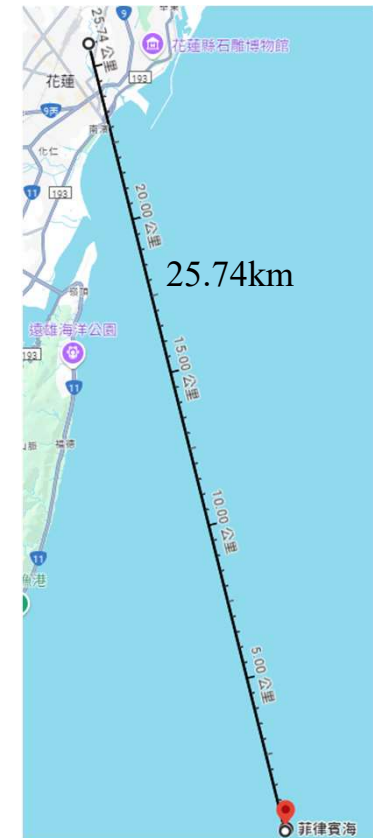
Retrofitted bldg.

- Retrofitted with RC shear walls
- Minor cracks in stucco

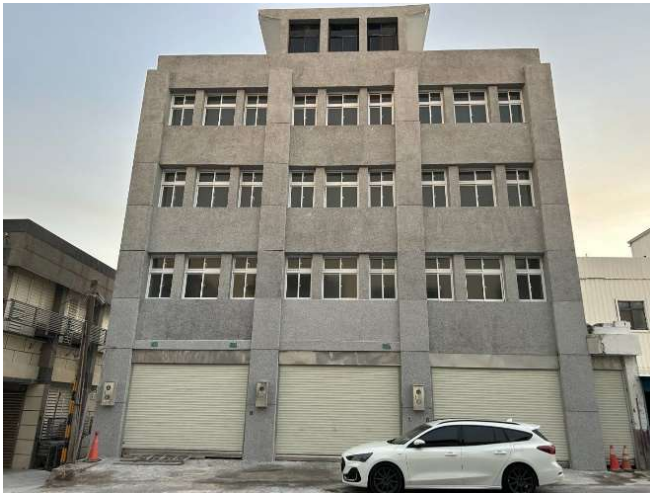
# Retrofitted Building A01900 in Taitong City

- Seismic Intensity: 4
- Structural Damage Severity: Light
- Maximum Acceleration on 1st-floor slab: 105 gal
- Maximum Acceleration on 2nd-floor slab: 175 gal
- Maximum Acceleration on roof slab: 319 gal
- Displacement Ratio (1st floor): 0.035% (Safety threshold: 0.02%)
- Displacement Ratio (2nd floor and above): 0.146% (Safety threshold: 0.250%)

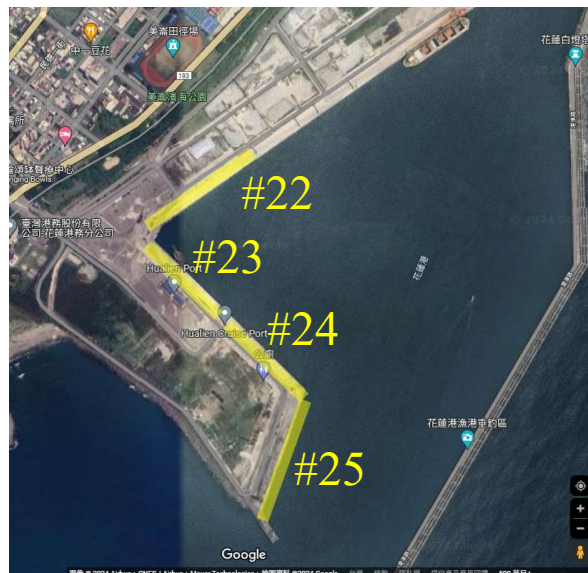
- Distance=23 km to the epicenter.
- The earthquake caused subsidence and soil liquefaction behind pier 23-25.

Location	#25
PGA(gal)	410.5
PGV(cm/s)	58.7
Sa0.3s (gal)	776.9
Sa1s (gal)	596.6

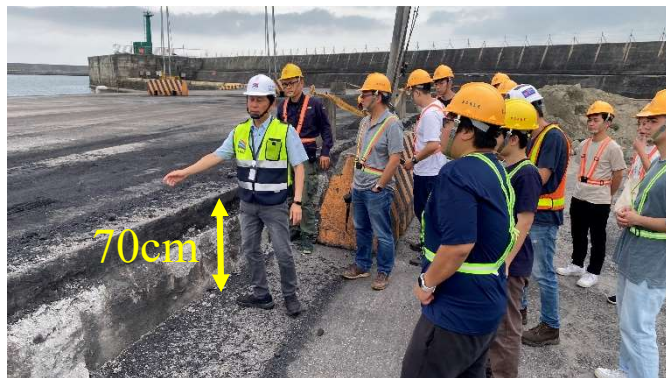
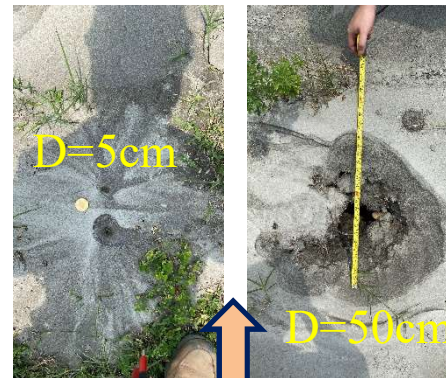
## Hualien port (2/2)

- The backfill subsidence was most severe at pier 25. The gravel sand backfill areas behind the dock lines also showed sand boils and cracks.

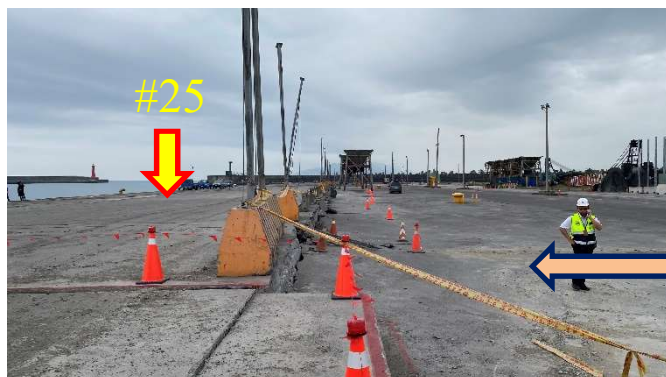
Sand boils

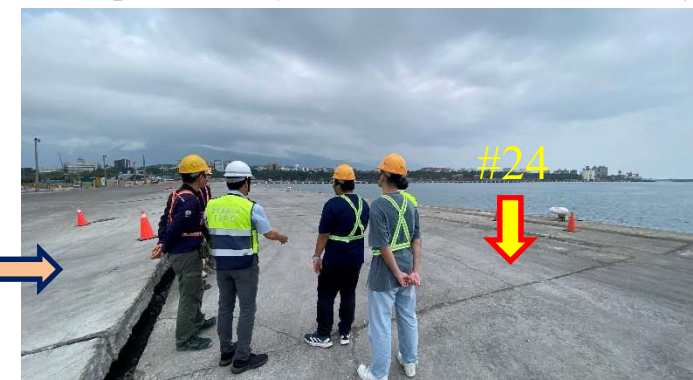
The reinforced concrete pavement has sunk and tilted.

Pier No,	Max. Subsidence
#25	70cm
#23~#24	50cm
#19~#22*	50cm
#17~#18*	12cm

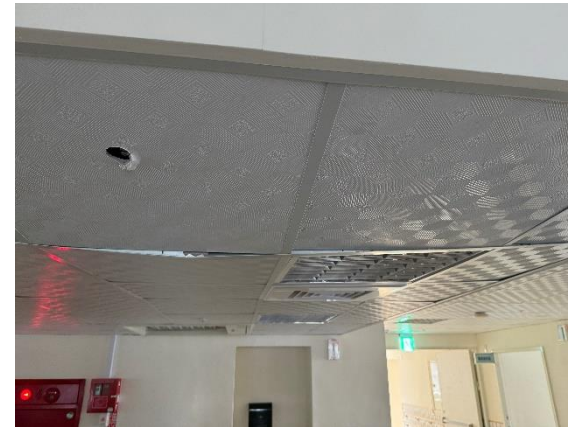
Damaged ceiling at elevator hall on the first floor ↑

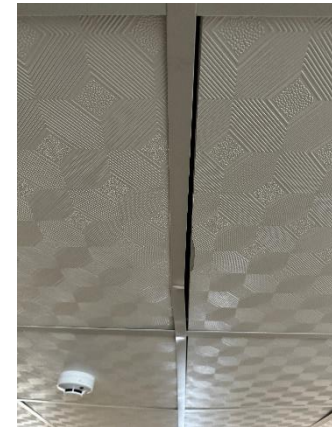
Deformed ceiling grid above the nursing station on the sixth floor ↑

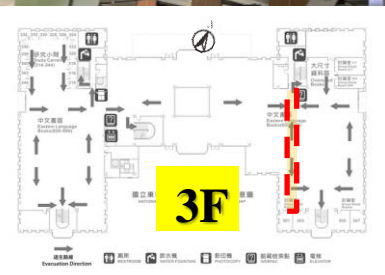
Fallen ceiling at the edge (3F)

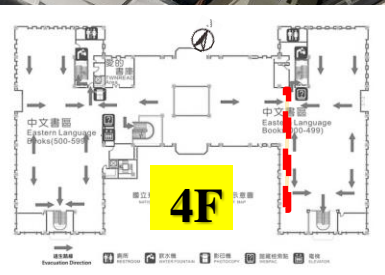
Fallen ceiling at the edge (4F)

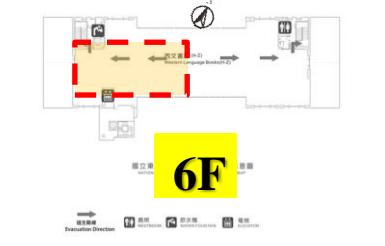
Collapsed Large-area ceiling (6F)

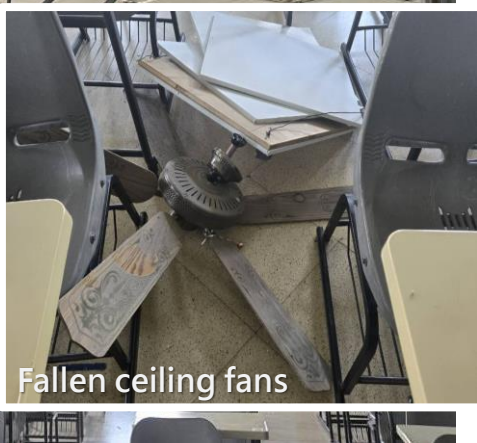
Fallen ceiling fans

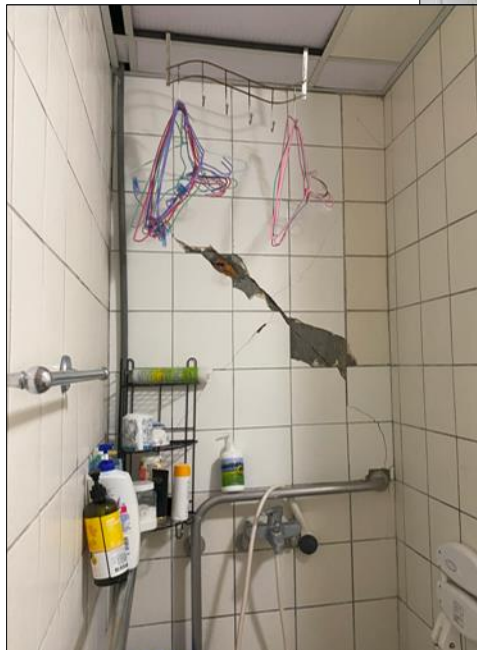
Damaged masonry walls (5F)

Cracked tiles on the opposite side of the wall

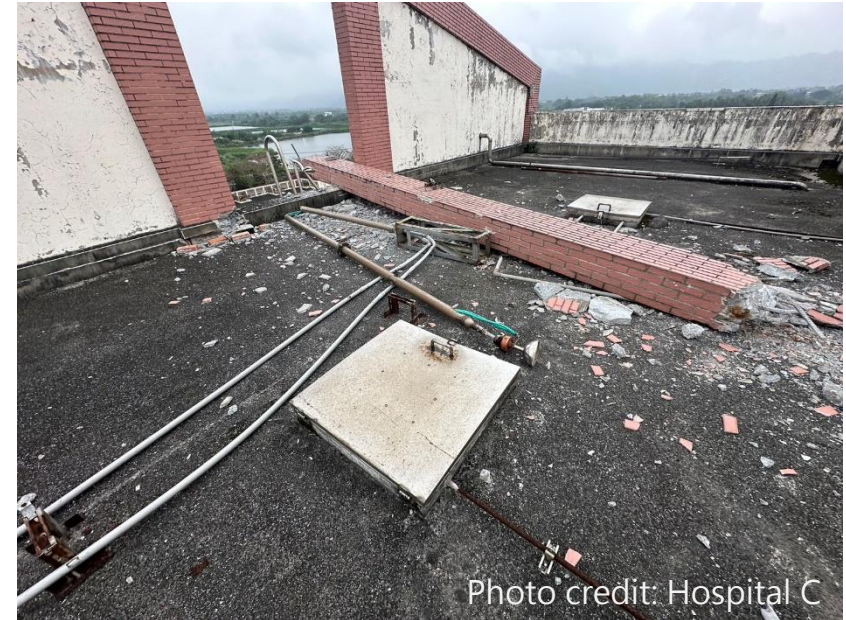
A beam connected to decorative gables collapsed on the penthouse

Another intact penthouse

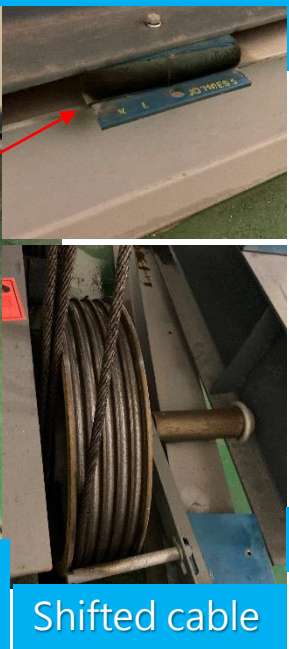
Shifted cable

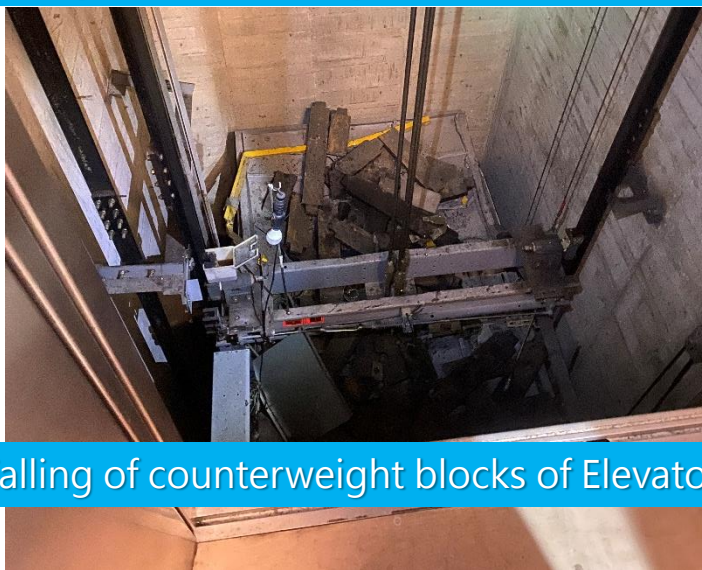
Falling of counterweight blocks of Elevator A

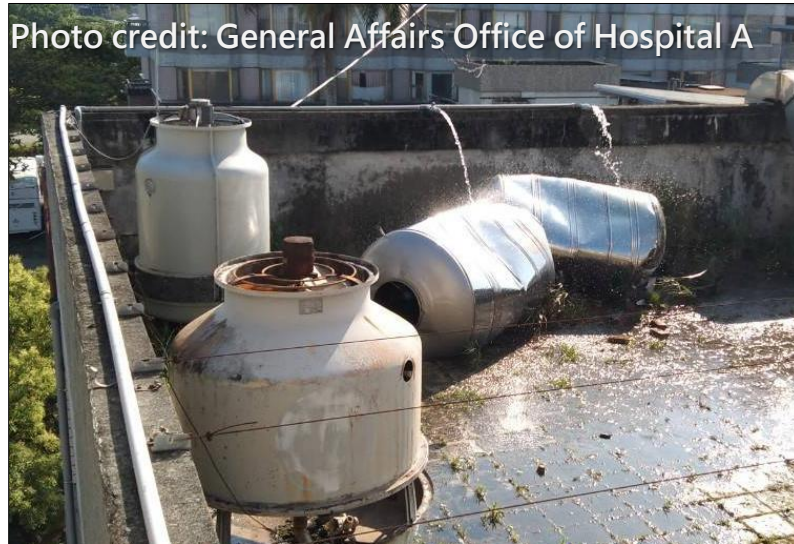
Collapsed tanks at rooftop of Bldg. A1

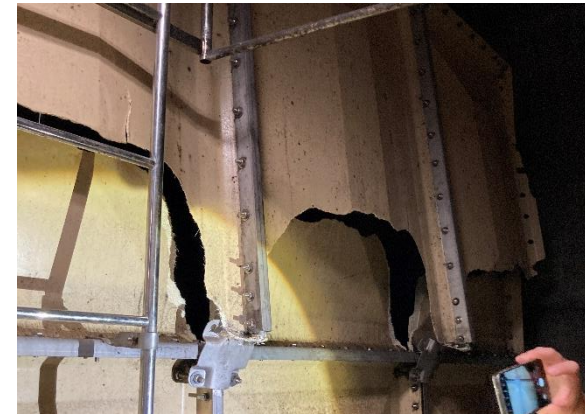
- In the basement, there are four FRP tanks, each with slight variations in form. The FRP panels are joined with angle steel. The innermost tank suffered damage.
- Among the four tanks, only the angle steel of the damaged one was not well-connected. The connection joints were damaged during the earthquake, resulting in tearing and damage to the FRP tank wall. ↗

Tearing and damage to the FRP tank wall

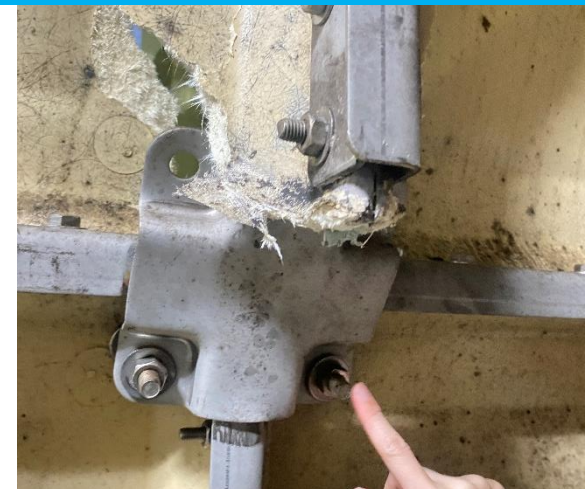
Damage to the connection joints

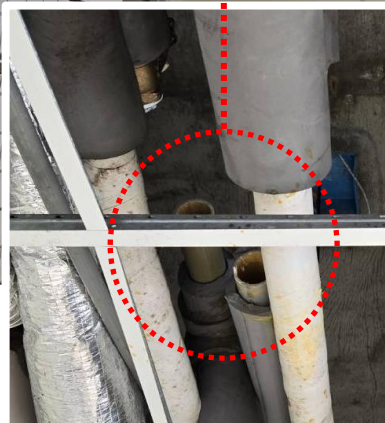
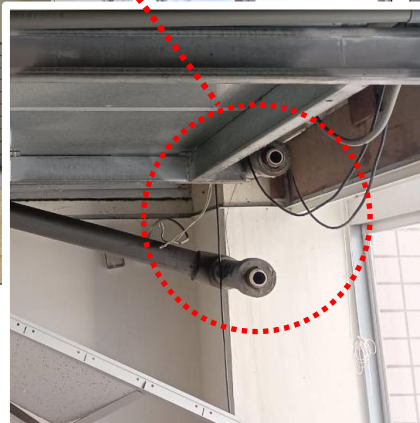
Excessive displacement of the air conditioning unit led to complete rupture of the adjacent fire sprinkler head due to impact (6F)
