# Summary Report of Hualien Earthquake in Taiwan on April 3, 2024 (2<sup>nd</sup> edition, V2.0)

**Chung-Che Chou, Chiun-Lin Wu, Juin-Fu Chai, George C. Yao**

**NCREE, Taiwan**

**May 25, 2024**

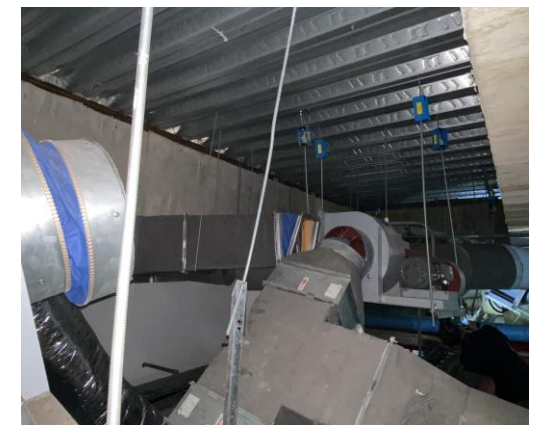
Separated ventilating machine and ductworks

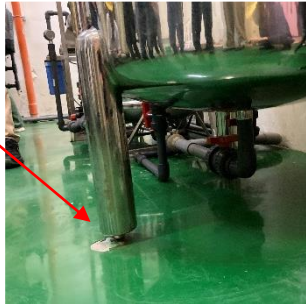
Freestanding water storage tank

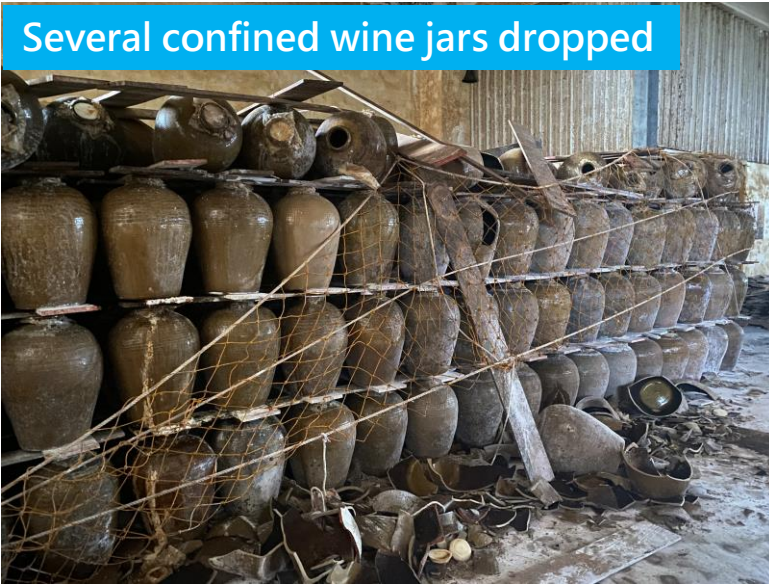
Unconfined stacked wine jars collapsed

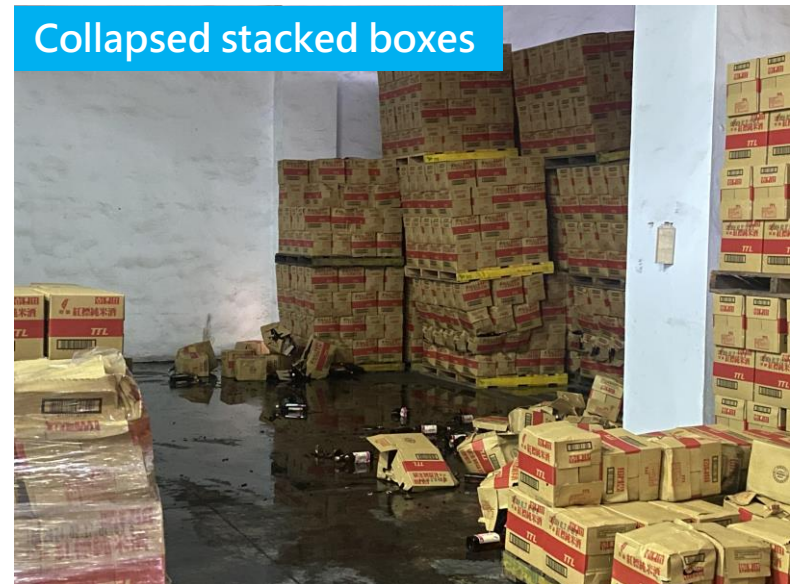
Collapsed stacked boxes

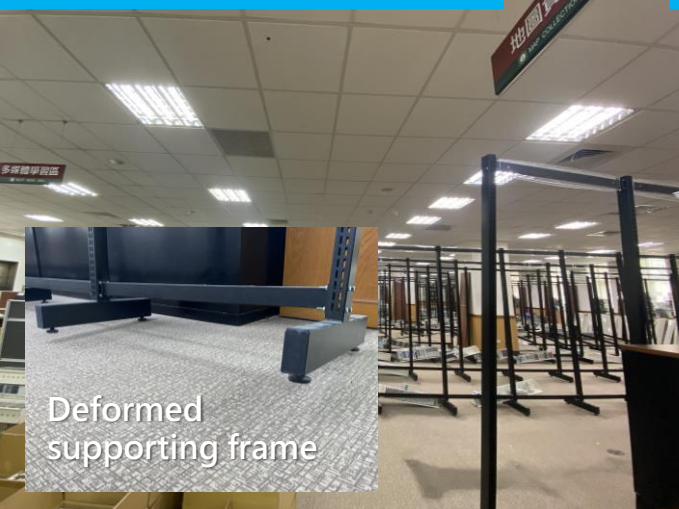
Deformed supporting frame

Deformed transverse ties (2F)

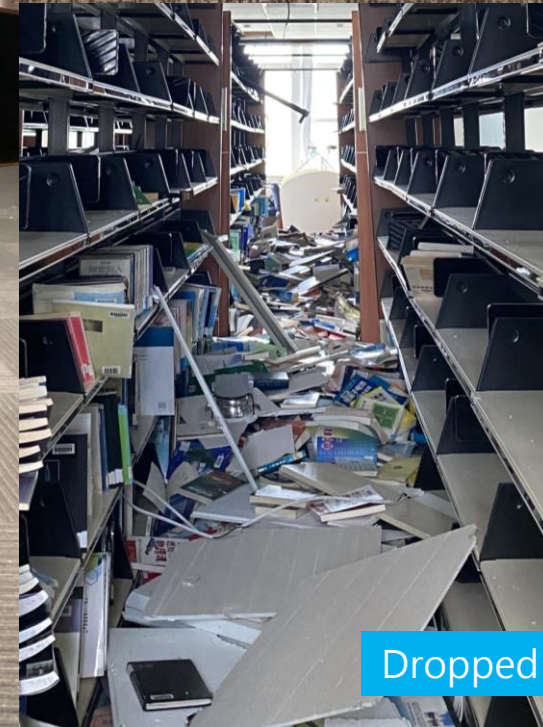
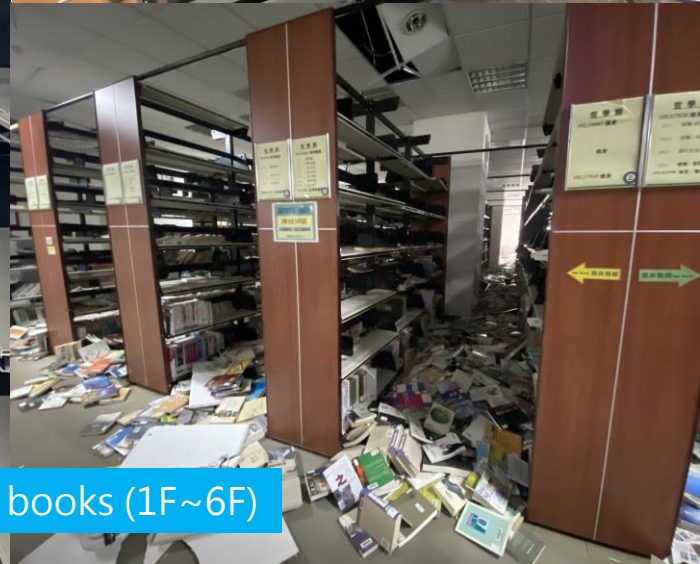
Dropped books (1F~6F)

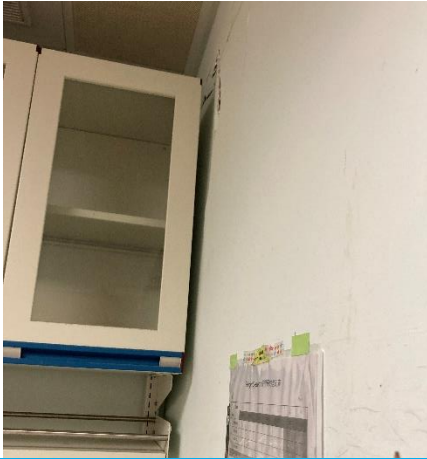
Partition wall damaged due to the tilted furniture

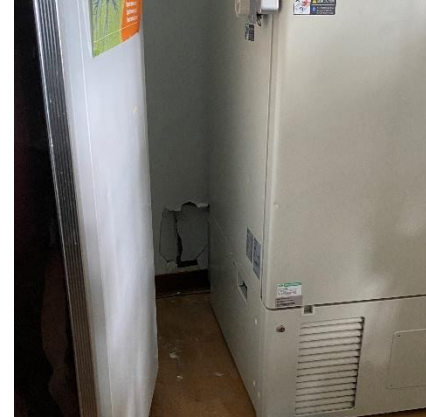
Partition wall damaged due to the displaced refrigerator

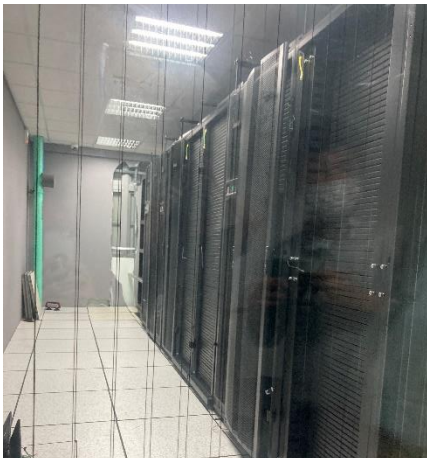
Partition wall hit by adjacent cabinets

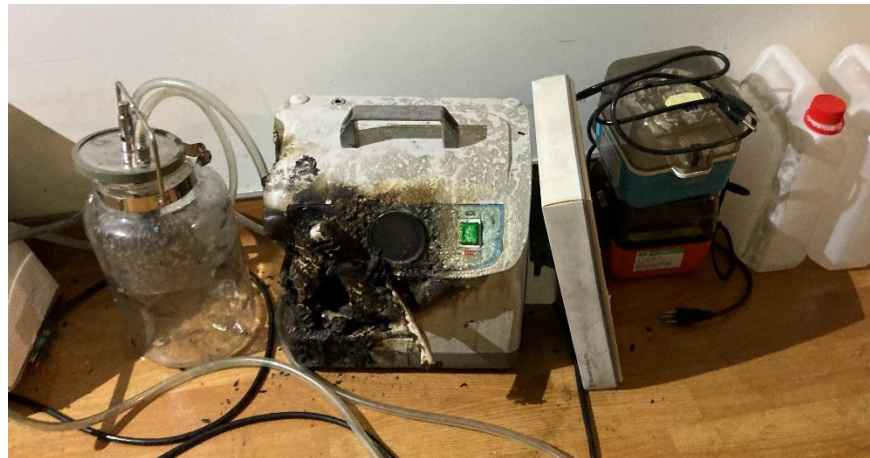
Experiment equipment was fallen and fired, and triggered the fire protection system.
